SILVER LAKE RESERVOIR
RICHMOND COUNTY, NEW YORK
INVENTORY NO. 60

PHASE I INSPECTION REPORT
NATIONAL DAM SAFETY PROGRAM

Name of Dam: SILVER LAKE RESERVOIR (I.D. NO. 60)
State Located: NEW YORK
County Located: RICHMOND
Date of Inspection: AUGUST 17, 1978

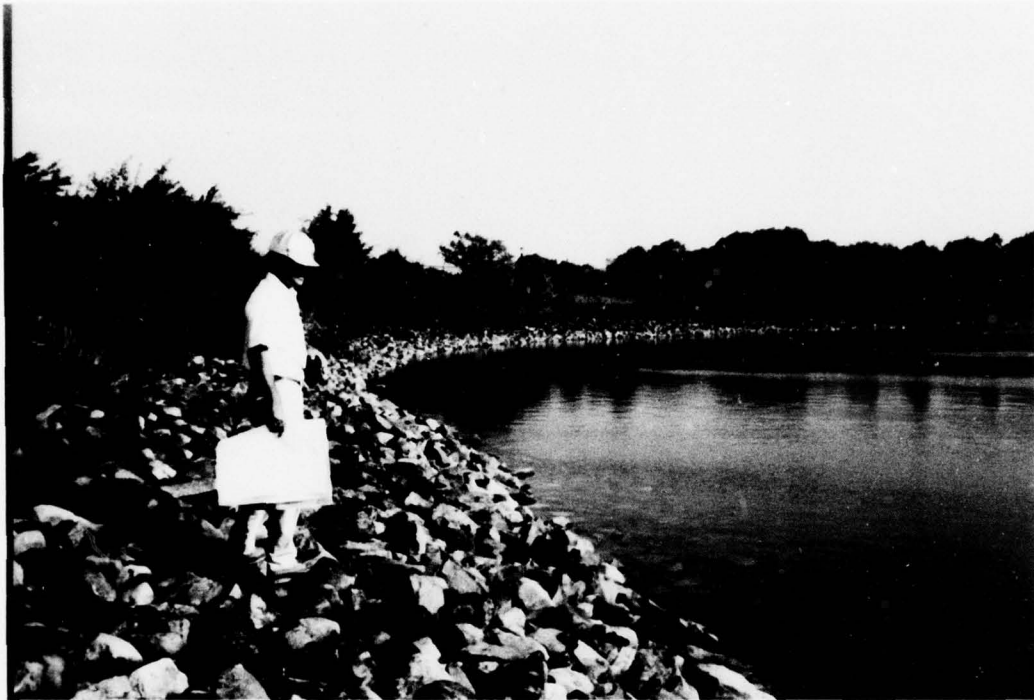
UPSTREAM SLOPE OF NORTH DIKE,
LOOKING NORTH

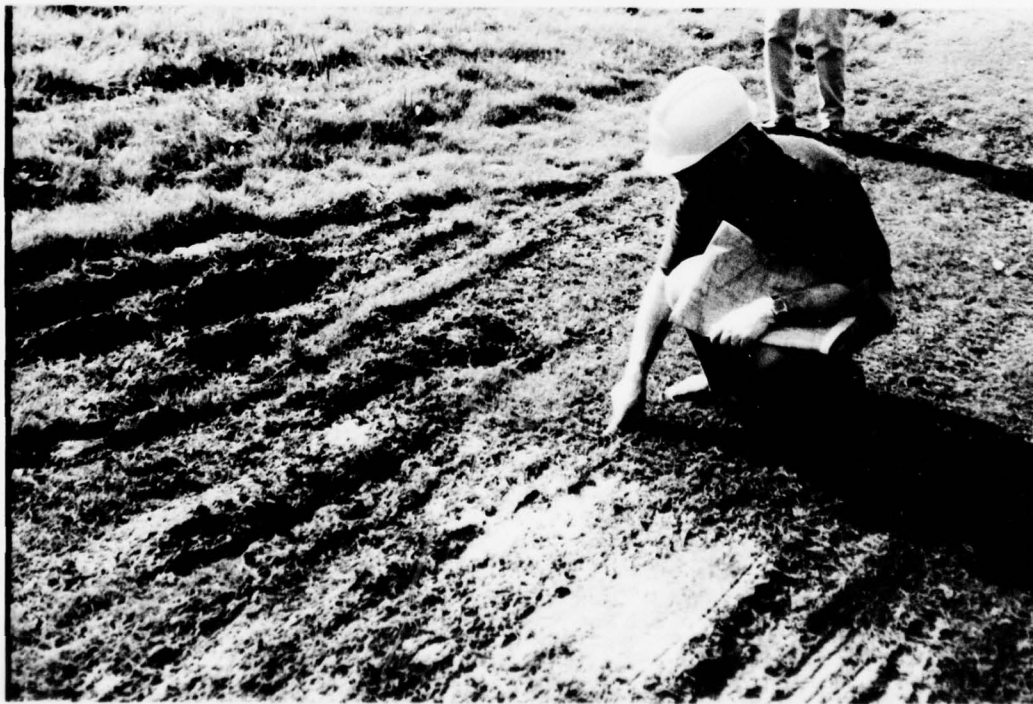
No seepage was visible on either the downstream slopes, toe or area below the toe of the West and South Dikes. At the time of the inspection, there was a wet, soft area visible on the downstream berm of the North Dike; no seepage was visible at this location. There were also wet areas just below the toe of the North Dike; these areas correspond to the general vicinity of a spring which is noted on the preconstruction drawings.

On the basis of this inspection, it could not be determined whether the wet area at the berm level of the North Dike is caused by seepage or poor surface drainage; in any event it is not considered to represent an unsafe condition. The wet area at the toe of the North Dike preexisted the dam and does not appear to be related to the impoundment.

WET AREA AT BERM LEVEL (EL 218⁺)
OF NORTH DIKE

- Establish a program of periodic inspections.
- Prepare an operation and maintenance manual for the project.
- Monitor periodically the wet areas on the downstream slope and at the toe of the North Dike.

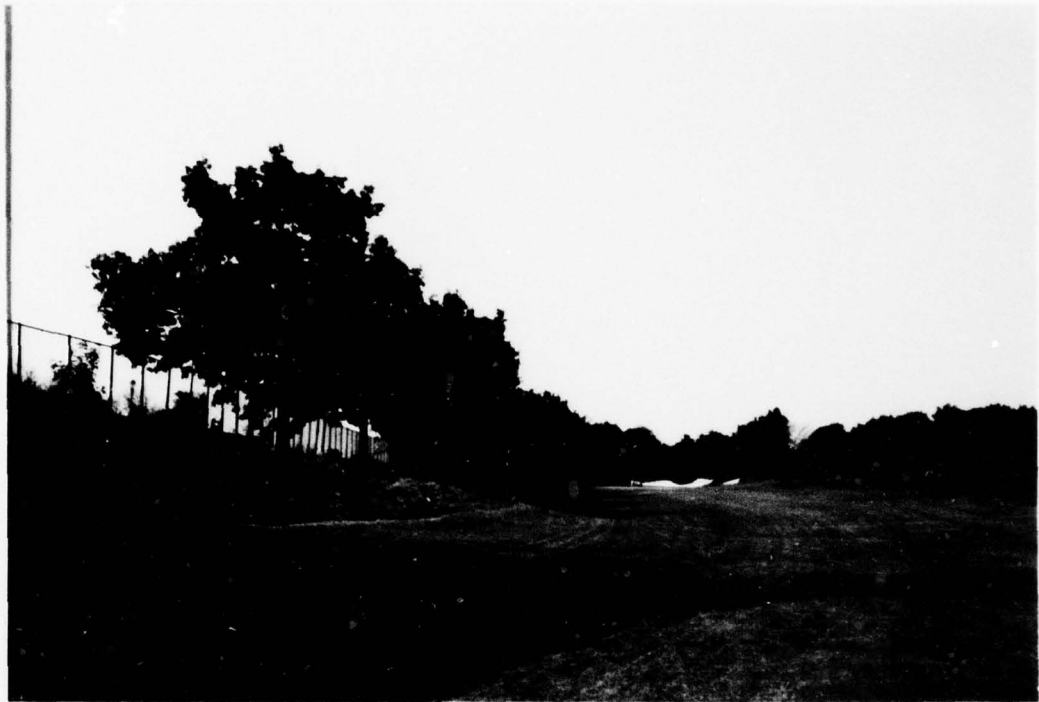
DOWNSTREAM SLOPE OF WEST DIKE, LOOKING SOUTH

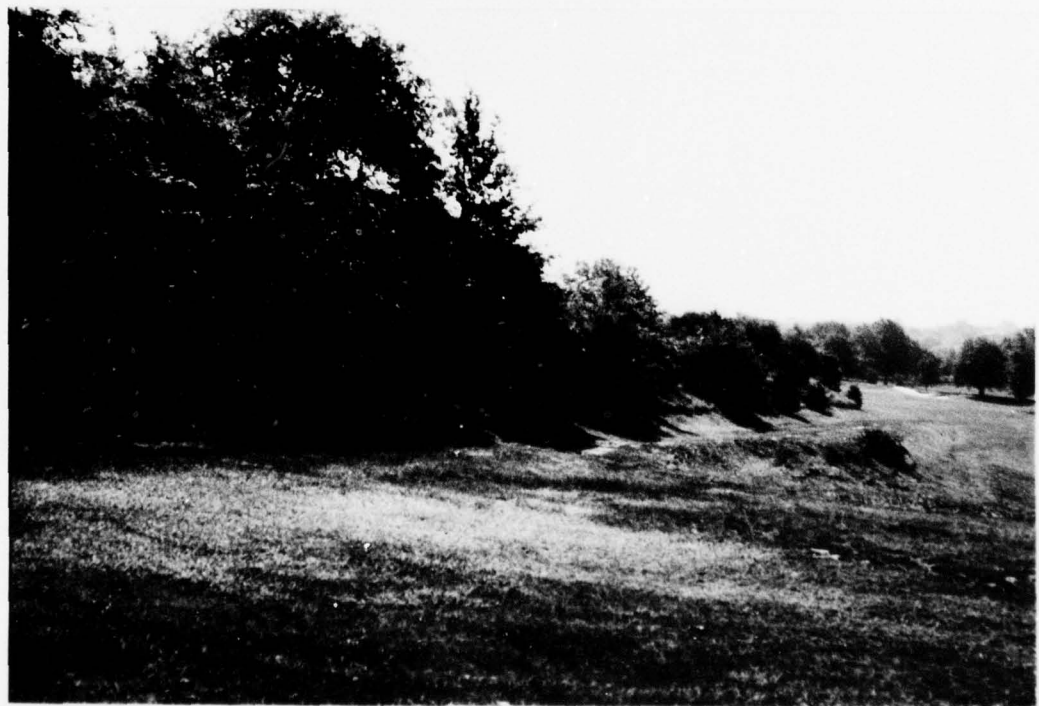
DOWNSTREAM SLOPE OF SOUTH DIKE, LOOKING EAST.
CREST IS NOT VISIBLE; FLAT AREA IS BERM AT EL 218±

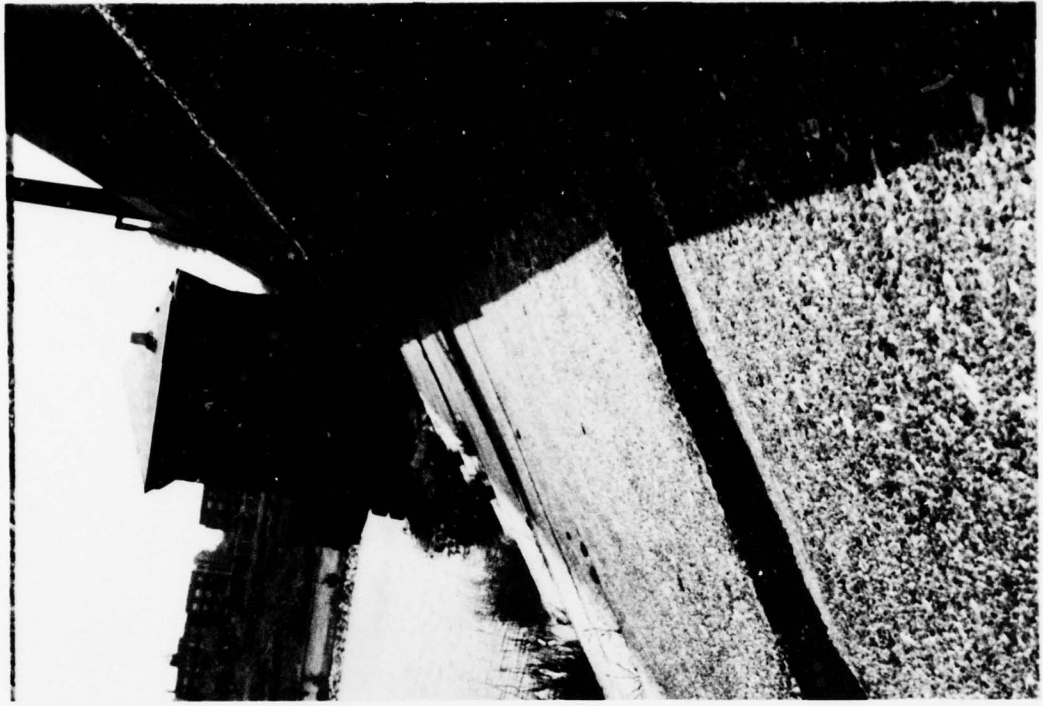
The upstream and downstream concrete slope facing slabs are cracked at many locations; grass and brush grow from the cracks and panel joints. At several locations there appeared to be differential vertical movement between adjacent slab panels. There were no other signs of distress on the visible portions of the Middle Dike.

Visual observation did not indicate either existing or potential problems with the dams and gate structures. The observed cracks in the concrete slabs on the upstream and downstream faces of the Middle Dike are not considered to represent an unstable or otherwise dangerous condition. The differential settlement between adjacent slabs is also not considered to represent a dangerous condition.

DIFFERENTIAL SETTLEMENT OF FACING SLABS
ON NORTHWEST FACE OF MIDDLE DIKE

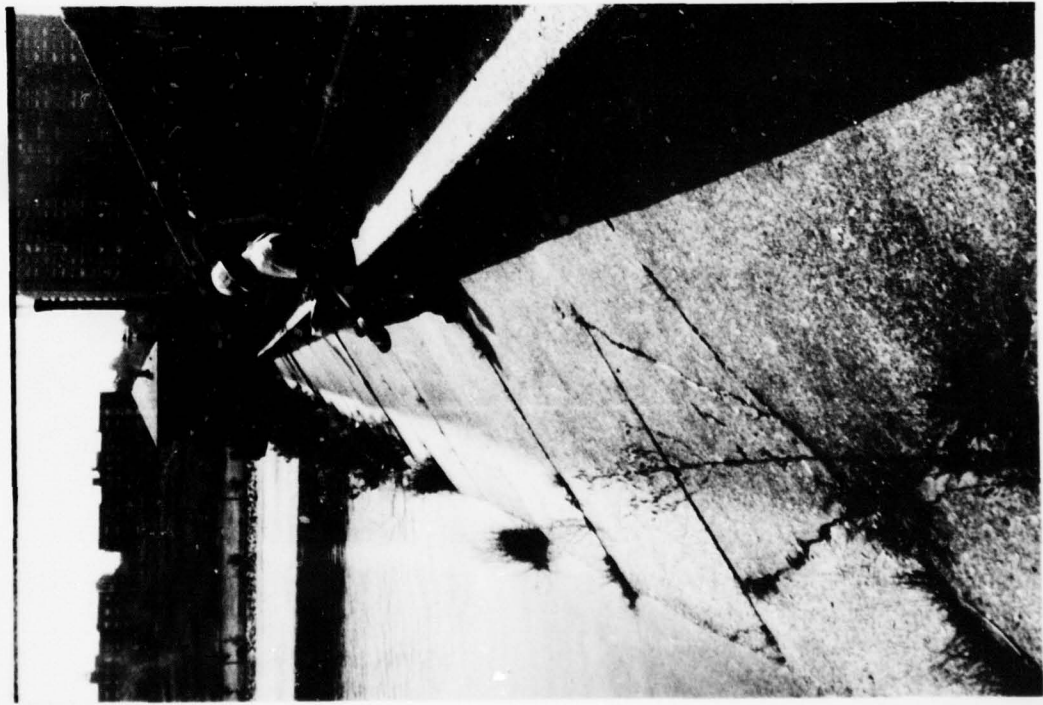
NORTHWEST FACE OF MIDDLE DIKE, LOOKING
EAST AT NORTH GATE HOUSE FROM WEST END OF DIKE

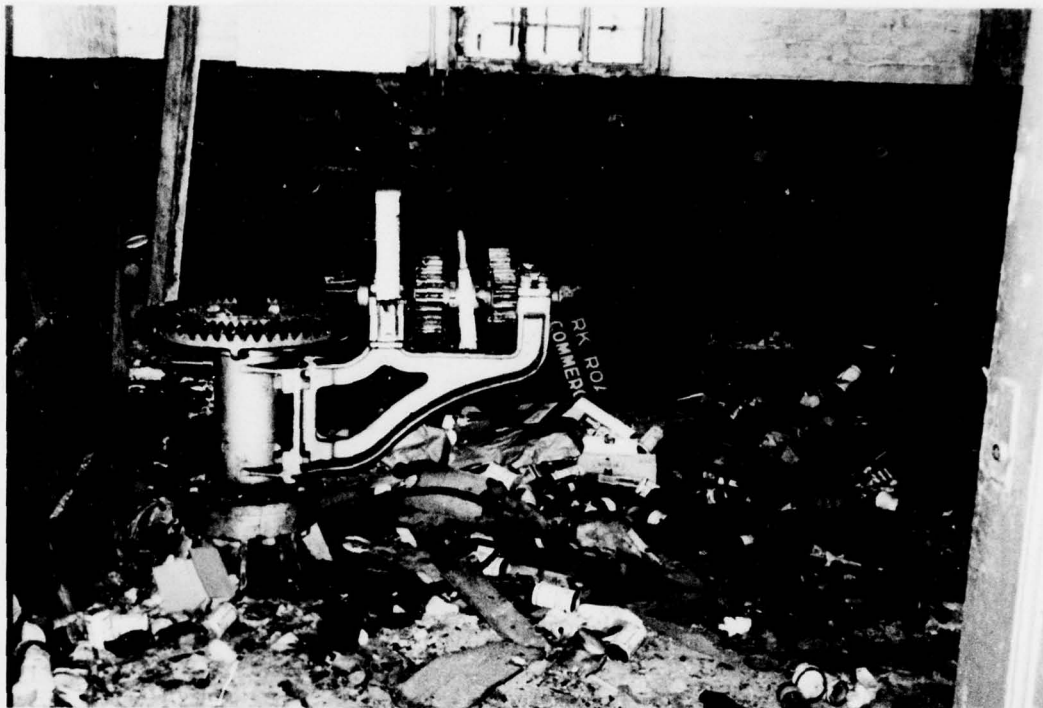
GATE OPERATING STAND FOR SOUTH
BLOW-OFF SLUICE GATE

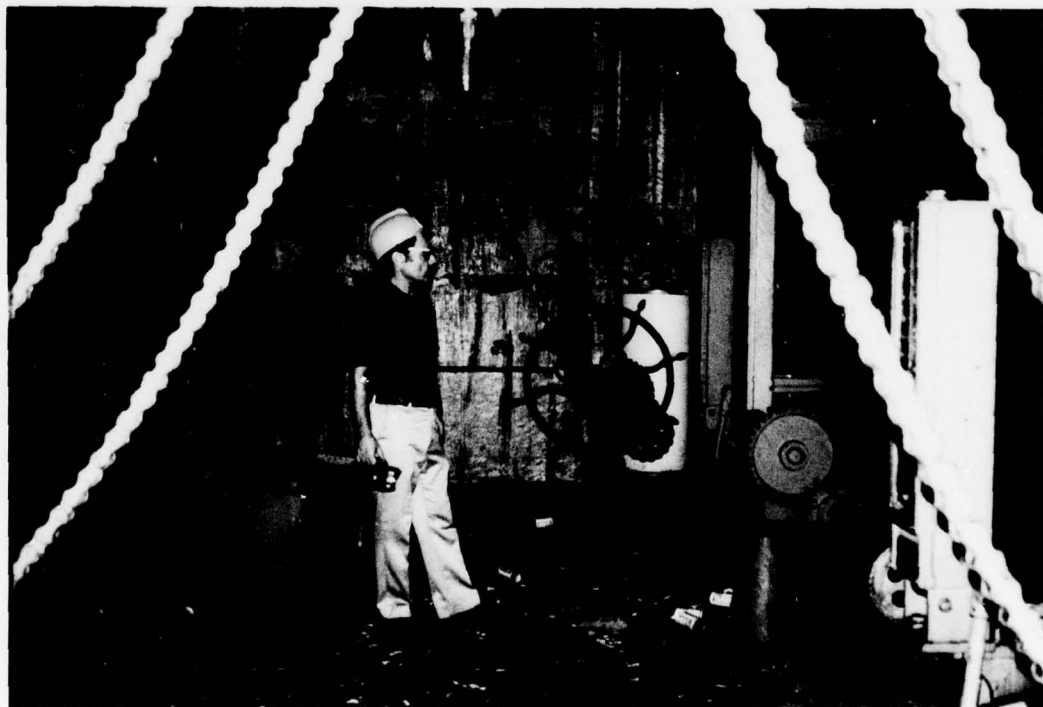
GATE OPERATING CHAMBER; LOOKING WESTERLY.
GATE OPERATING STAND FOR NORTH BLOW-OFF.
GATE VALVE AT CENTER OF PHOTO.

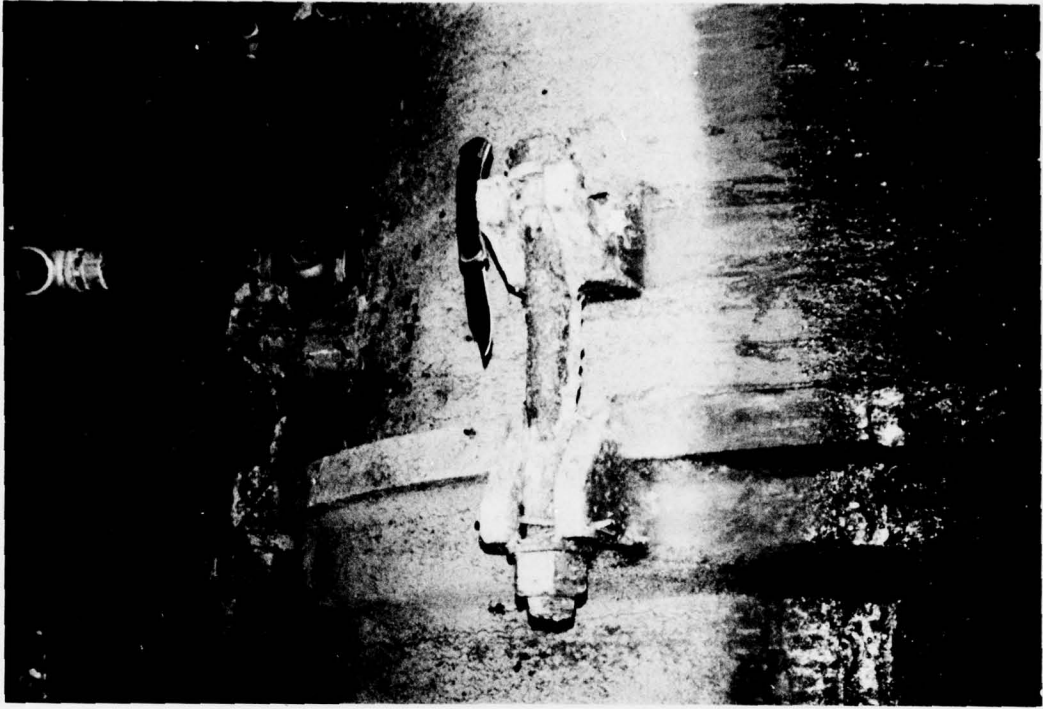
It was not determined whether the gate operating motor or drive train were operational. In general, the gate operating stands appeared to be in good condition to be operated manually. The gates themselves appeared to be in operable and in relatively good condition, even though they had been neither operated nor maintained since 1971. The condition of the exposed conduits appeared to be good. In general, the tie rods connecting gates to conduits were severely corroded.

The debris in the weir chamber should be removed to prevent blockage of the overflow well. The corrosion of the tie rods is considered to be an undesirable condition.

CORRODED TIE RODS (TYPICAL) CON-
NECTING CONDUIT TO 48 INCH CAST
IRON MANIFOLD

- d. Replace corroded tie rods in the valve chamber.
- e. Heavy brush, shrubs and young saplings should be removed from all locations on the embankments. Large conifers, but not deciduous hardwoods, should be removed. The remaining trees should be inventoried and their condition monitored. If a tree dies, the area around the tree should be closely monitored for seepage.

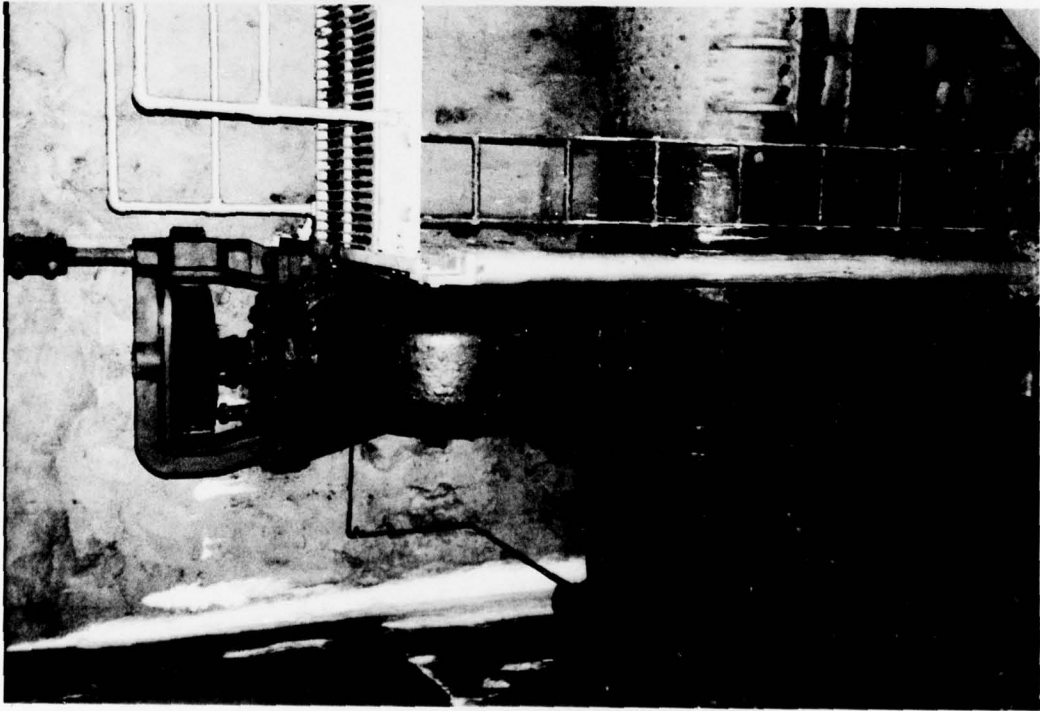
SOUTH BLOW-OFF GATE VALVE,
LOCATED IN VALVE CHAMBER

- b. Repair and maintain, as required to operate manually, the low level outlets (the 36 inch blow-off gate valves and the 30" x 92" sluice gates).
- c. Maintain in a clean and operable condition the waste weirs, the weir chambers and overflow wells.
