BUCK HORN LAKE DAM

OTSEGO COUNTY  
NEW YORK

INVENTORY NO 362

PHASE I INSPECTION REPORT  
NATIONAL DAM SAFETY PROGRAM

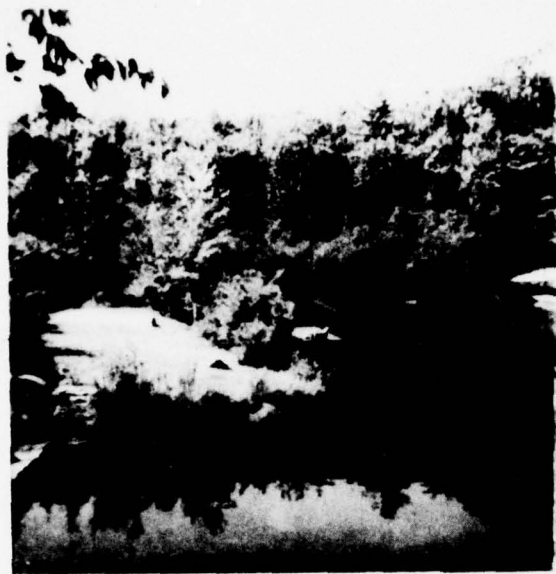
1. View looking west across face of dam.  
Spillway is in left portion of picture.

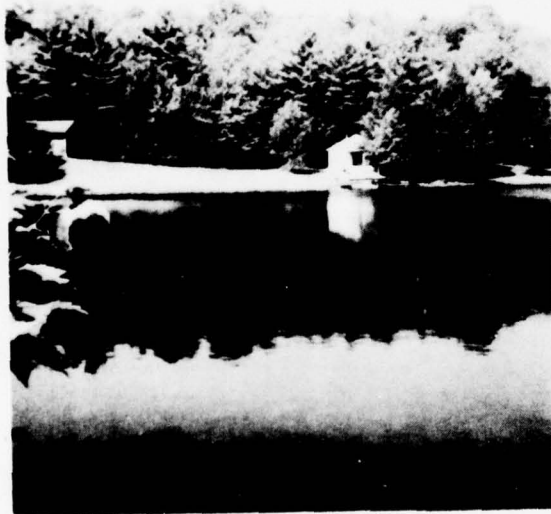
2. View looking west shows typical over-bank area and structures close to the water's edge.

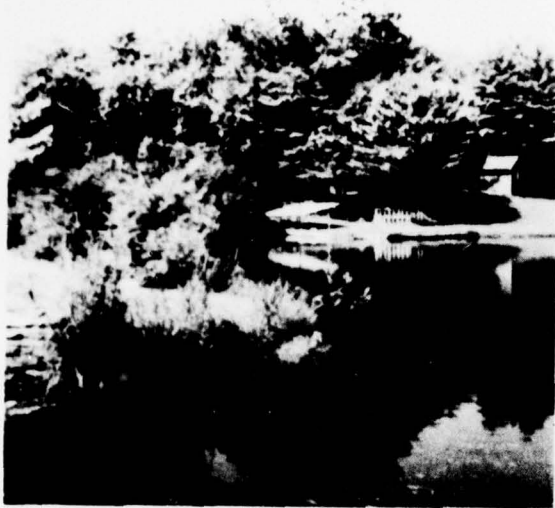
3. Another view looking west showing lawns and docks in the area.

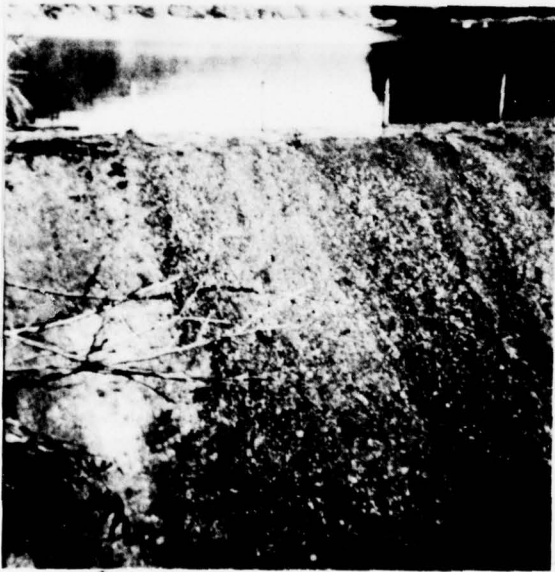
4. Closeup of spillway surface which is in serviceable condition with some surface erosion.

The concrete spillway is in generally good condition. At the time of the inspection the spillway was covered with dry algae; a small flow was observed over the top of the spillway. The face of the spillway is somewhat eroded. A small crack exists across the face of the spillway.

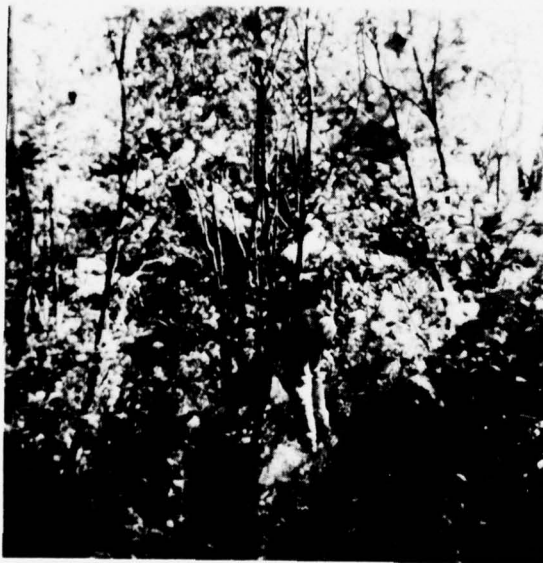
6. Typical picture showing treed area on top of dam.

- 1) Trees and brush should be removed from the dam surface and the areas should be seeded and mowed so that they may easily be inspected. Trees and stumps should be removed from the abutments and the stump holes should be properly backfilled with impervious material.
- 2) Riprap should be placed on the upstream face of the dam at the waterline to provide adequate protection from wave action.
- 3) The drainline from the dam should be inspected throughout its length to determine the amount of deterioration that has taken place in areas that are not visible from the outlet end. The drainline, if severely deteriorated throughout its length, should either be replaced or relined and grouted. The shear gate controlling the dam outlet pipe should be accessible for operation from the water surface.

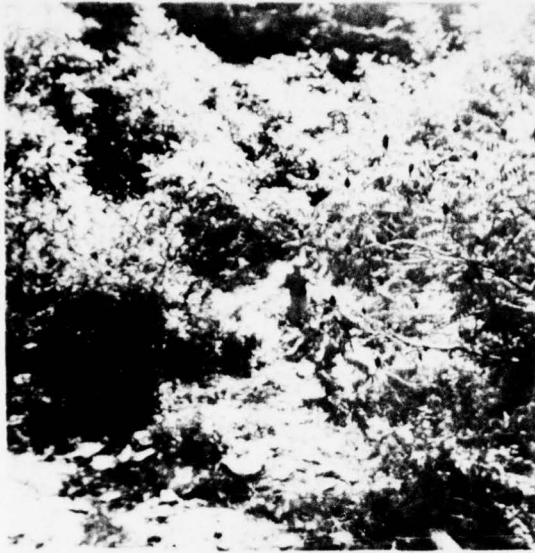
7. View of downstream spillway channel.

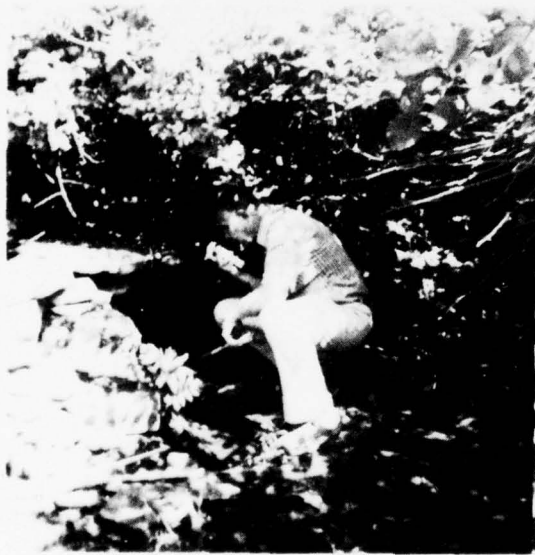
8. Outlet pipe area.

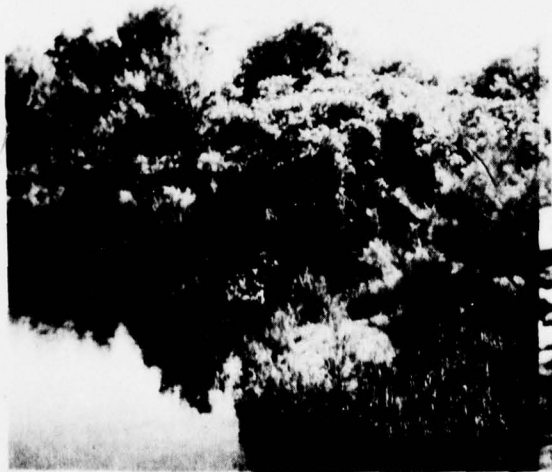
10. View of heavily treed area along the eastern portion of embankment looking across the spillway.
