HILLVIEW RESERVOIR
WESTCHESTER COUNTY
NEW YORK

INVENTORY NO 187

PHASE I INSPECTION REPORT
NATIONAL DAM SAFETY PROGRAM

JULY 1978

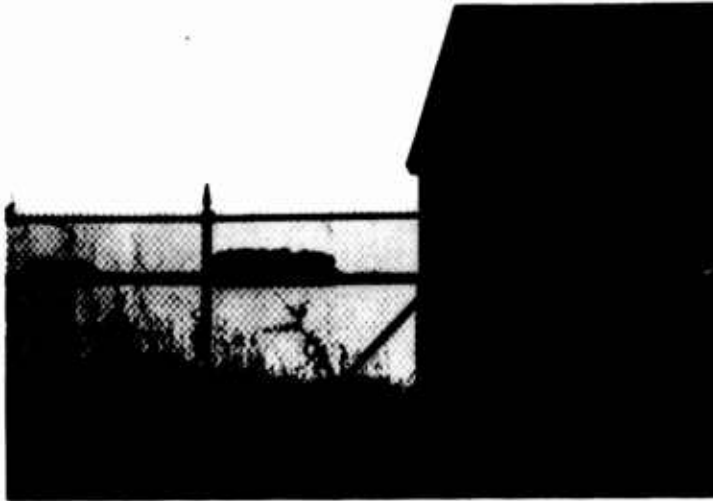
1. View of reservoir looking past dwtake #1.

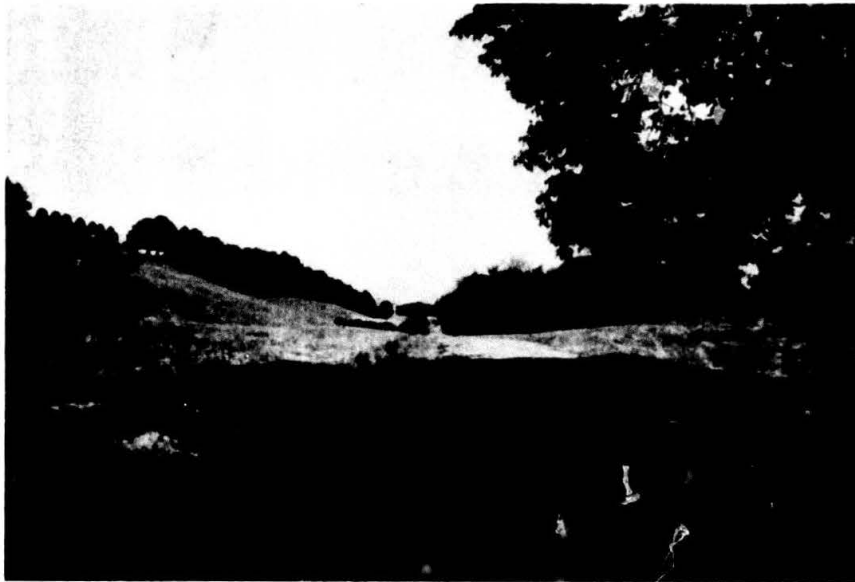
4. Another view looking west along property access road.

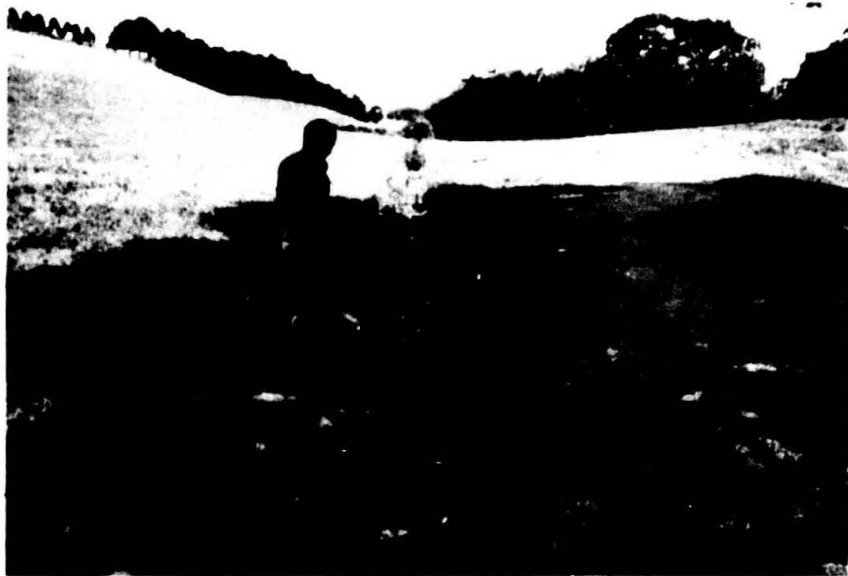
5. Detail of local drainage works along access road at toe of embankment.

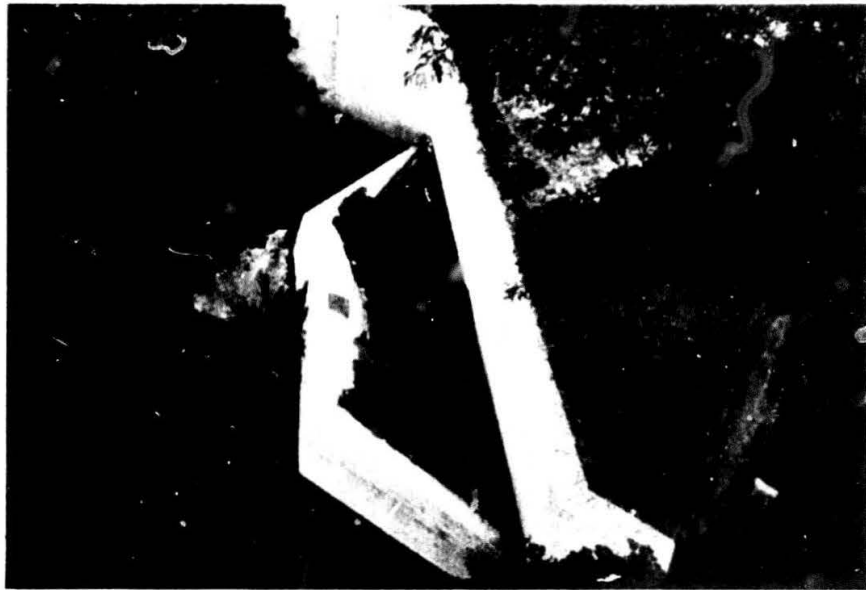
7. View of Wakefield Street outfall into Bronx River. No discharge at time of inspection.

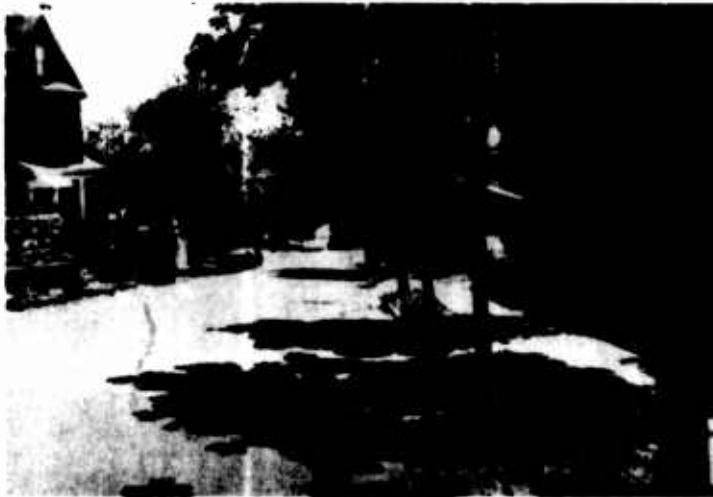
10. View of Wakefield Street area east of reservoir.
