**JEROME PARK RESERVOIR DAM
BRONX COUNTY, NEW YORK**

**PHASE I INSPECTION REPORT
NATIONAL DAM SAFETY PROGRAM**

4. TITLE (and Subtitle)
Phase I Inspection Report
Jerome Park Reservoir Dam
Bronx County, New York
Inventory No. N.Y. 64

12. REPORT DATE
5 September 1978
13. NUMBER OF PAGES

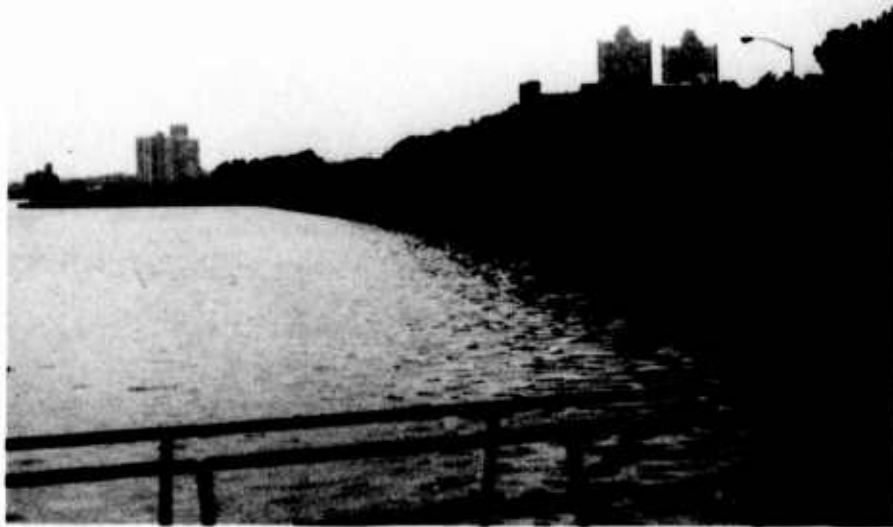
FIGURE 1 EAST RETAINING WALL

All sections of retaining wall at the water's edge along the western, southern and eastern boundaries of the dam were of stone masonry construction and consisted of mortared, rock-faced, granite blocks with a surface-finished granite cap (Figs. 1 and 5, Appendix D). In all cases, the retaining walls were found to be in generally good condition and very well maintained.

The roadway that extends around the perimeter of the dam at about elevation 140.1 appeared to be in generally good condition. Occasional cracks (Fig. 5, Appendix D) were observed in the paved sections of the roadway on the northern, western and southern perimeter; however, inspection of the embankment near the cracks revealed that they were not due to movement or cracking of the embankment, but were probably the result of expansion or vehicular stress. The southern portion of the perimeter roadway is unpaved (Fig. 12, Appendix D); it is easily passable, although there is tall vegetative growth on its sides (Figs. 1 and 12, Appendix D).

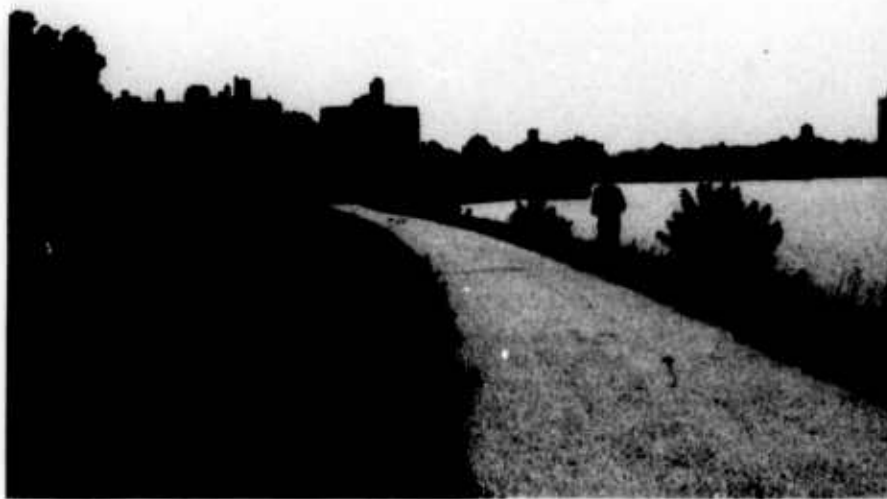
FIGURE 2 WESTERN EMBANKMENT AND SEDGEWICK AVENUE
LOOKING NORTH

In general, all earthen embankments were found to be grass covered and very well maintained (Figs. 2 and 3, Appendix D). No seepage was detected on or at the toe of the downstream slopes. A chain link fence, with barbed wire top in some areas, encircles the reservoir (Fig. 3, Appendix D). Along the western and northern portions of the perimeter, the fence is at or near the toe or toe wall of the embankment. There is a paved city street usually within 50 feet of the fence in these areas, and beyond that private residences. Consequently, no evidence of seepage beyond the toe could be observed.

A small section of the chain link fence surrounding the reservoir was missing along the eastern perimeter on the day of the inspection. We were informed by NYCDWRBWS personnel that breaches such as this were commonplace and that the one observed had not been there the previous day. It became apparent during the inspection and from conversations with Messrs Ragucci and Kuse that security measures in effect at the reservoir were not totally effective. We were informed that four trespassers had drowned in the reservoir in the past two years. On the day of the inspection, joggers (trespassers) were observed within the compound (Figs. 2 and 3, Appendix D).

(e) Breaches of the chain link fence should be repaired.

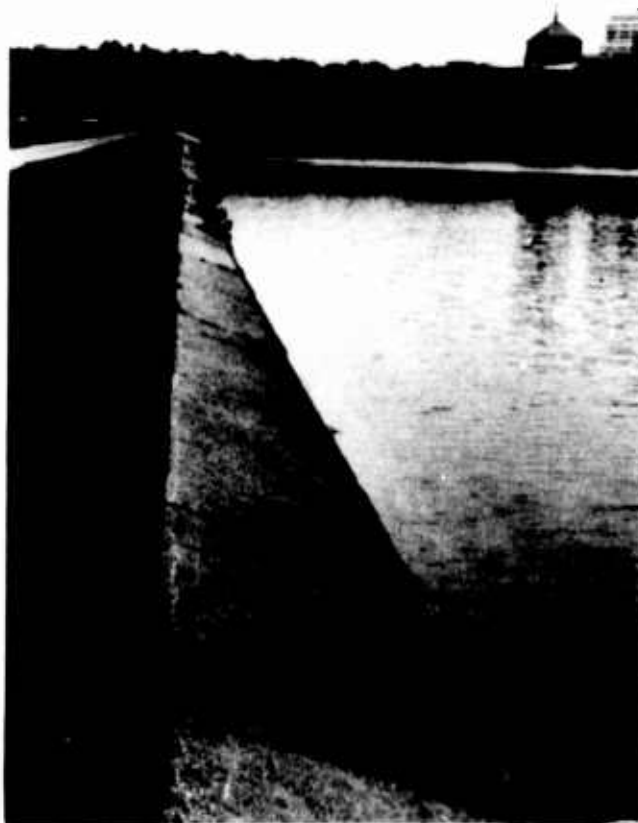
FIGURE 4 CONCRETE APRON AT NORTHERN END OF RESERVOIR

The earthfill and core wall section at the northern end of the reservoir was inspected and found to be in generally good condition. No significant deterioration of the upstream concrete apron was observed; vegetative growth in some of the construction joints was noted (Fig. 4, Appendix D).

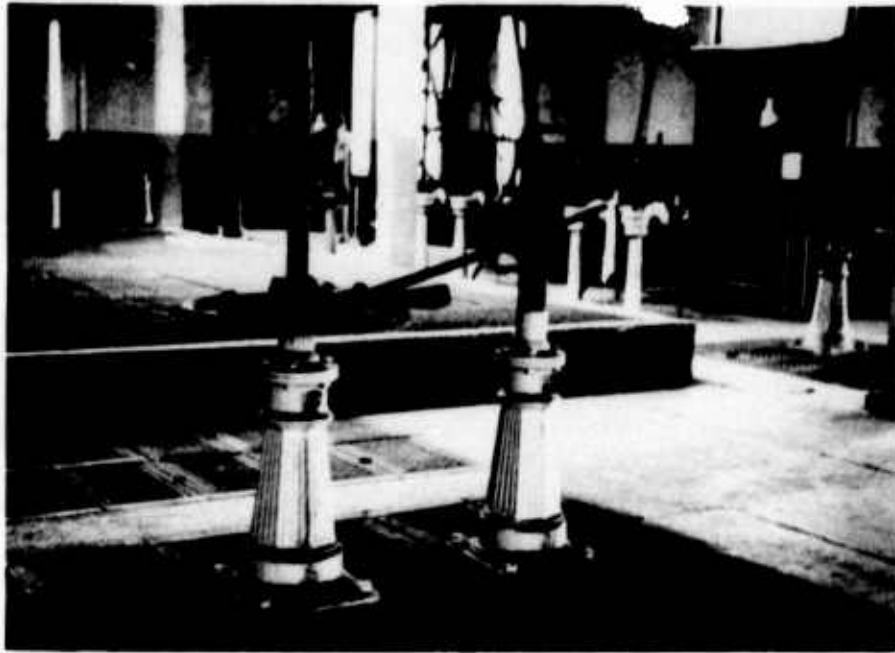
FIGURE 7 GATEHOUSE No. 5 GATE STAND ARRAYS

The four gates controlling flow from Main Chamber No. 19 in Gate House No. 5 to Shaft No. 21 (Manhattan's water supply line) were inspected and observed to operate satisfactorily. They are driven by a portable electric motor mounted on a tripod (see Background in Fig. 7, Appendix D).

The operating facilities are in generally good condition. The only exception noted was that the "lock dogs" on five out of six gate controls in Gate House No. 5 were missing. These gates are important in that they control flow from the aqueduct to the reservoir via the south portal.

(a) "Lock dogs" should be provided; they were missing on the five gate stems controlling flow to the south portal inlet in Gate House No. 5.

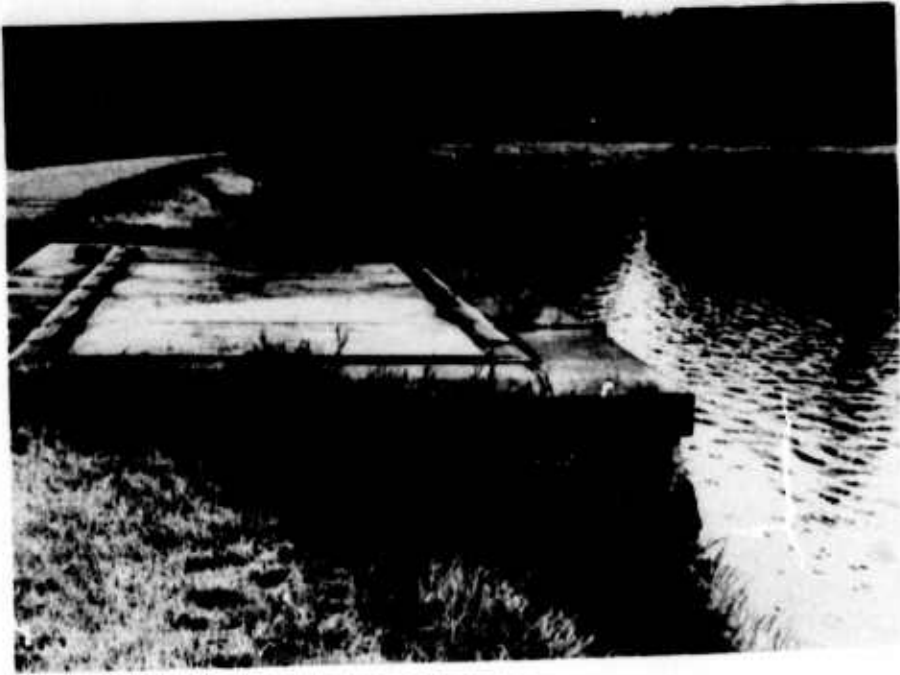
FIGURE 11 WASTE WIER

The exposed portion of the waste weir was inspected and found to be in generally good condition (Fig. 11, Appendix D). Here again, the top grill had been replaced by steel plates welded to the grill mounts because of past experience with vandalism. Water was heard flowing over the waste weir; flowing water could also be observed through joints between the steel cover plates. From field observation and from a review of the design drawings, it seemed that if the weir structure should fail, water from the reservoir would flow freely into the Broadway Sewer.
