⑥ National Dam Inspection Program, Dehart Dam (Inventory Number NDS-PA-561), Susquehanna River Basin, Clarks Creek, Dauphin County, Pennsylvania. Phase I, Inspection Report.

DEHART DAM

## PHASE I INSPECTION REPORT

Name of Dam: DEHART DAM  
 State & State No. PENNSYLVANIA - 22-9  
 County: DAUPHIN  
 Stream: CLARKS CREEK  
 Date of Inspection: July 7, 1978

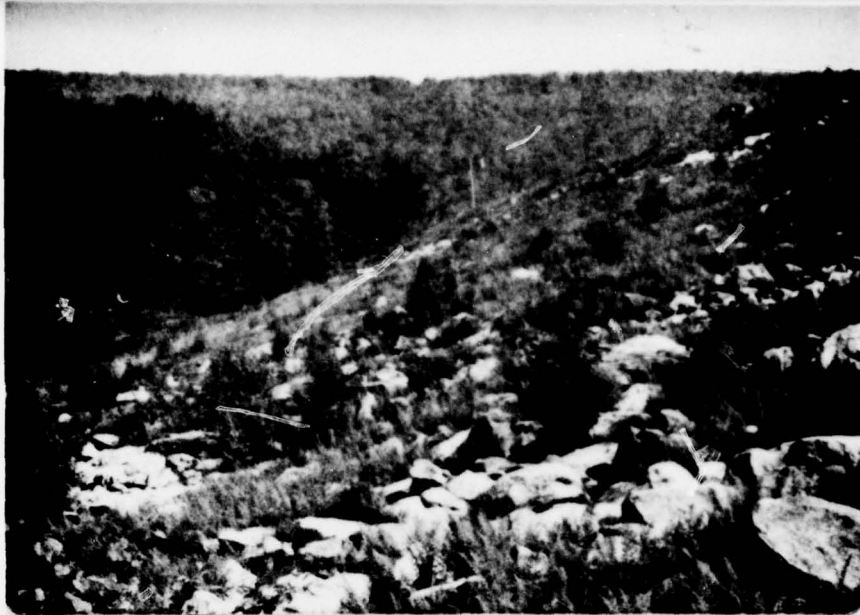
Downstream  
Slope

The embankment shows no signs of distress. The rock slopes, both upstream and downstream are relatively uniform considering the size of rock (18 to 48 inches) which cover these surfaces. Heavy fern growth is found between the nested rocks on the downstream slope. Some light fern growth is located near the top of the slope on the upstream slope. The presence of this vegetation does not have any influence on the stability of the embankment; however, some trees on the downstream slope should be removed.

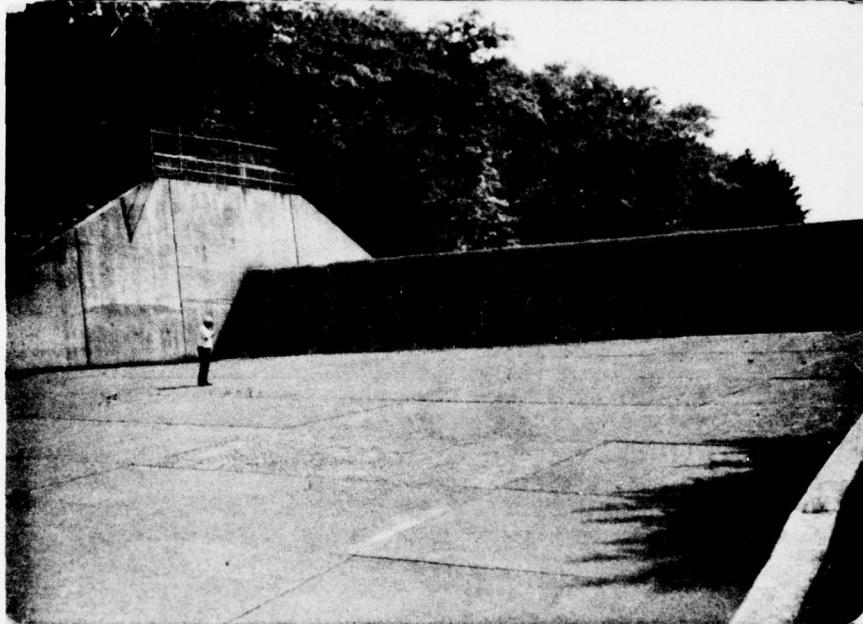
Spillway

The spillway was observed to be in good condition. Its dimensions were checked and found to be in accordance with the 1954 modifications.

The cutoff wall at the right abutment was found to be exposed at the surface indicating a short low section just behind the wall.

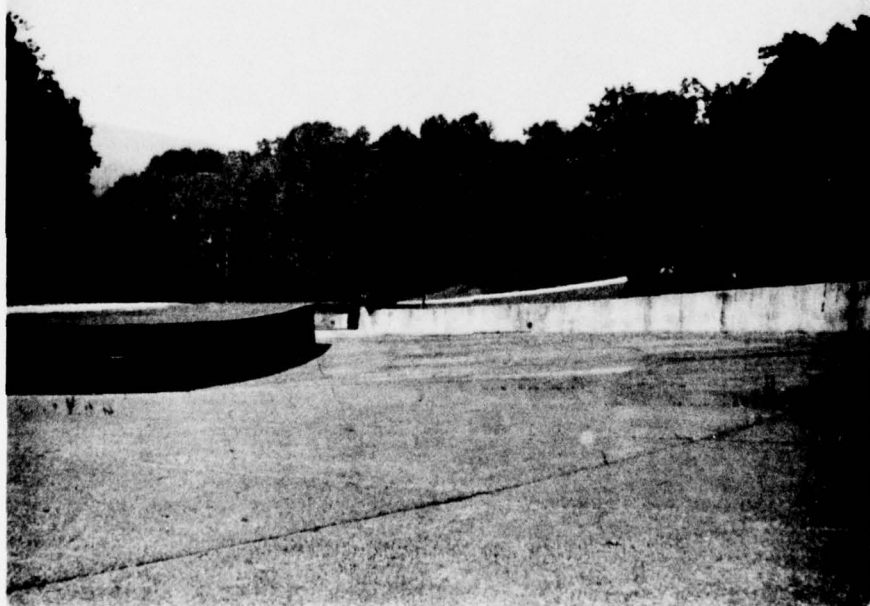
Spillway  
Channel

With the exception of some surface weathering on several slabs and exposed joints, the slabs of the spillway channel are in good condition. The walls are also in good condition. Some heavy spalling was observed at the top of some of the wall sections at the construction joint. These conditions do not impair the function of the spillway but preventative maintenance should be encouraged.

1. Observe and record the behavior of the apparent seepage at the toe of the embankment left of the left spillway wall. Take appropriate remedial measures if indicated.
2. Repair the spillway walls and slab of the spillway outlet channel as soon as possible.

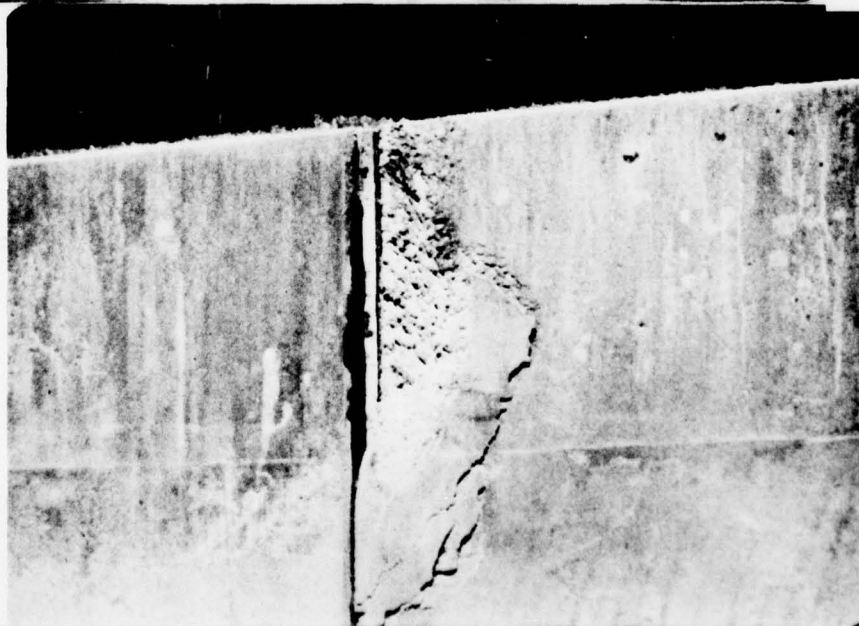
Spillway  
Wall Joint

C. DISCHARGE CHANNEL Lining Cracks Spilling Basin	Spalling on wall at end of sloped section on left side at top plus several others along the entire channel. Slabs in good condition. Curbed, superelevated channel Cracks in top of right spillway sloping wall.
