⑥ National Dam Inspection Program, Gunter Valley Dam (Inventory Number NDS-PA-323), Susquehanna River Basin, Trout Run, Franklin County, Pennsylvania. Phase I Inspection Report.

GUNTER VALLEY DAM

INVENTORY NUMBER NDS PA-323

PHASE I INSPECTION REPORT

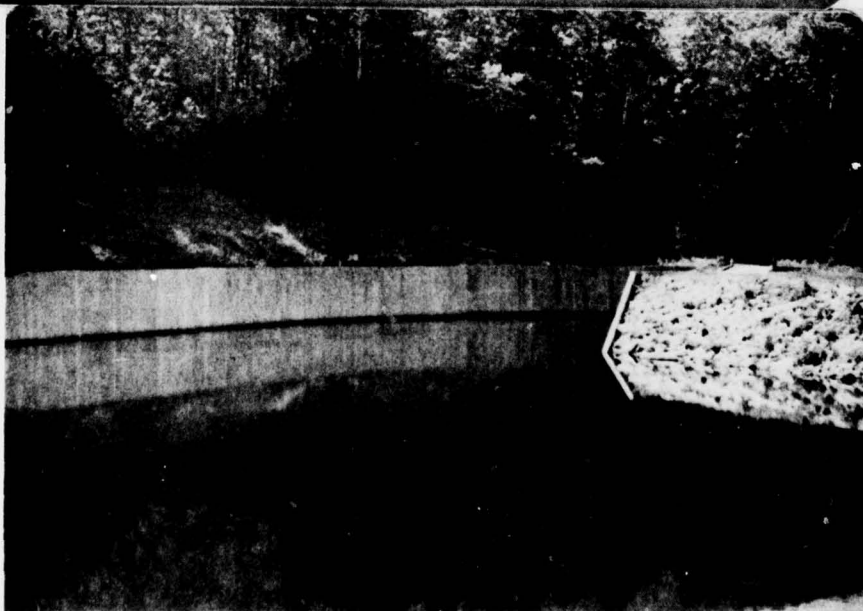
Forebay

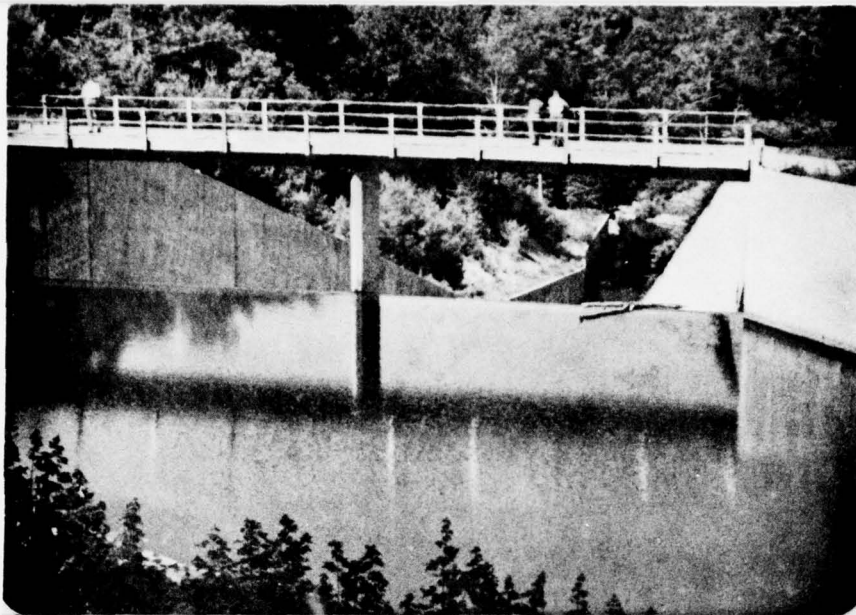
Spillway &
Bridge

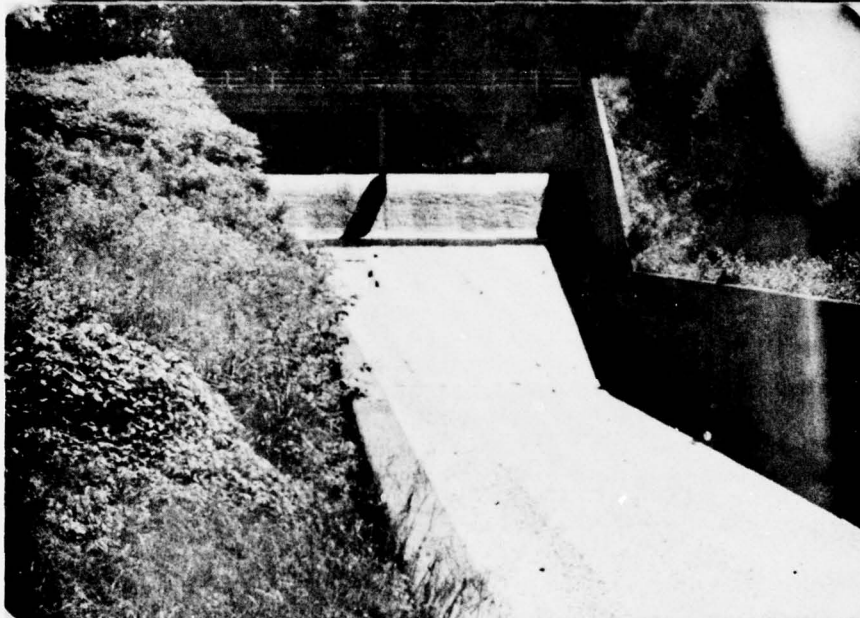
All other walls were in good condition, except that it was noted that there were no weep holes in the right spillway wall. A slight spalling of the concrete spillway slab has occurred about 50 feet downstream of the spillway bridge and some reinforcement has been exposed.

Spillway Channel

1. The owner shall repair the spillway slab if any further deterioration occurs.
2. A formal surveillance and downstream warning system shall be established by the owner to be used during periods of high precipitation.

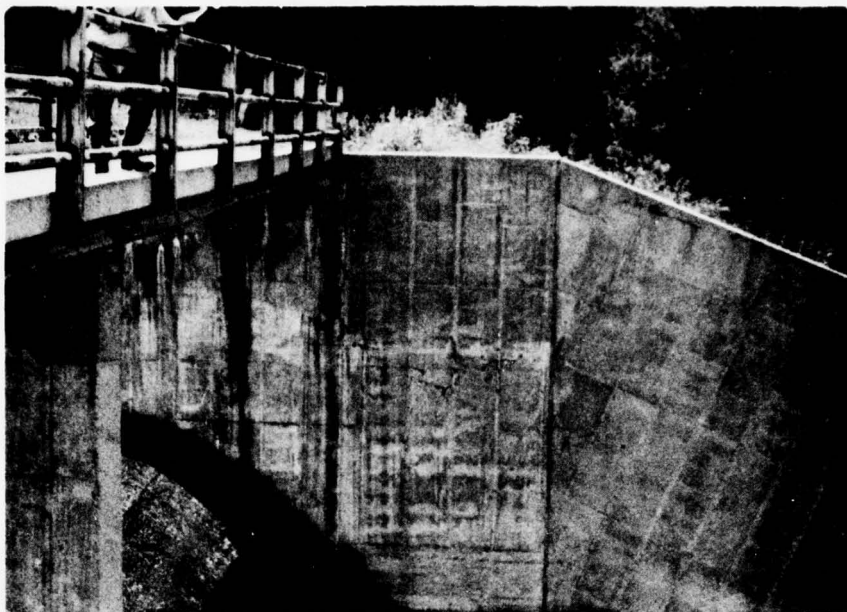
The spillway, located in the left abutment was in good condition. The forebay walls and ogee weir were in excellent shape. Some minor cracking has occurred in the abutment walls under the bridge across the spillway. All joints appeared to be in good condition. The wall in the right spillway wall just below the bridge had deflected slightly (Appendix D, Plate V), but not significant in relation to its height (See Section 6.1.B.2).

Wall Cracking

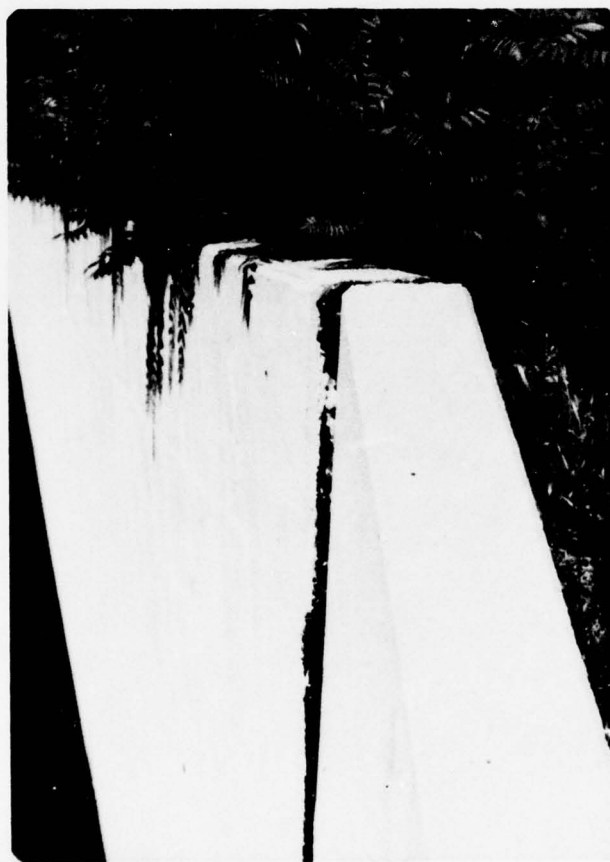
Visual observations indicate no present stability or stress problems in any of the appurtenant structures. Some deterioration of the spillway chute slab has occurred and one wall has slightly deflected (Appendix D, Plate V). Some concern exists about the hydrostatic pressure behind the right spillway over the length of wall where water was running over the surface. There were no weep holes in this wall.

On Sheets 3 and 4 a deflection calculation for the spillway wall adjacent to the bridge was made. This 28.5 foot high wall has deflected approximately one inch and this was reported first in 1965. Assuming that the footing does not rotate, an active soil pressure of 35 lbs/cu.ft. causes a deflection of 5/16-inch. However, the soil pressure will be higher due to some saturation and the U-shaped design makes a small rotation of the footing feasible. Above calculations are short term deflections. Long term deflection will be about twice as high. The deflection of the wall is not considered to be serious and a logical result from the type construction.

Wall Movement Spillway Wall

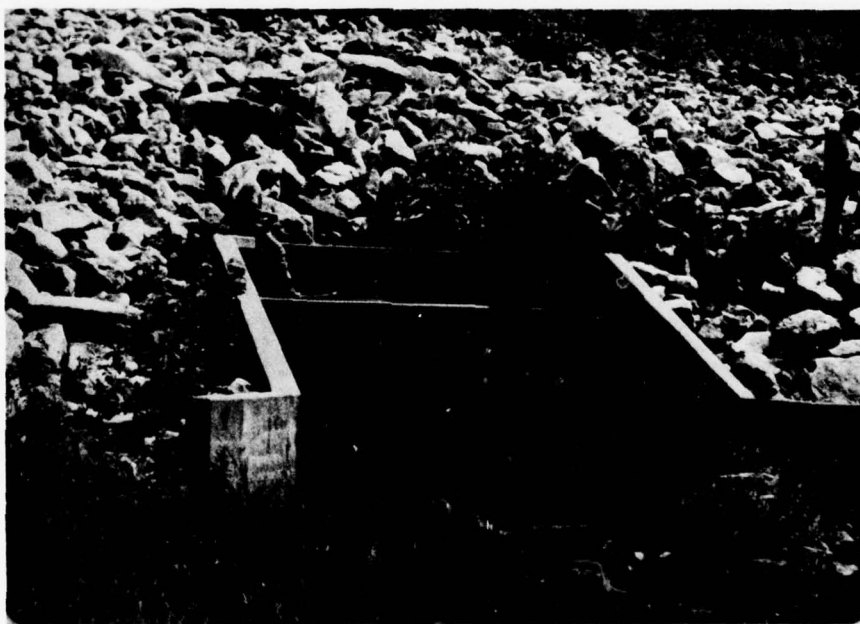
Heavy weed growth on the downstream slope prevents very close inspection of this slope in the summertime. No signs of sloughage, erosion or slope movements were detected. Since the dam became operable in 1961, leakage has occurred at several locations. See Sketch 1 in Appendix A for locations of leakage points and weir locations. These weirs were installed in 1963. Seepage is coming out of the rock toe on both sides of the conduit outlet structure. The weir near the left wing of the outlet is not operable at present and flow is by-passing this measuring device. Seepage is also coming out of the rock toe about 50 feet to the right of the conduit.

Outlet Structure

1. The owner should repair the weirs and monitor the amount of leakage on a regular basis. This information should be correlated with previous weir readings and pool levels. If a change in quantity or any turbidity in the water would occur, immediate action should be taken to prevent a hazard to the downstream area.
