SHEPPARD MEYERS DAM

YORK COUNTY

PHASE I INSPECTION REPORT

NATIONAL DAM SAFETY PROGRAM

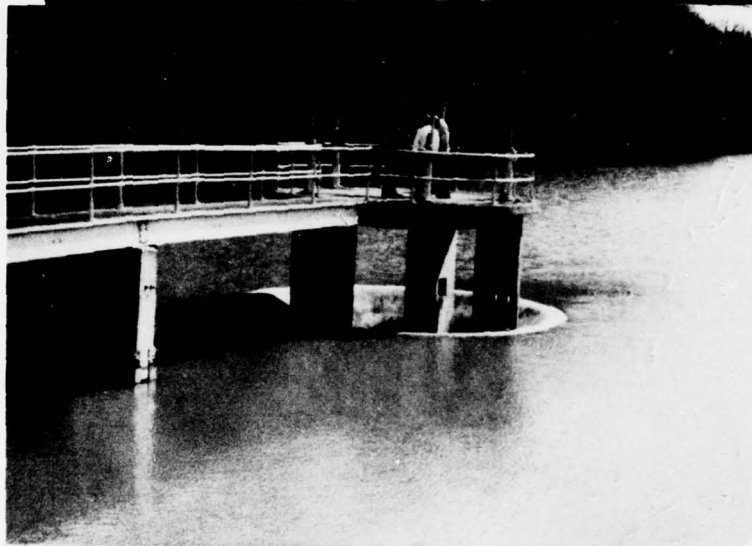
Morning Glory
Intake Tower

This structure was in good condition except for the base of one manual crank for the sluice gate at elevation 686.0. The base is broken loose from the concrete and the gate probably cannot be operated. The inside of the morning glory was not inspected (Plate III).

The opening to the spillway is obstructed by the supports for the valve operating platform which are also the concrete enclosures for the five valve stem risers. Floating drift could catch on these obstructions and reduce the capacity of the spillway.

The slab movement in the spillway is the most serious failure of the structures. The cracked base of the stand on the intake tower could cause water loss if the gate would be used and could not be closed.

1. The owner should repair the spillway slab as soon as the water level will permit.
2. Owner should investigate the need and feasibility of installing a trash boom around the morning glory.
3. Repair gate lift.

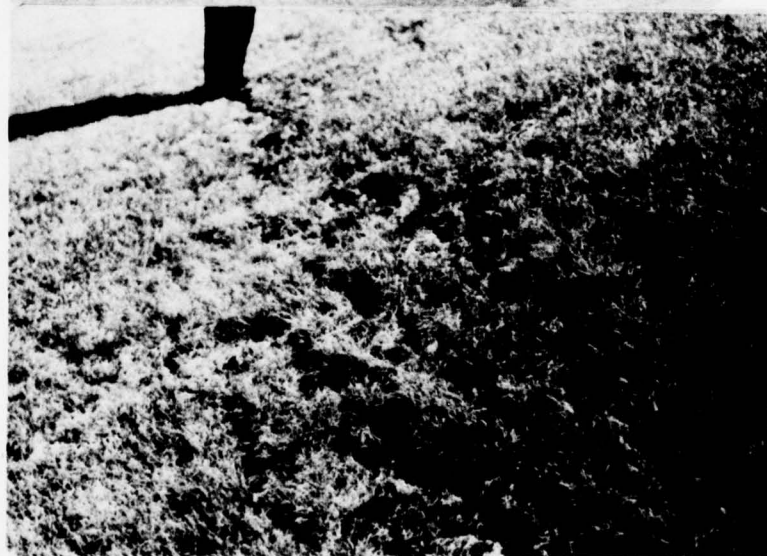
Embankment Slope
"Mole Activity"

The dam embankment is maintained in excellent condition. There was no evidence of seepage on the slope and the toe was dry and hard. A few places on the embankment indicated mole activity under the snow during the winter. Downstream of the embankment is a large wet area which reportedly dries out in the summertime (Plate VI). This wet area is probably caused by a spring and the area has been tiled. The area is about 100 feet from the toe of the embankment. There was no evidence of any cracking, sloughage or visually detectable settlement in the embankment. The riprap on the slope and the dam crest road is in excellent condition.
