PINE GROVE DAM

INVENTORY NUMBER NDS PA-23

PHASE I INSPECTION REPORT

NATIONAL DAM INSPECTION PROGRAM

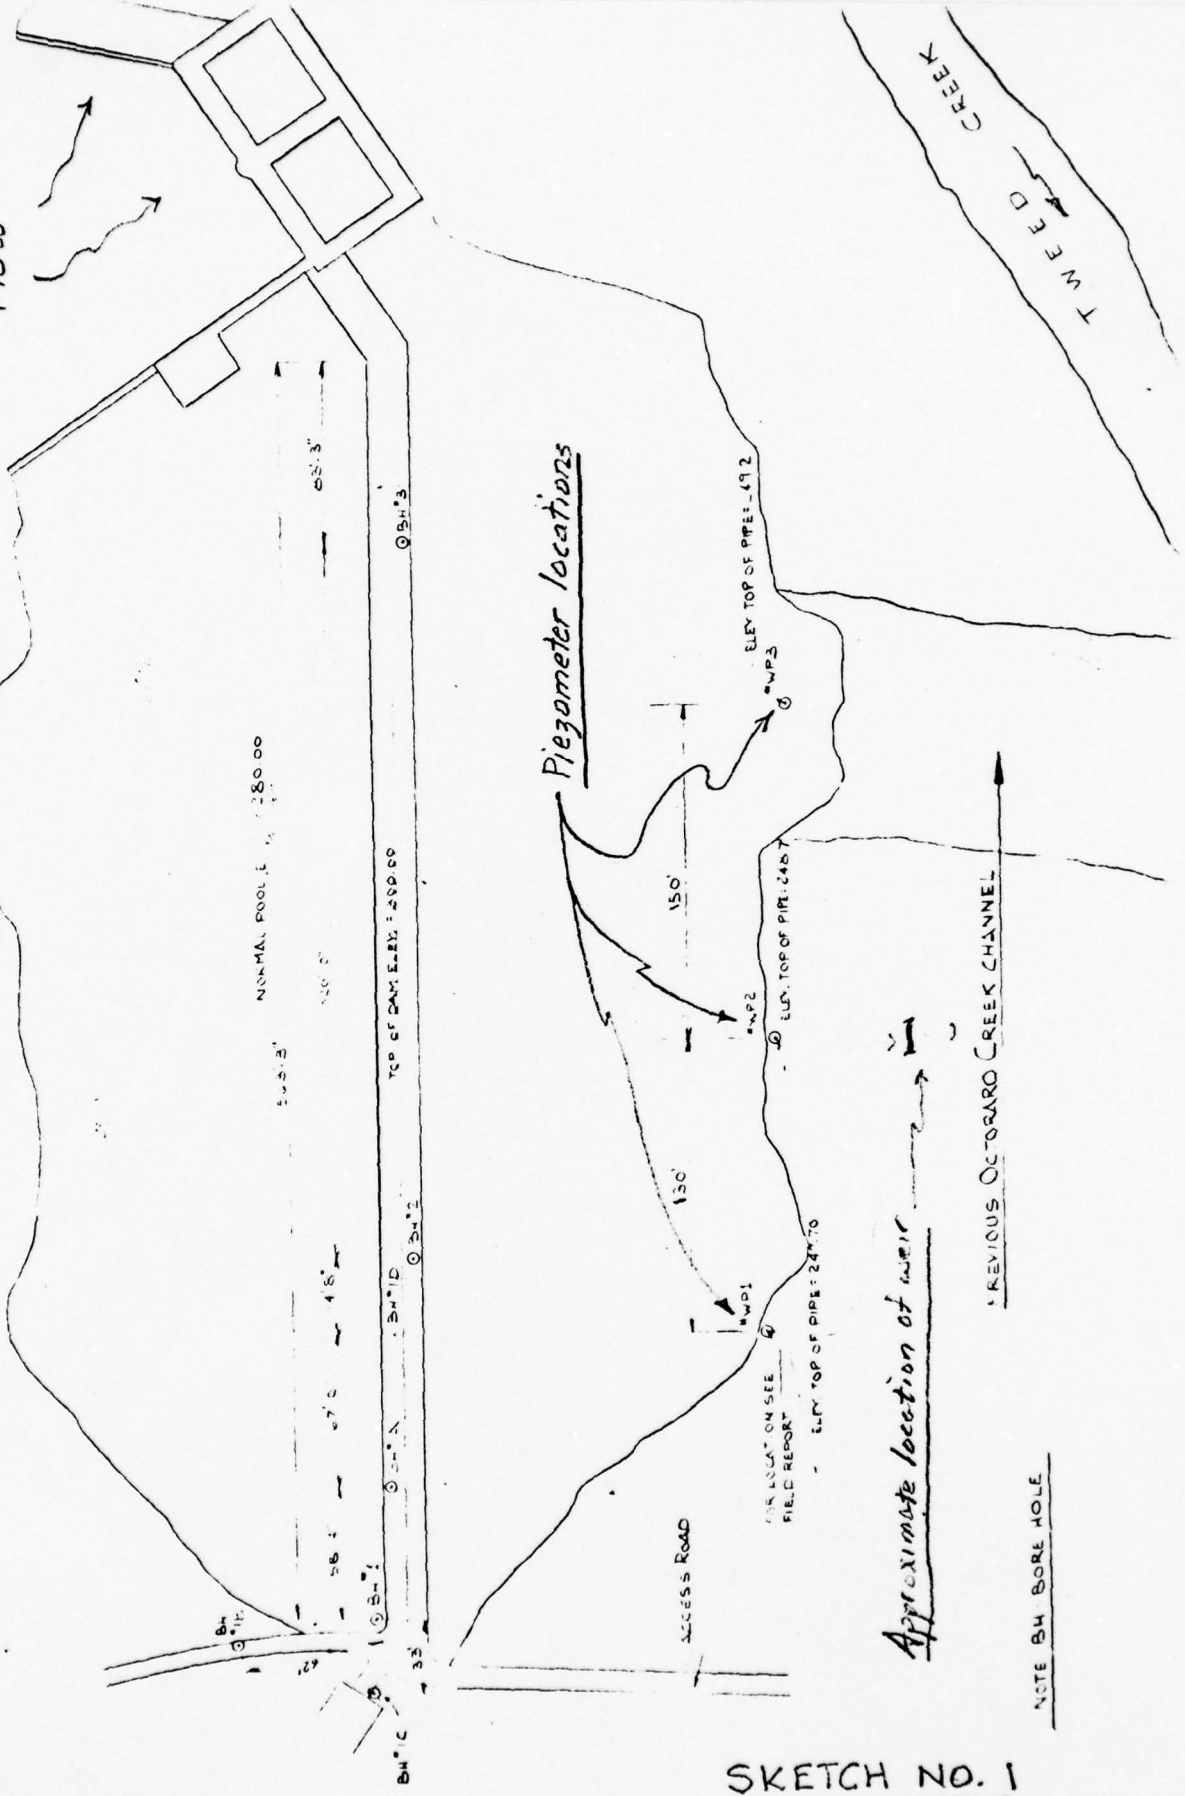
A persistent seepage condition was observed at the downstream toe of the embankment. Tall grass and weeds grow in this otherwise closely mowed area. The wet area is well defined by the tall growth of grass, weeds and reeds. Three piezometers are installed at the toe of the slope. Refer to Sketch #1 in Appendix A for plan of locations. A "V" notch weir is located in the wet area for the purpose of measuring the seepage volume. The water was flowing at 1-inch over the weir at the time of this inspection. Seepage was not detected on any portion of the slope.

Piezometer locations

Approximate location of water

1. That the seepage condition continue to be monitored on the schedule as now in effect. If changes in flow or if turbidity is noted, an engineering assessment should be made immediately and if conditions dictate, remedial action should be taken.
2. That the outlet channel from the outlet control structure be extended to meet the existing stream.

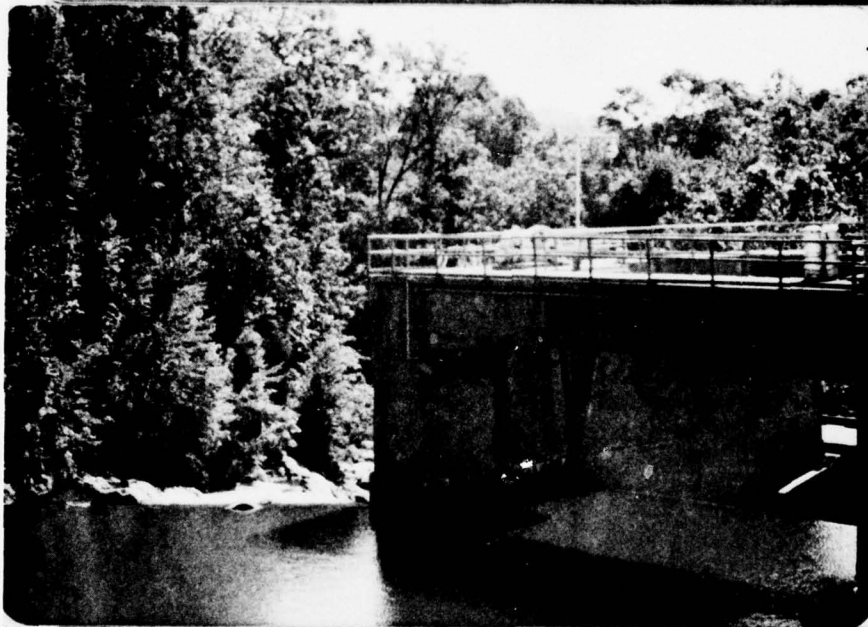
Spillway and
Tainter Gate

The spillway is an uncontrolled concrete ogee section. Appendix D, Plate IV. The condition of the spillway is good. The spillway is at an angle of 80° with the axis of the dam. The left

abutment is tied into the natural rock and appears sound. The right abutment joins the left abutment of the Tainter gate structure and is also in good condition.

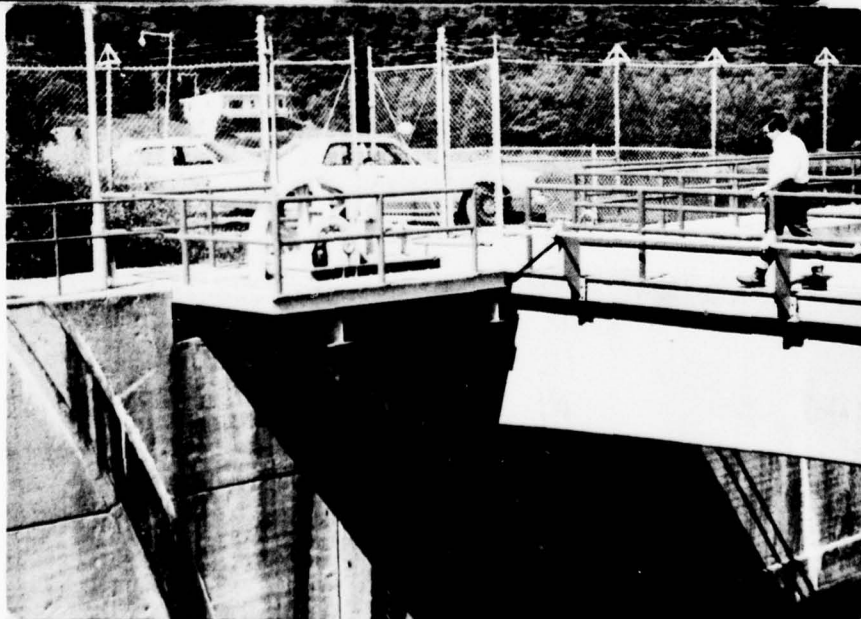
Chain of
Tainter Gate

Two 44 feet wide by 30 feet high Tainter gates are located between the uncontrolled spillway and the left abutment of the embankment. The gates are operated by electrical power with a propane fueled engine as a standby power source. The gates can also be operated manually. Refer to Appendix D, Plates VI and V. Each gate was operated for observation at the time of this inspection. The total installation of the gate and controls is in good condition.

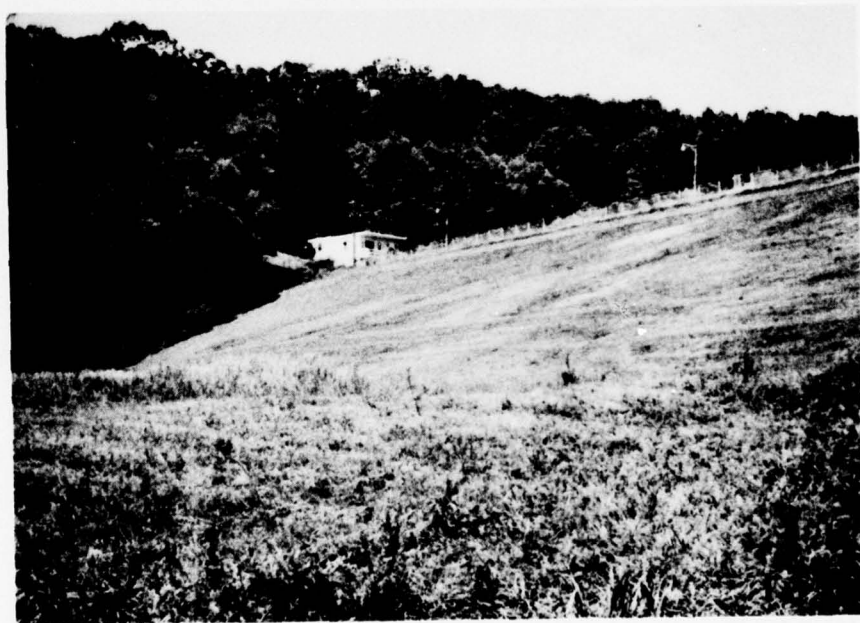
Downstream Slope

The embankment of this facility shows no signs of cracking, sloughing or settlement. The dumped riprap on the upstream slope is reasonably level and is in good condition. The top of the dam has a stoned surface and is fenced on both sides. The fence post foundations are partially exposed and the fence is tilting. The top is used as a roadway and provides access to the spillway, intake tower and Tainter gate controls. The downstream slope is covered with closely cropped grass and weeds. Dumped rock fill underlies this cover.

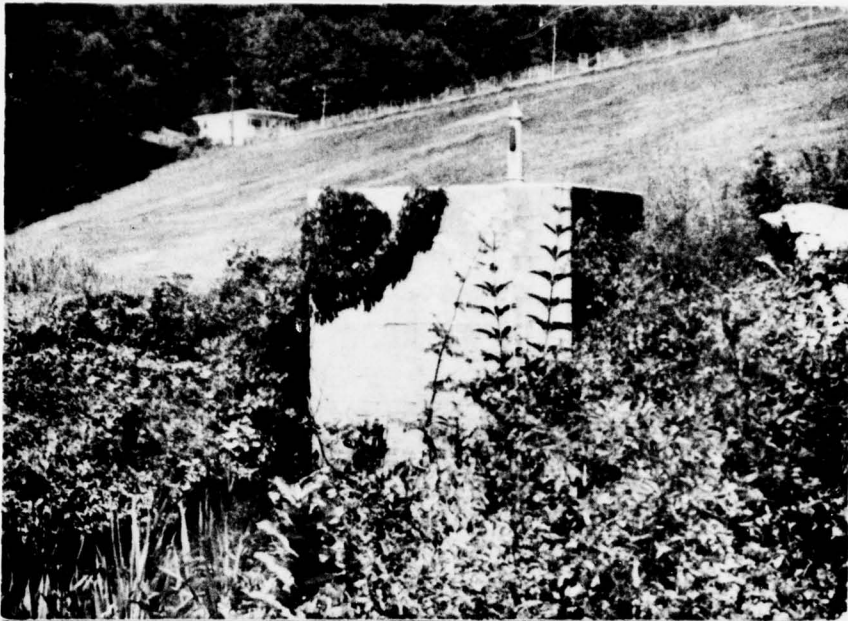
Conduit Outlet

The outlet structure channel does not provide a positive outlet to the creek. It stops about 75 feet downstream from the outlet structure. This condition should be improved.

The spillway, Tainter gates and intake structure all appear to be in good condition. The outlet structure channel should be continued downstream until it meets the natural stream.

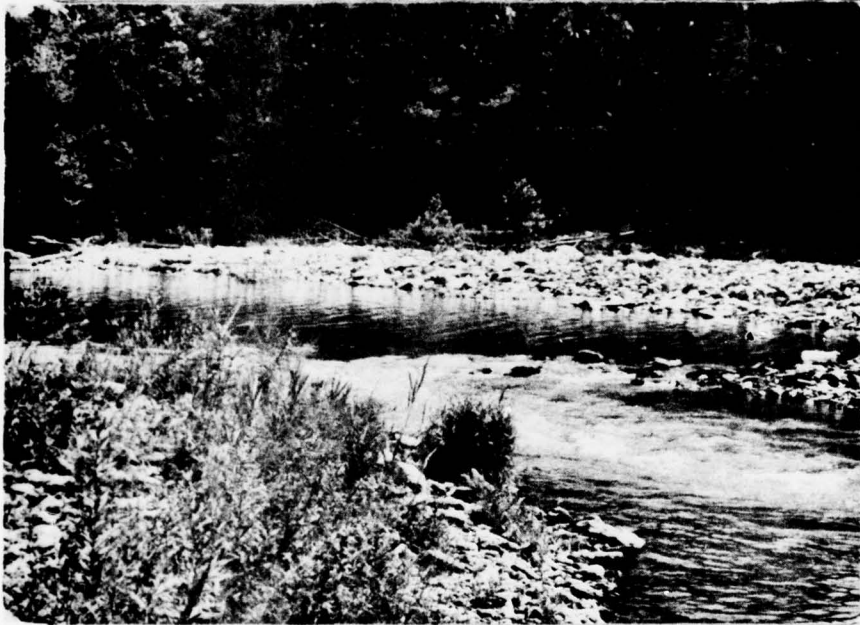
Downstream
Channel

The downstream spillway outlet channel has been heavily eroded as a result of the 1972 tropical storm Agnes and other high discharge storms. Repairs to the dam side of the channel have been made and plans for additional protection of this condition are being considered by the owner.

The water discharging through the spillway has to make a sharp (90°) bend directly below the dam. Heavy erosion has occurred at the opposite hillside as a result of the 1972 tropical storm Agnes and other high runoff storms. Some repairs are being considered to improve this condition. A covered roadway bridge and a low dam cross the stream at a distance of about 1,500 feet below the dam. Aside from the treatment plant there are no residents along or in the flood plain for the next 10 miles. A developing mobile home area is located 10 miles from the dam. This area is adjacent to the stream in its flood plain and is subject to flooding and at the time of this inspection contained five mobile home units. It is expected that the additional loss of life due to dam failure after overtopping would be limited to a few and the additional economical loss would be appreciable. The hazard classification for this dam is considered to be "Significant".
