National Dam Inspection Program,
Little Buffalo Creek Dam, Susquehanna
River Basin, Commonwealth of
Pennsylvania, Perry County (NDS-PA-582),
Phase I Inspection Report.

LITTLE BUFFALO CREEK DAM

PHASE I INSPECTION REPORT

11 Sep 78

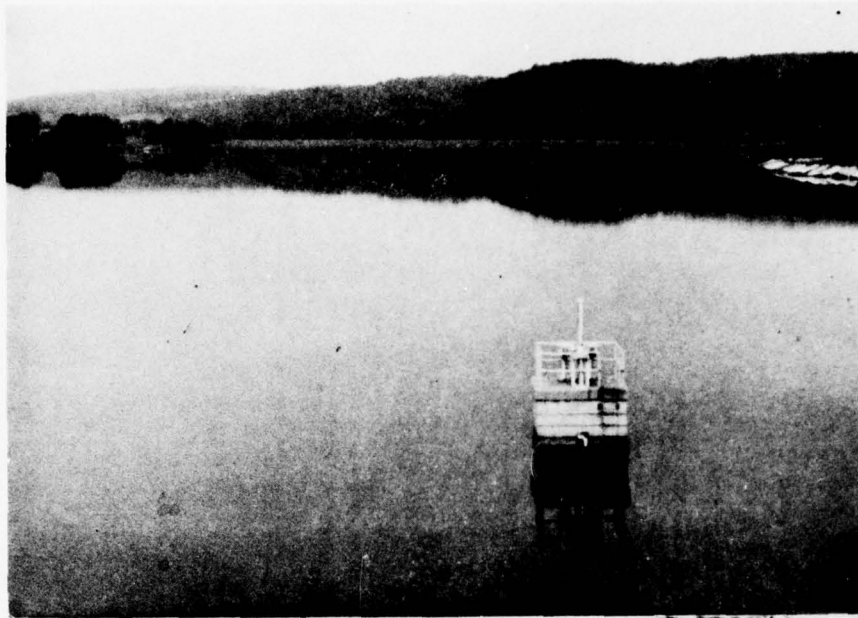
Access to the intake tower is by boat. The visual observations indicate that this structure and its gate and valves are in good condition. The 36-inch sluice gate was opened and closed for this inspection. It is noted that the deck of the tower is below the crest elevation of the dam (515.5 vs. 500.0).

Reservoir and
Intake Tower

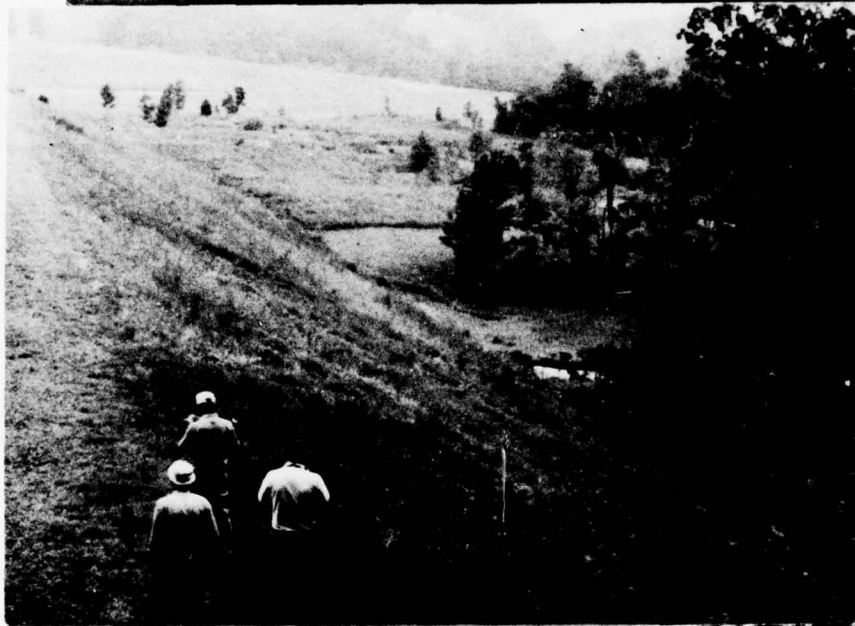
There is concern for the wet spots detected on the downstream slope and the apparent high volume discharge in the toe drain.

There were no visual observations of embankment distress with regard to cracks, settlement or sloughage. Wet spots were noted on the downstream slope and constant flow of subsurface water was detected in the toe drain to the left of the outlet structure. Refer to Section 3.1.B and 3.2.

Downstream Slope

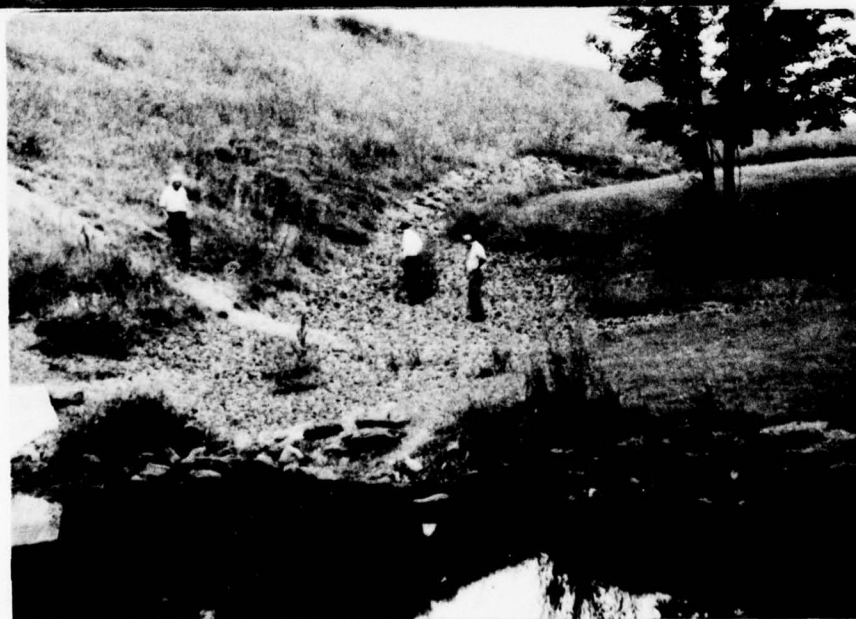
The overall condition of this facility, on the basis of this visual inspection appears to be good. The major concern is the apparent volume of the leakage at the downstream toe of the embankment and the wet spots noted on the slope above the outlet structure; both to the left of the outlet structure.

Inspection reports in 1973, 1974 and 1975 mention a seepage condition on the downstream slope. The records of 1976 indicate the need to repair a weir that was used to measure leakage from the dam. This apparently refers to the weir observed at the end of the plunge pool downstream from the outlet structure. Although these records are not complete, they indicate that there has been an ongoing seepage condition near and to the left of this structure.

Examination of the construction drawings, the test boring data and the geologic setting of this dam indicates that the rock formations are subject to leakage along the bedding planes and fractures. Since grouting was carried out in the foundation formations beneath the south abutment and beneath the spillway, the condition was noted and accounted for in these areas. The reason for partial treatment of the foundations is not described in any of the available records. It suggests that the leakage may be coming from the foundation formation which has not been grouted.

Toe Near
Conduit Outlet

1. That the weir in the outlet channel be restored to operating condition.
2. That the seepage from the toe drain be monitored on a regular schedule. If changes in volume or clarity of the discharge occur, a detailed investigation should be carried out and if conditions warrant, remedial action taken as necessary.
3. A study be made to determine the nature of the seepage problem on the downstream slope to determine the long time effect on the safety of the dam. Necessary remedial action shall be taken as required.

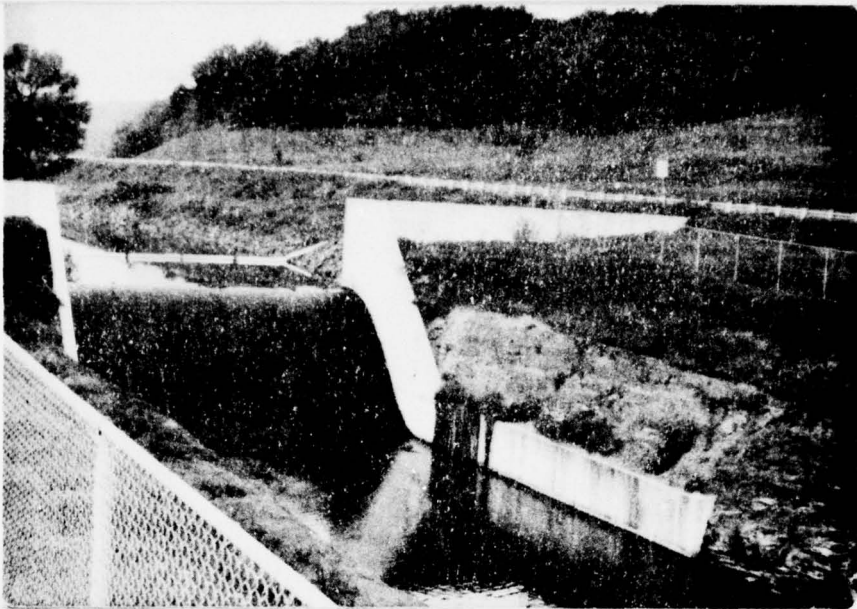
The concrete forming the spillway, emergency spillway, and wall is all in good condition. Water was barely spilling over the primary spillway crest at the time of this inspection. The maximum flow reported for this dam was 4.9 feet over the spillway during the 1972 storm, Agnes. This flow did cause some damage to the spillway outlet channel. This damage was subsequently repaired in March, 1974 when a permit was issued to draw the lake down for this purpose.

Spillway and
Emergency Spillway

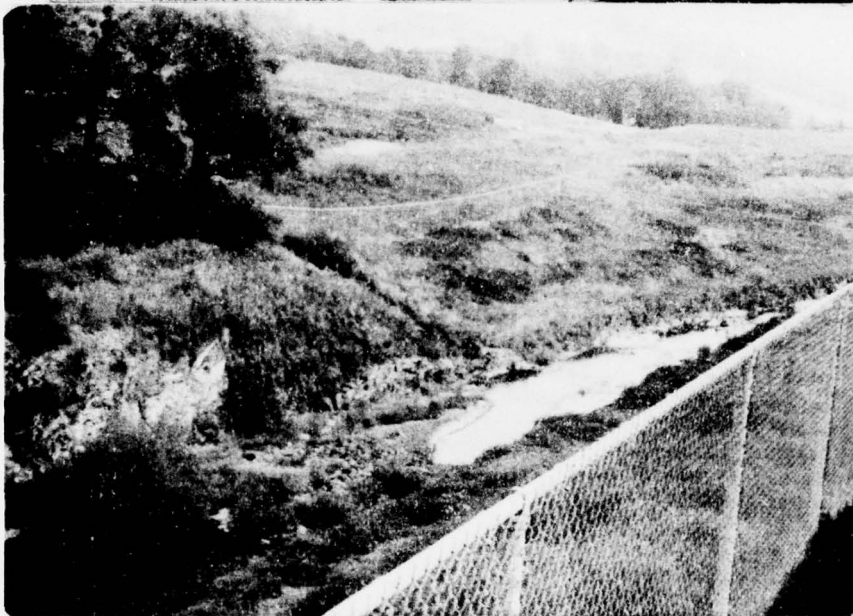
Spillway Channel
Looking Downstream
