6
National Dam Safety Program,
High Bridge Dam, Susquehanna River Basin,
Commonwealth of Pennsylvania,
Schuylkill County (NDS-PA-679).
Phase I Inspection Report.

HIGH BRIDGE DAM

PHASE I INSPECTION REPORT

Name of Dam: HIGH BRIDGE
 State & State Number: PENNSYLVANIA - 54-157A
 County Located: SCHUYLKILL
 Stream: FISHING CREEK
 Date of Inspection: August 7, 1978

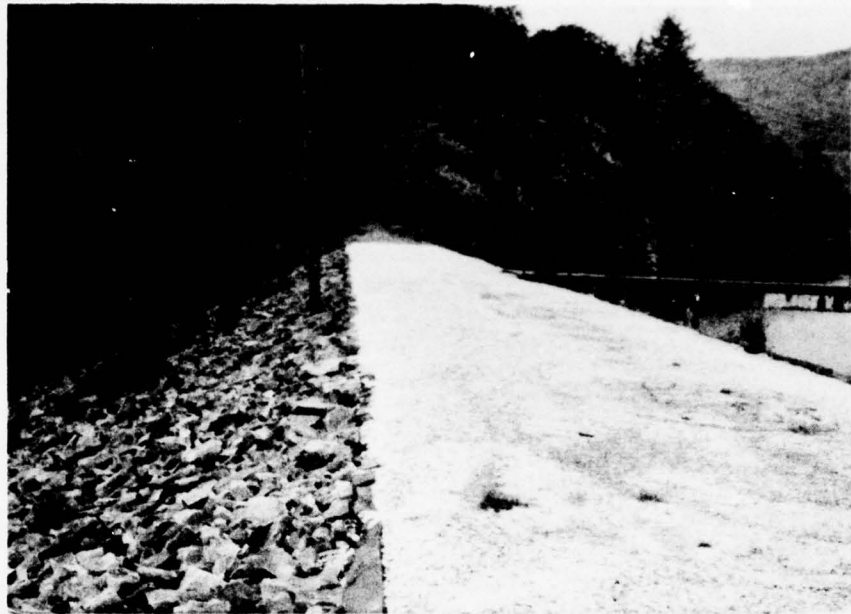
Dam Crest

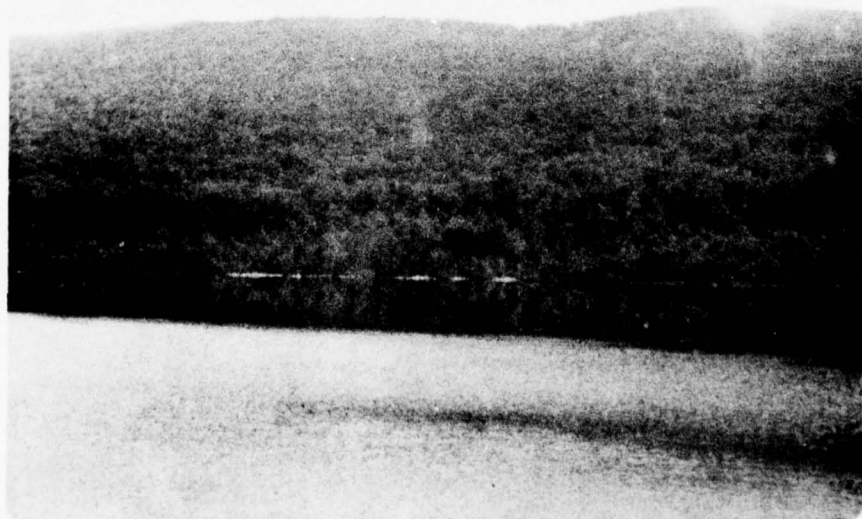
Reservoir

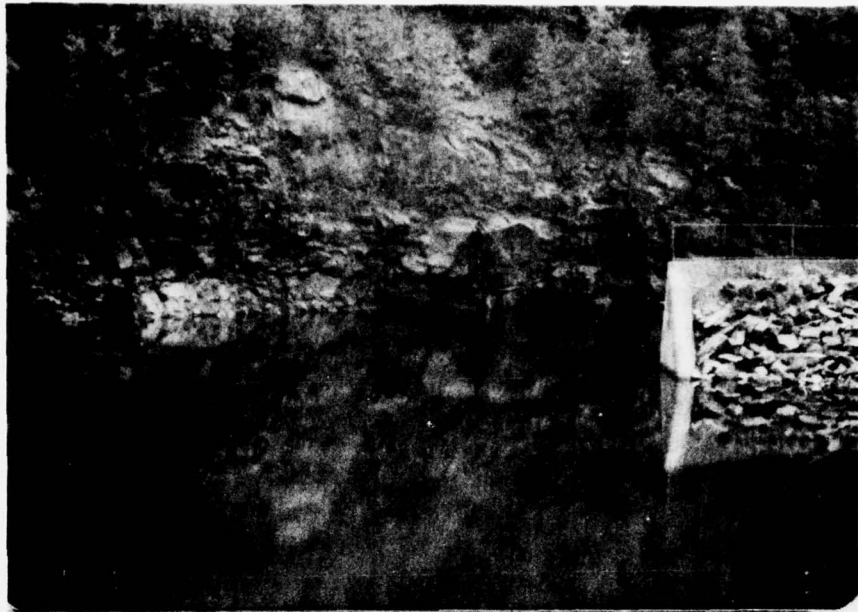
The approach channel to the spillway abuts and is excavated into the natural rock formation. It appears to be in sound condition. The right side of the channel is formed by the concrete spillway wall and also is in good condition. The forebay is a curved approach to the spillway. Refer to Appendix D, Plate VII.

Forebay

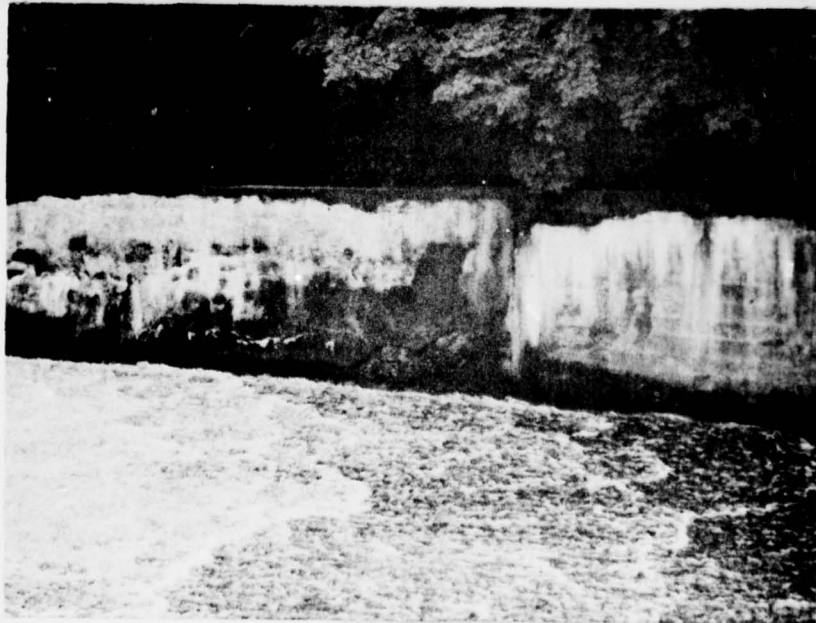
The spillway outlet chute is a concrete channel with vertical walls. Considerable cracking and deterioration of the walls was noted. The channel leads to the stilling basin downstream beyond which the discharge returns to the natural stream channel. Refer to Appendix D, Plate VII.

Walls of
Spillway

There were no visual signs of structural instability in the spillway area, the intake tower or the spillway outlet channel. Although some deterioration and slight cracking of the channel walls were noticed, they will not have an influence on the stability of the units at the present time. Regular maintenance can take care of these conditions.

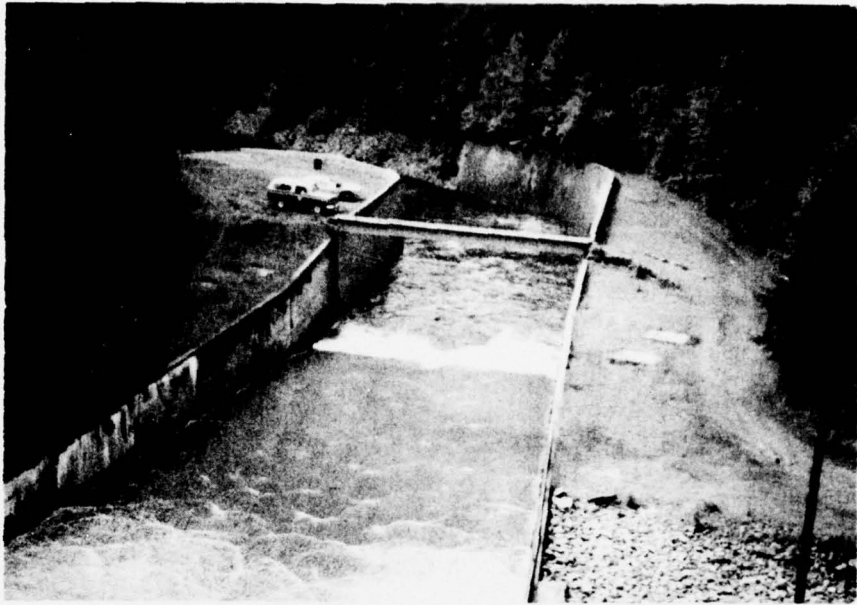
Stilling Basin

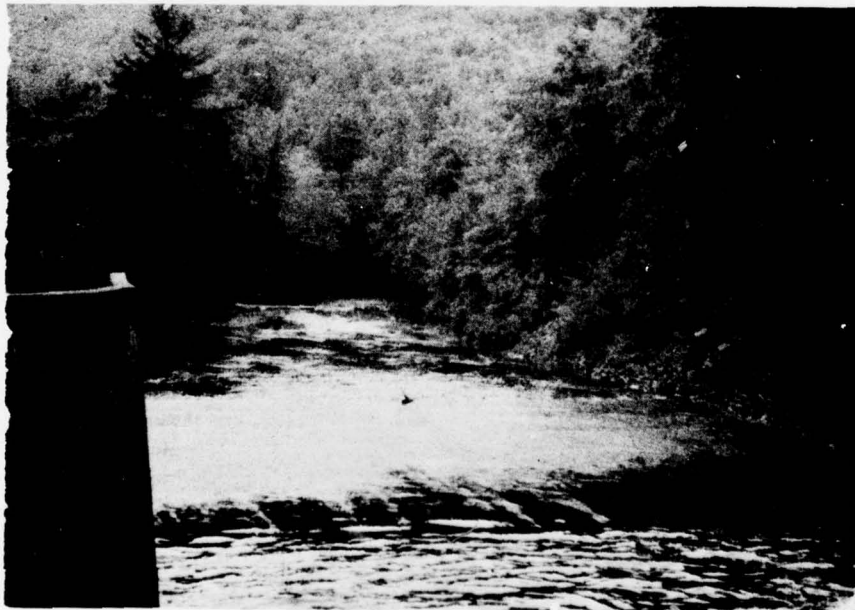
The downstream channel is a natural stream with trees and underbrush forming the overbank areas. The slopes are described as woody and rocky. Approximately nine permanent residences are located between the dam and Swatara Creek about two miles downstream. Approximately 30 to 40 persons live in this area. The hazard category, on the basis of these facts is "High".

Downstream Channel
