ANTIETAM DAM

INVENTORY NUMBER NDS PA-332

PHASE I INSPECTION REPORT

6 NATIONAL DAM SAFETY PROGRAM.
Antietam Dam (NDS PA-332). Potomac River Basin, Adams County, Commonwealth of Pennsylvania. Phase I Inspection Report.

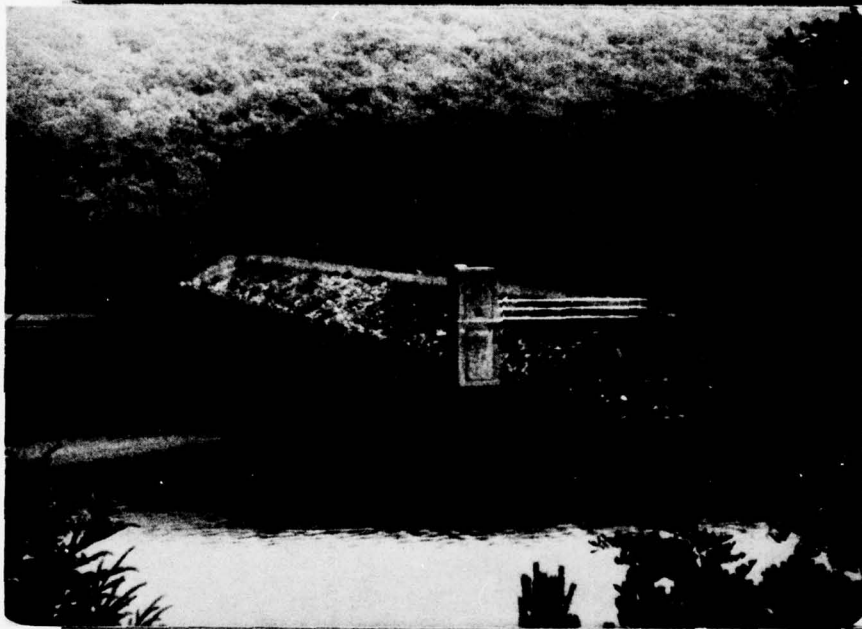
The intake tower is a concrete structure which houses three valves (two 10-inch and one 14-inch) at different elevations. The structure and its access bridge from the embankment are in good condition. Refer to Appendix D, Plate III. The gates in the tower were

Upstream Slope
& Intake Tower

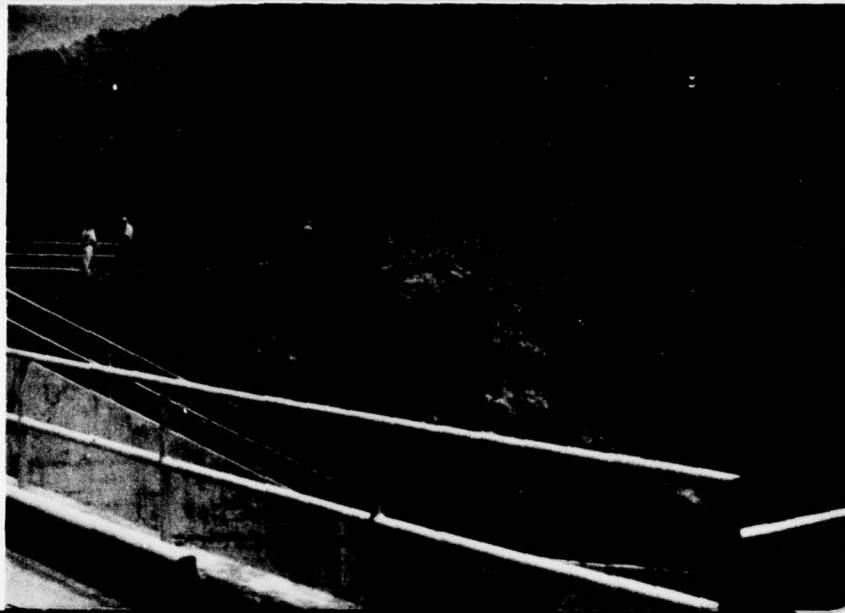
Downstream Slope
Standing On Bridge

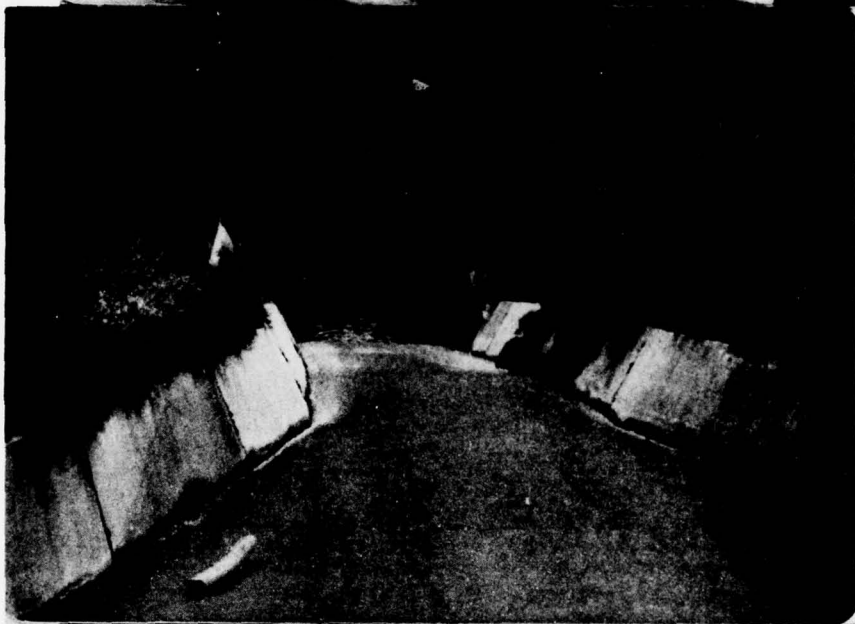
The spillway, which is an uncontrolled concrete ogee section shows some slight weathering on the surface as a result of the flow of water. The abutments appear to be in good condition although there are some very fine cracks in the walls with calcite stains. The concrete slabs in the spillway outlet channel and the walls along this descending chute are in good condition. Refer to Appendix D, Plate IV. The foot-bridge across the spillway is also in good condition as is the stilling basin.

Spillway Chute

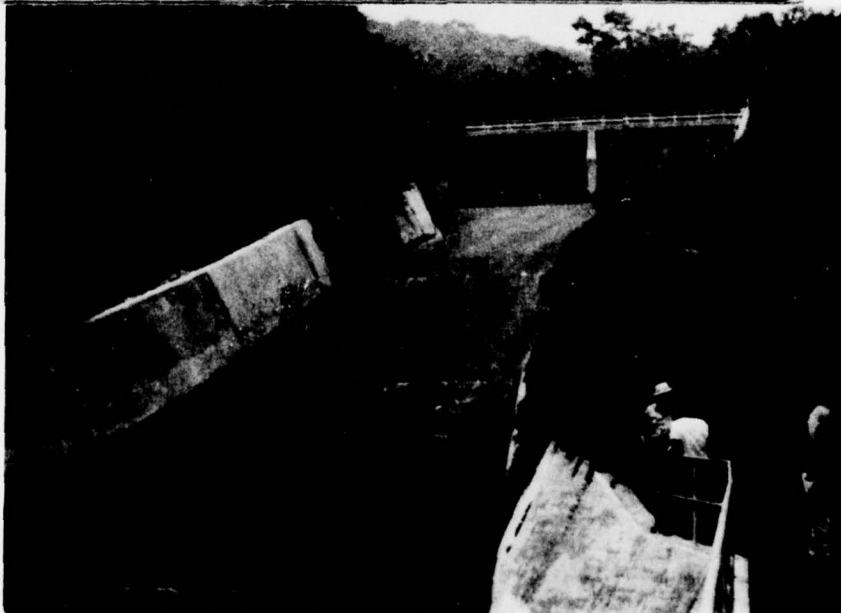
Spillway Chute
And Bridge
