**NDI No. Pa.-355
GREENLICK RUN DAM**

**PHASE I INSPECTION REPORT
NATIONAL DAM INSPECTION PROGRAM**

**PREPARED BY
GAI CONSULTANTS, INC.
570 BEATTY ROAD
MONROEVILLE, PENNSYLVANIA 15146
OCTOBER 1978**

PHASE I INSPECTION REPORT
NATIONAL DAM INSPECTION PROGRAM
GREENLICK RUN DAM
NDI# PA-355, PENNDR# 26-97

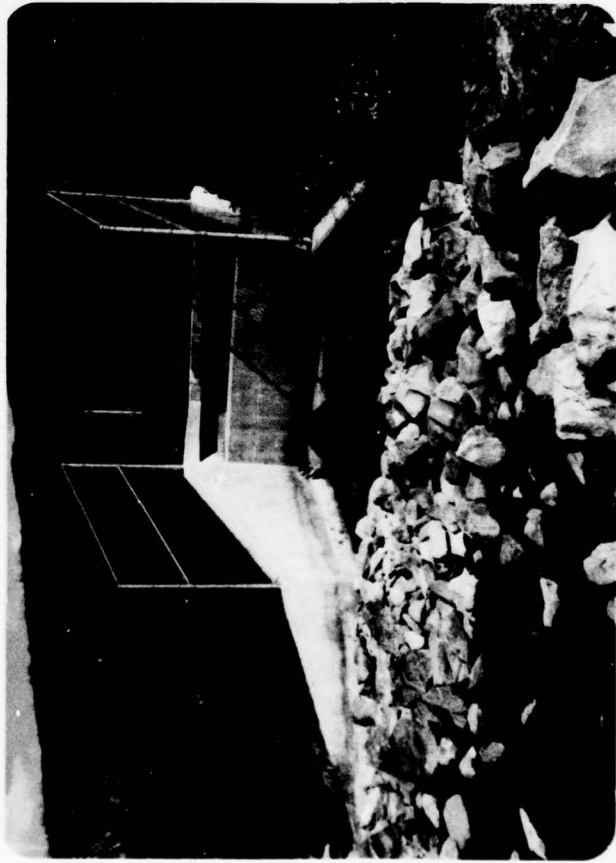
3. Outlet Conduit. The only portion of the low level outlet conduit which could be visually inspected was the discharge end (see Figure 7 and Photograph 7). The concrete portion of the discharge basin is in good condition with only slight evidence of any deterioration. Immediately beyond the basin is a riprap-lined channel approximately 20 feet in length and 20 feet in width. The channel appears to contain an excess of riprap that may obstruct discharge through the outlet channel during high discharges (see Photograph 7).

Trapezoidal or near rectangular channel with a riprap channel floor extending approximately 20 feet from the outlet basin. An apparent excess of riprap was observed at the discharge end of the outlet basin which could create tailwater effects.

PHOTOGRAPH 7 Detail view of the outlet structure. Note the embankment toe drain outlet in the right wingwall (left in photo). Note also the excessive riprap at the outlet apron.

c. Remove the excess riprap observed in the outlet channel to eliminate undesirable tailwater conditions.
