OHIO RIVER BASIN
McCUNE RUN, WESTMORELAND COUNTY
PENNSYLVANIA

NDI No. Pa. - 480
KEYSTONE DAM

PHASE I INSPECTION REPORT
NATIONAL DAM INSPECTION PROGRAM

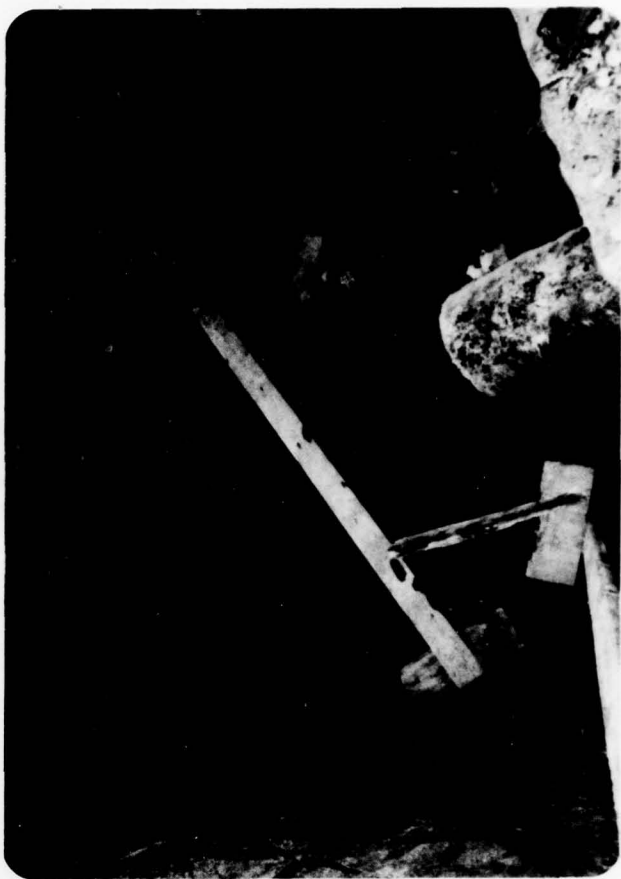
The valve house is in a serious state of disrepair. The building needs repointed, some masonry reset, doors and locks installed. Furthermore, a safe access for operating personnel should be provided. Discussion with PennDER officials indicate that rehabilitation and/or replacement of the valve house is a priority project.

PHOTOGRAPH 8

Detailed view showing the interior of the valve house.
