National Dam Safety Program, George B. Stevenson Dam (Inventory Number PA-914), Susquehanna River Basin, First Fork Sinnemahoning Creek, Cameron County, Pennsylvania. Phase I Inspection Report.

GEORGE B. STEVENSON DAM

INVENTORY NUMBER PA-914

## PHASE I INSPECTION REPORT

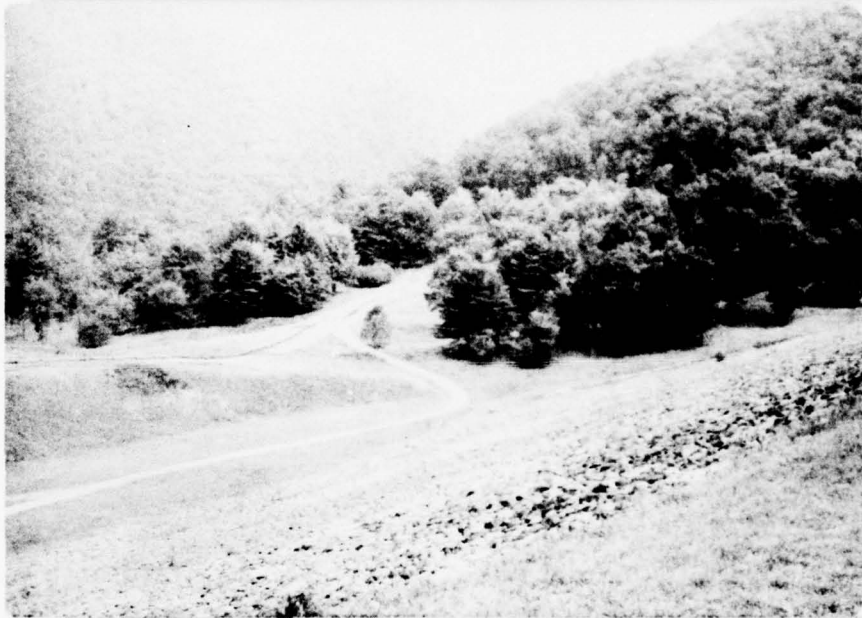
At the time of inspection the pool level was at elevation 920.5 and the full upstream side was exposed, except the toe which was used as a cofferdam during construction. The stone slope was in excellent condition. The top of the dam has a gravel roadway and had a good horizontal and vertical alignment. The downstream slope and toe is grassed, mowed closely and gives a very well maintained appearance. At a few locations the slope undulates slightly, but this was apparently constructed that way. Several groundhog holes and mole holes were noticed.

Upstream Slope

1. Remove groundhogs and fill the holes in the embankment.

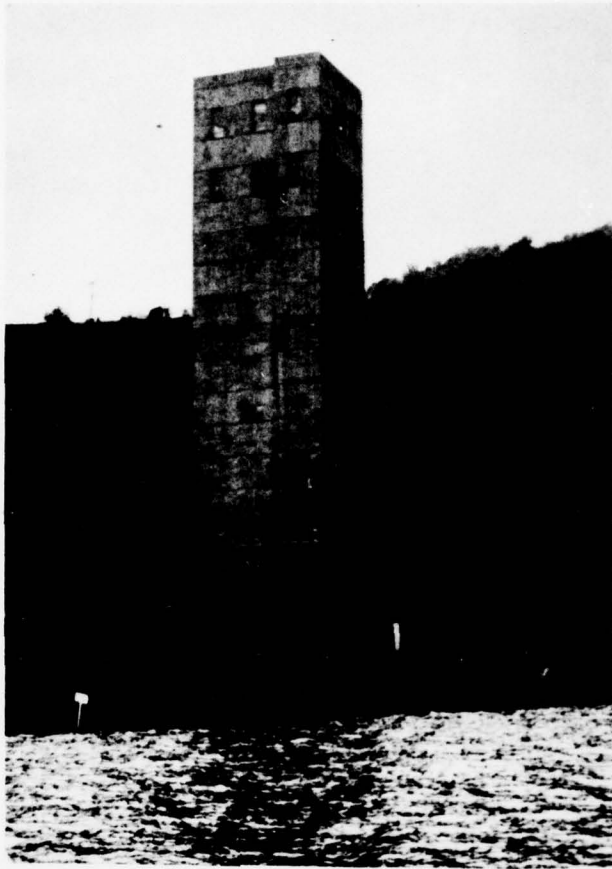
The intake structure was in good condition. The tractor type gates are pulled up once a year for maintenance after lowering an emergency close-off gate. The 8-foot by 16-foot gates are used regularly to maintain the conservation pool at elevation 920. They are used alternately on a monthly basis. The electrical hoist to open these gates is backed up with an L.P. gas generator.

Intake Tower and Trash Boom

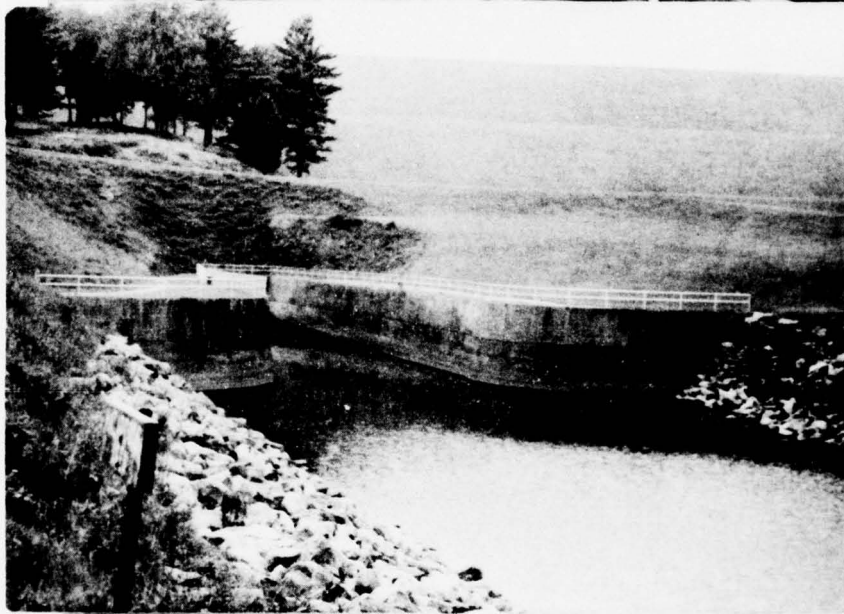
The water through the gates is discharged through a 16-foot diameter concrete lined tunnel, excavated through the hillside. The tunnel was in good condition. Only one small leak in the roof was noticed. The tunnel discharges in a tapered stilling basin with some energy dissipating blocks. The concrete of the stilling basin walls was in good condition and the downstream channel rock lining appeared to be stable. Some rock on the slopes had eroded during the tropical storm Agnes, but this has been repaired.

Conduit Outlet

If the amount of leakage in the roof at one joint increases, it is recommended that the owner grout the rock strata in that area.

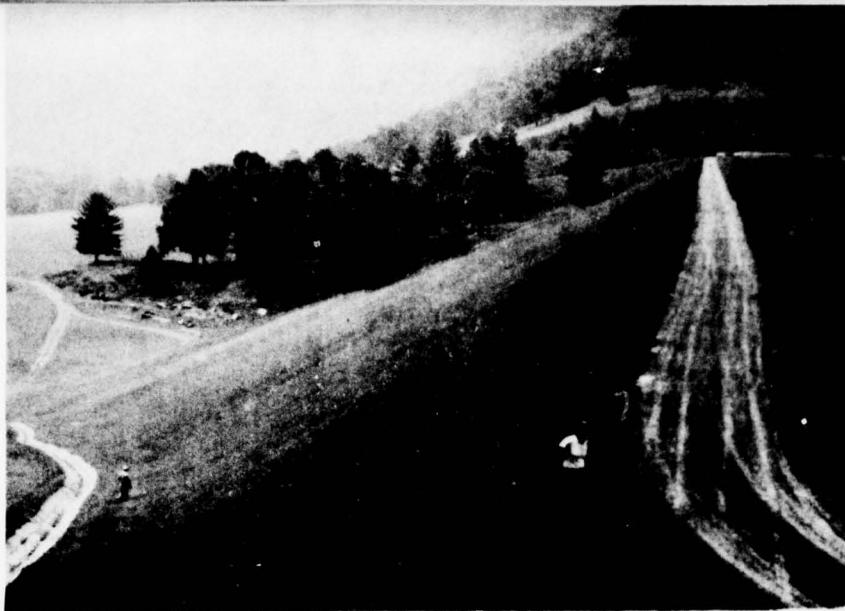
There are no visual indications of settlement or sloughing of the embankment slopes. The embankment is in excellent condition except the presence of some woodchuck holes on the downstream slope. It should be noted that the pool level at the time of inspection was 136 feet below top of dam and that critical seepage conditions could not be evaluated.

Downstream Slope  
Looking West

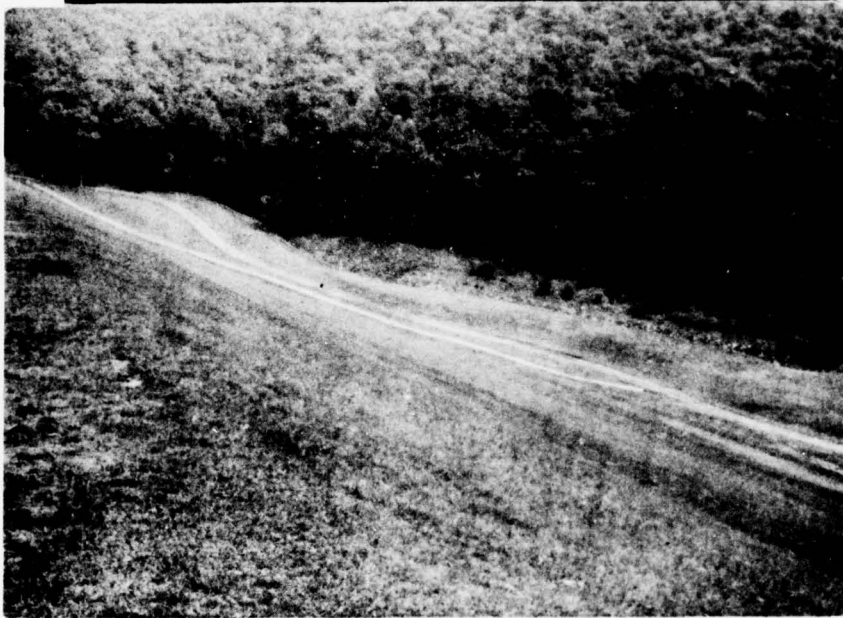
Downstream Slope  
Looking East

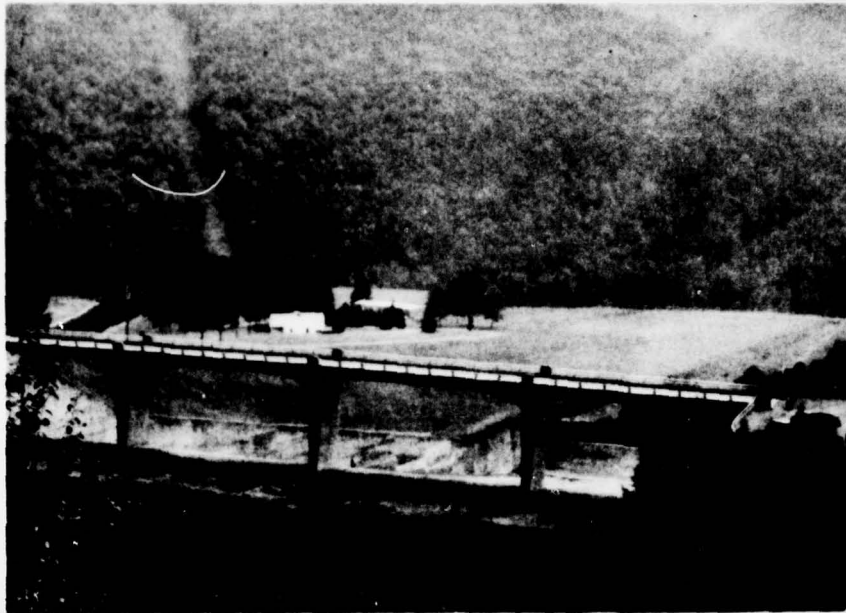
The spillway in the right abutment has never been tested. All concrete appeared to be in good condition and no wall movements were

Spillway
