National Dam Safety Program, Pinchot Lake Dam (Inventory Number NDS 335), Susquehanna River Basin, Beaver Creek, York County, Pennsylvania. Phase I Inspection Report.

PINCHOT LAKE DAM

INVENTORY NUMBER NDS 335

PHASE I INSPECTION REPORT

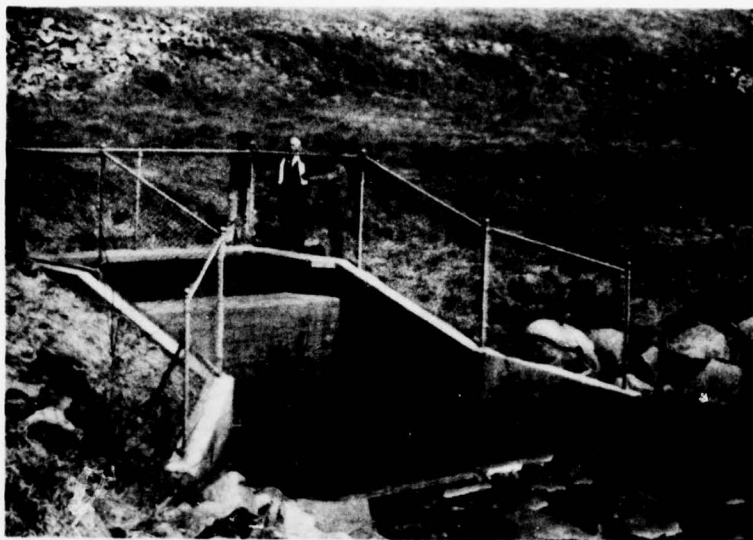
Conduit
Outlet

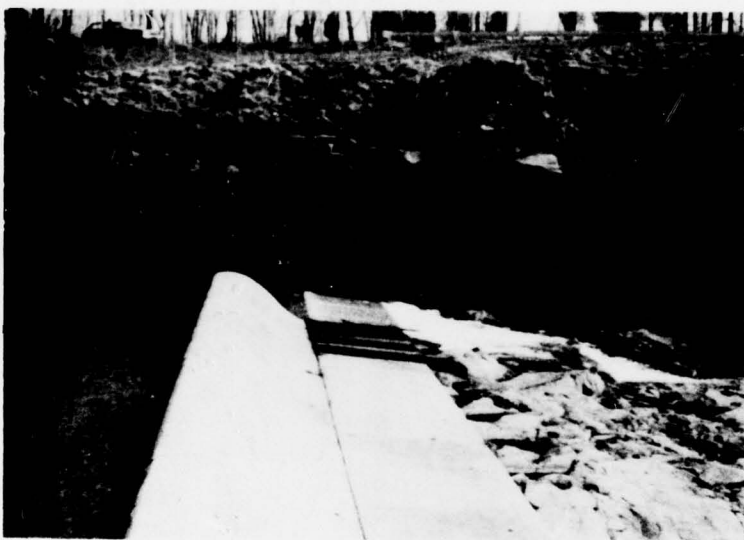
The spillway crest is in good condition. Some of the joints cause a maintenance problem due to loosening of the sealer. One vertical joint indicated some seepage.

Visual observations indicated no stability or stress problems in any of the concrete structures. Possible seepage through one of the joints in the ogee section should be observed for possible frost damage.

Notched Spillway
Ogee Weir

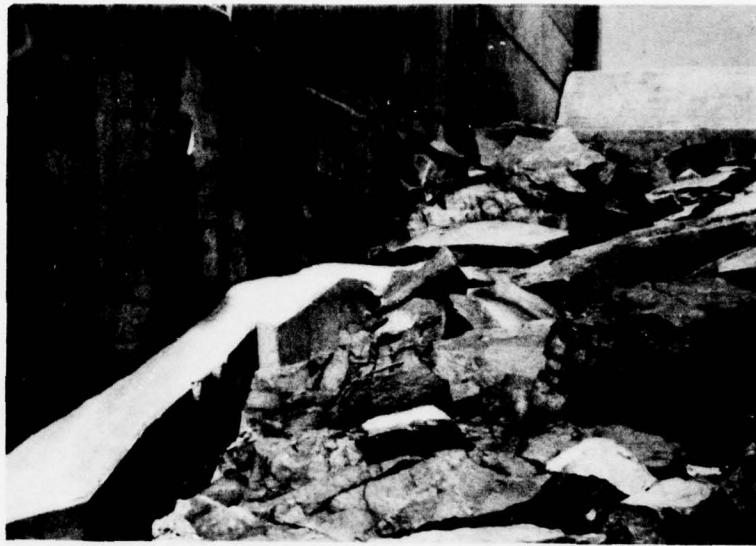
The only modifications made after construction was the installation of a concrete protection for the right wall of the spillway chute. The use of a sharp transition facing upstream in these walls is not desirable (Appendix D, Plate V). However, no damage was detected.

The right wall is of reinforced concrete set on a rock foundation. Some deep scour occurred during heavy discharges and additional concrete protection was placed along the toe of the wall. The appearance was good and no signs of distress were noticed. The stilling basin was in good condition, except for some erosion occurring at the left side of the outlet channel.

Spillway Chute
Wall Toe
Protection

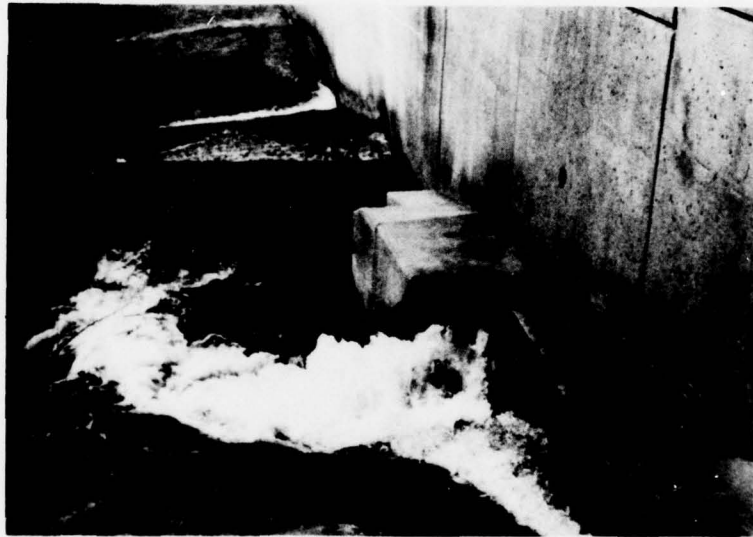
The spillway channel floor and left side are unpaved bedrock. Some erosion of the fractured rock is occurring and this requires cleaning of the stilling basin at certain intervals.

During past floods, pieces of rock have been torn loose from the unlined spillway chute and have filled up the stilling basin. Apparently this has lessened the effectiveness of the stilling basin and resulted in some erosion of the stream bank downstream from the dam. This erosion has been repaired with riprap.

Spillway Chute

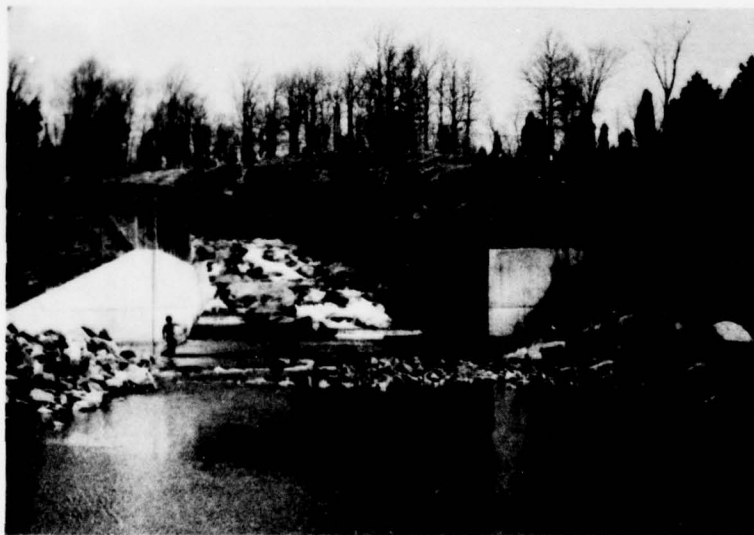
Stilling Basin

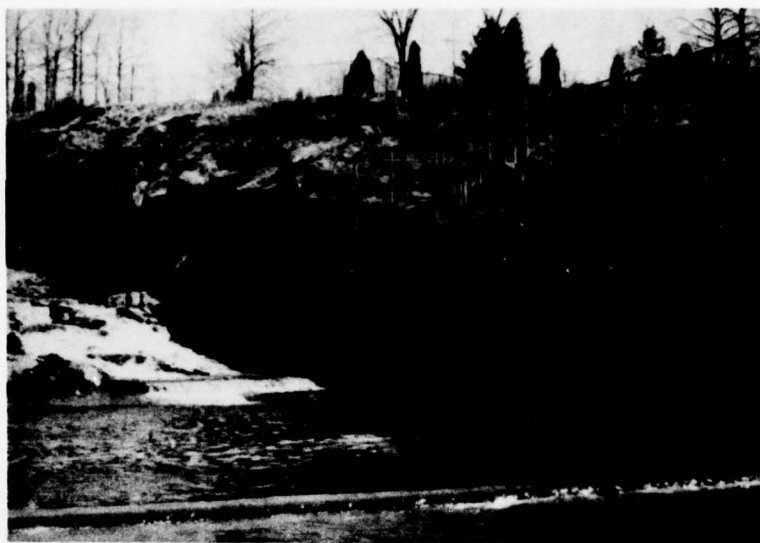
Stilling Basin

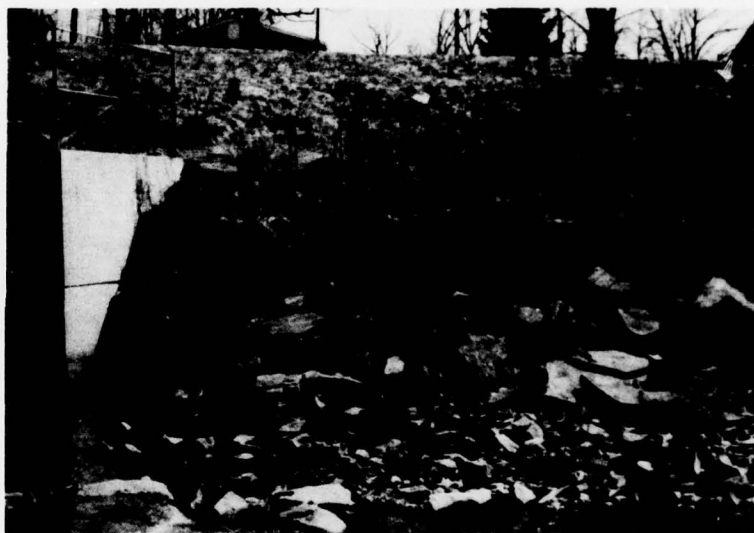
Left Wall
Stilling Basin

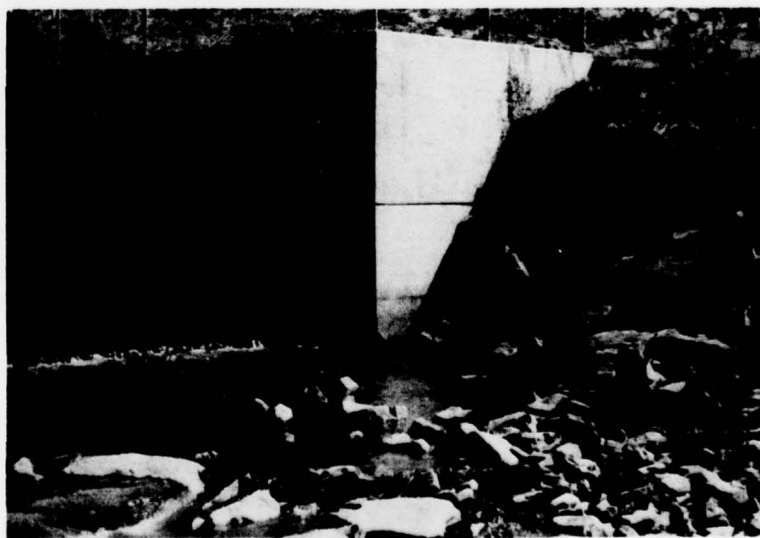
Erosion of
Left Stilling
Basin Wall

1. A formal surveillance and downstream warning system should be developed to be used during periods of high precipitation.
2. A regular inspection program should be developed to inspect possible damage to the spillway chute after high discharges, particularly in the area adjacent to the right spillway chute wall.
3. The stilling basin should be cleared at regular intervals.
4. The left wingwall of the stilling basin should be protected against further erosion.
