ELECTRONICS ENGINEERING GROUP (1842ND) SCOTT AFB IL
INDUCED VOLTAGE/LIGHTNING PROBLEMS AT USAF BRANDYWINE AND DAVID--ETC(U)
JAN 79 R VINASSA, J F ZYCH
1842 EEG/EEIS-TR-79-2

INDUCED VOLTAGE/LIGHTNING PROBLEMS
AT
USAF BRANDYWINE AND DAVIDSONVILLE SITES

As a result of site surveys performed 19-21 Sep 78 at USAF sites located in Brandywine and Davidsonville, MD, recommendations are made to decrease the vulnerability to lightning and induced voltages due to lightning which have been destroying communication equipment components at the sites. With the implementation of the recommendations contained herein, the number of component failures should be greatly reduced.

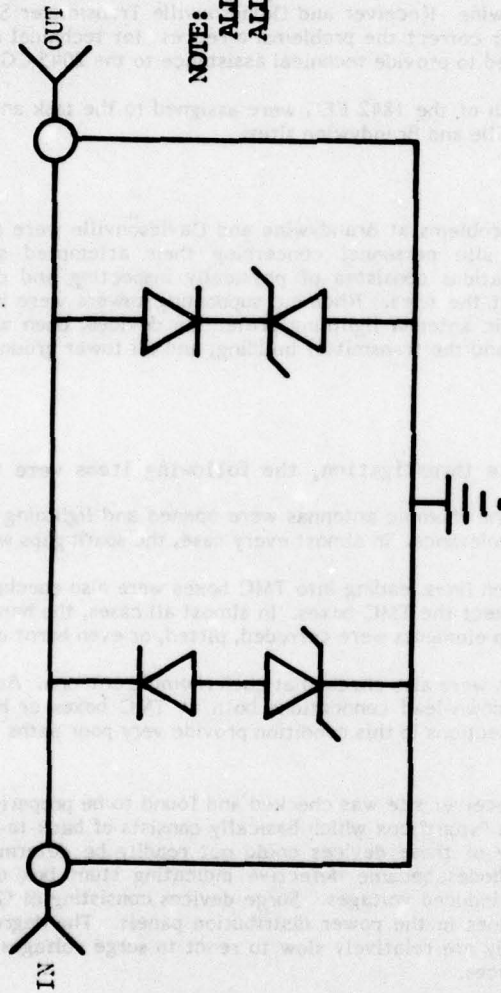
FIGURE 1. RF OVERLOAD ASSEMBLY (STUNT BOX)

3.1.4 The RF cable entry plate at the receiver site was checked and found to be properly grounded. RF inputs to the multicouplers were protected by a "stunt" box which basically consists of back-to-back diodes and zener diodes (see Figure #1). The adequacy of these devices could not readily be determined; however, during lightning storms, some of the zener diodes became defective indicating stunt box operation and possibly providing some type of protection from induced voltages. Surge devices consisting of GE home type lightning arresters were installed on the power lines in the power distribution panels. The degree of protection these devices provide is questionable since they are relatively slow to react to surge voltages and therefore provide inadequate protection for solid state devices.

4.1.5 Additional surge protection devices should be installed at TMC boxes and at the RF multicoupler inputs. These devices are listed in Figure #3. Devices to be installed in the TMC box will be prototyped by the 1842 EEG. Recommend that the initial installation be coordinated with NCA and the actual installation be witnessed (and engineering assistance provided) by the co-authors of this report. It is also recommended that a ground rod be carefully driven directly outside and opposite the cable entry plate at the receiver site and the plate connected to the ground rod. The new ground rod should provide a more direct path to ground for existing RF cables.

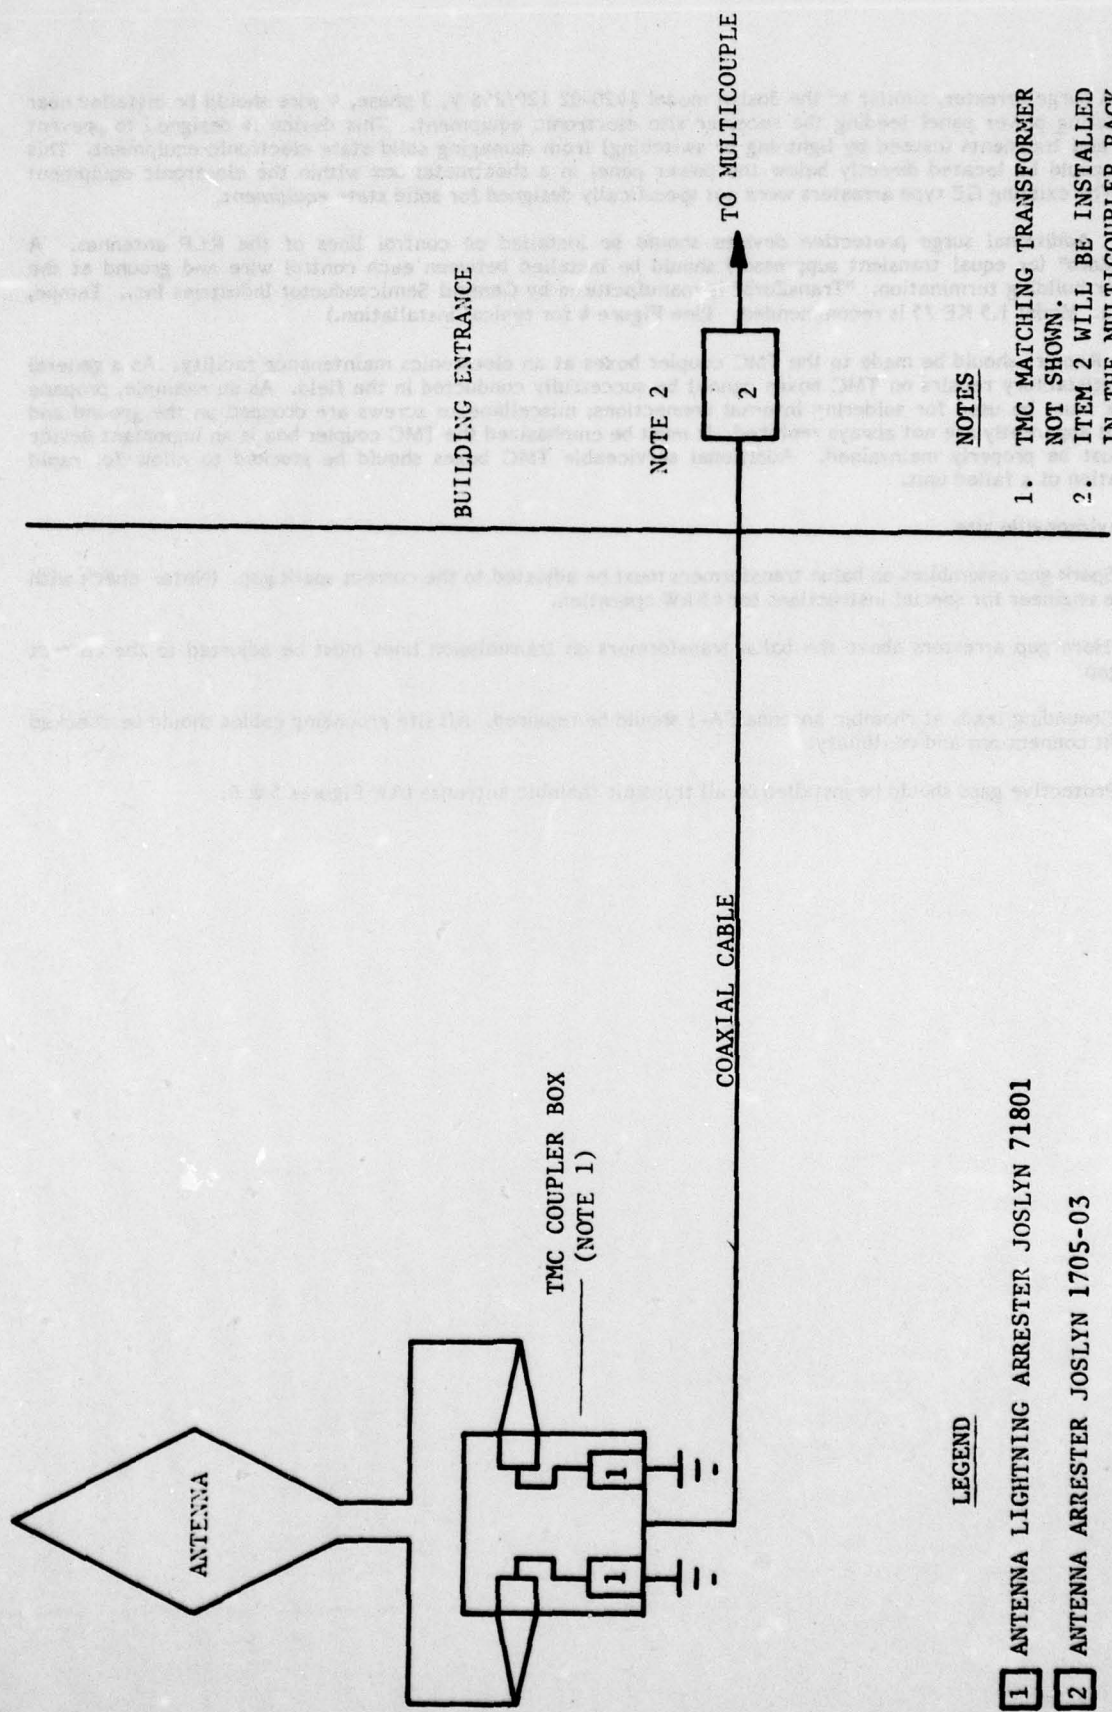
FIGURE 3. RECEIVE RHOMBIC

3.1.1. Existing TMC coupler boxes on the rhombic antennas were opened and lightning protection spark gaps were checked to see if they were within tolerance. In almost every case, the spark gaps were set too wide.

3.1.2 Lightning protection on transmission lines leading into TMC boxes were also checked. At each down lead a horn gap assembly was installed to protect the TMC boxes. In almost all cases, the horn gap was not adjusted to specifications. In some cases, horn gap elements were corroded, pitted, or even burnt off.

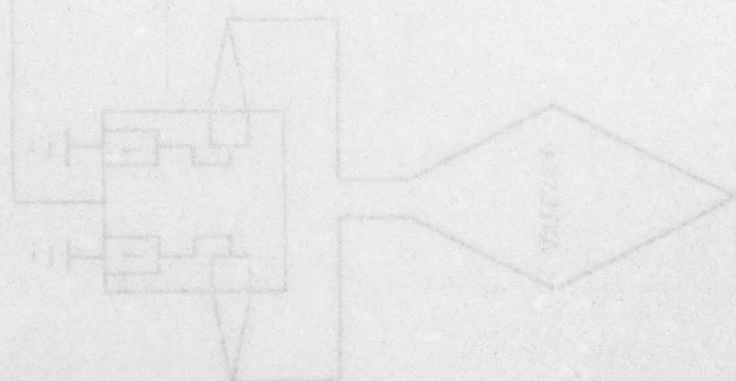
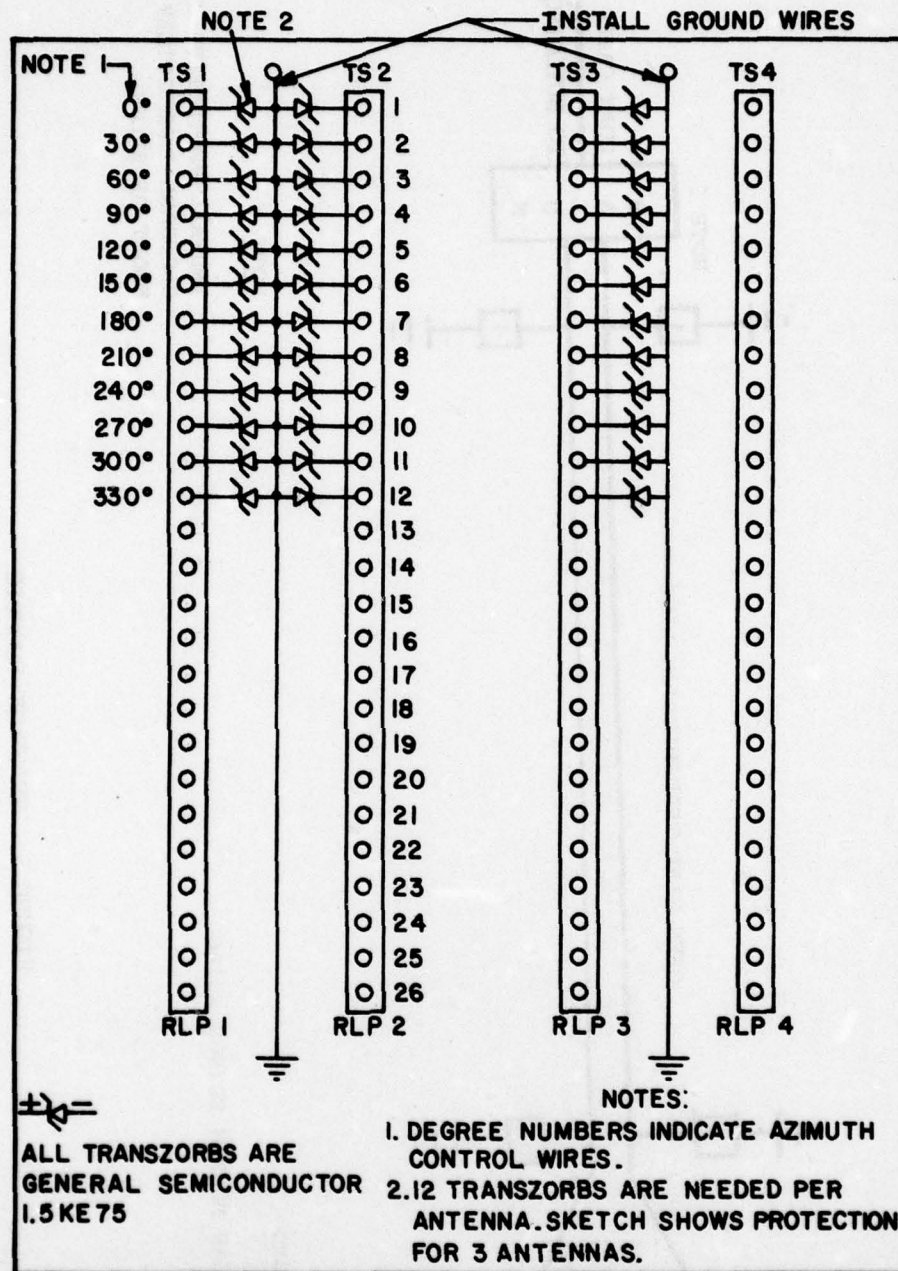
FIGURE 4. MATRIX CONTROL DIODE PROTECTION

3.1.5 RLP antennas 7, 8 and 9 were checked for lightning protection. These antennas are connected to the Scope Control system. Radio maintenance personnel indicated a considerable number of diode failures were occurring in the matrix control rack during lightning storms. Diode failure usually resulted in a continuous rotation of the affected RLP antenna. To eliminate this problem, the diodes were relocated to removable PC boards. The PC boards are usually removed during lightning storms. The diodes act as isolating devices and are used only for azimuth display purposes on the matrix control rack. Further inspection revealed diode failure only on RLP antennas 7 and 8. The remote control cables leading from each antenna to the interior of the building were inspected. Remote control cables for antennas 7 and 8 were unshielded. Antenna #9 had a shielded remote control cable. It is evident that in this case a shielded cable does provide protection from lightning induced voltages.

4.1.10 Additional surge protection devices should be installed on control lines of the RLP antennas. A "TransZorb" (or equal transient suppressor) should be installed between each control wire and ground at the receiver building termination. "TransZorb" is manufactured by General Semiconductor Industries Inc., Tempe, Arizona. Model 1.5 KE 75 is recommended. (See Figure 4 for typical installation.)

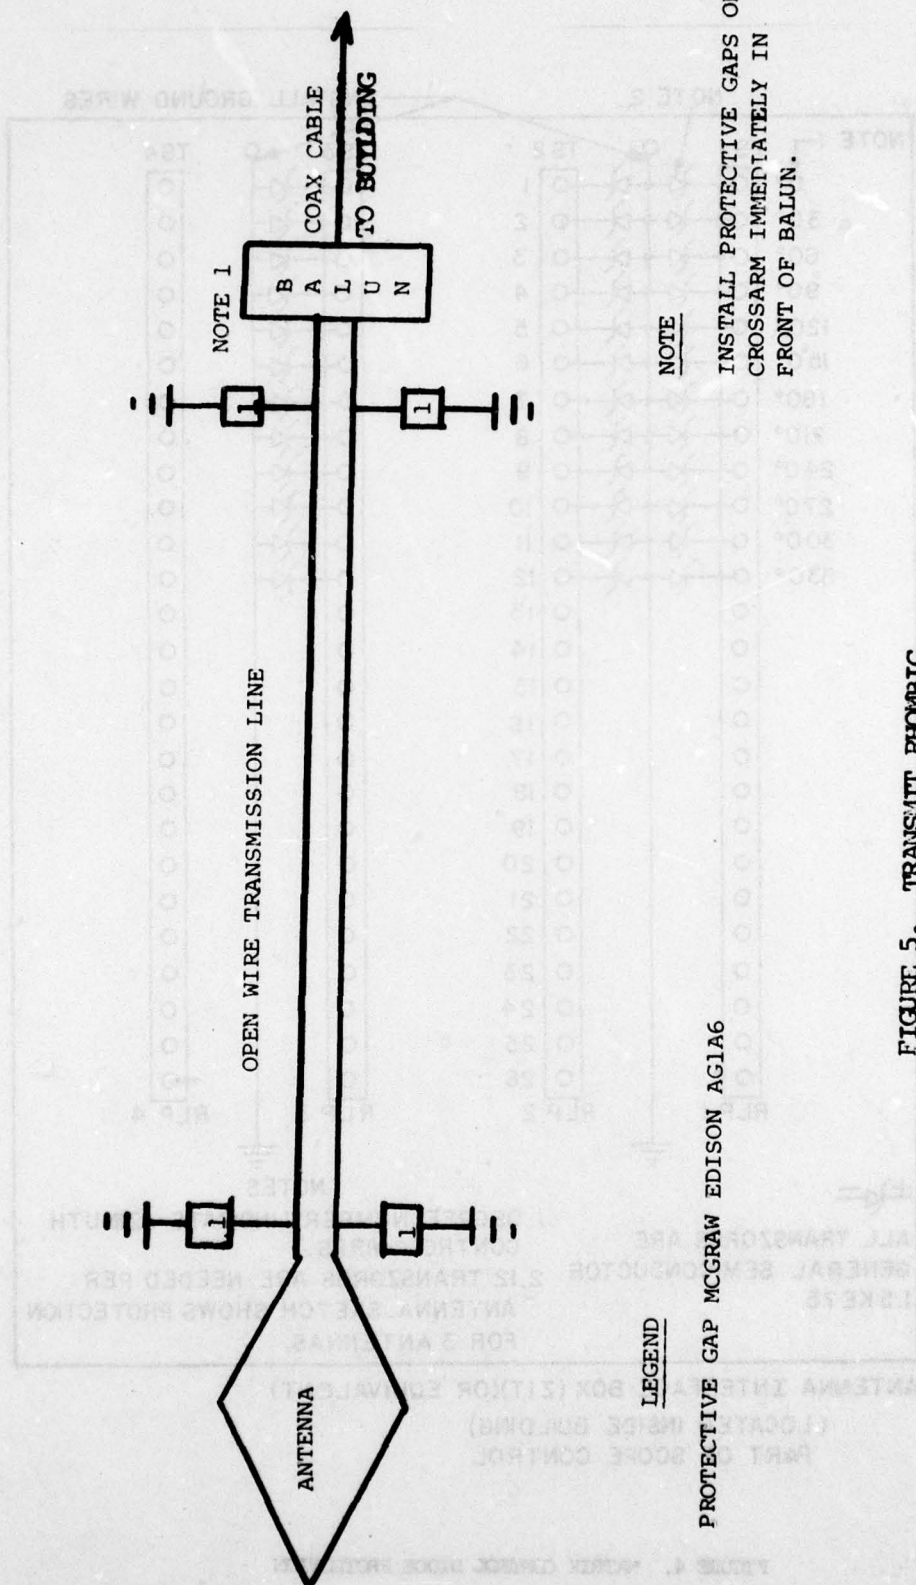
FIGURE 5. TRANSMIT RHOMBIC

3.2.1 The horn gap arresters above the balun transformers were checked and in most cases the existing gap was set too wide.

3.2.3 Spark gap assemblies on balun transformers were out of specifications. In most cases, the gap between arrester and case was too wide. Also, in some cases, the gap material used was incorrect (J-bolts) or incorrectly aligned. If incorrectly aligned, lightning protection is non-existent.

4.2.4 Protective gaps should be installed on all transmit rhombic antennas IAW Figures 5 & 6.
