MOHAWK RIVER BASIN BATAVIA KILL WATERSHED PROJECT DAM No. 1

I.D. No. NY-615 PHASE I INSPECTION REPORT

PHASE I REPORT . NATIONAL DAM SAFETY PROGRAM

Batavia Kill Watershed Project Dam No. 1

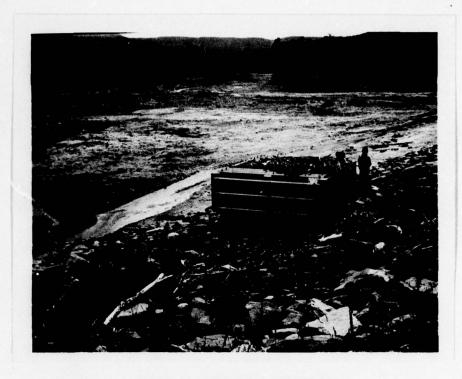
- 1. Hairline cracks in the concrete were evident at the inside corner of the intersection of the vertical drop inlet and the crown of the concrete pressure pipe.
- 2. Joint separations of less than 0.75 inches at the first two pipe sections downstream of the drop inlet base.

INLET OF PRINCIPAL SPILLWAY
@ RISER

- a. Periodic operation and lubrication of the mechanicallyoperated slide gate mechanism to insure a continued ease of operation of the reservoir drain conduit.
- b. Monitoring of the principal spillway hairline cracks in the concrete at the intersection of the vertical drop inlet and crown of the concrete pressure pipe. This monitoring is to insure that any future crack development, if it occurs, may be discovered prior to the need for major corrective action.
- c. Periodic inspections of the principal spillway concrete pressure pipe joint separations to determine if additional separation is occurring.

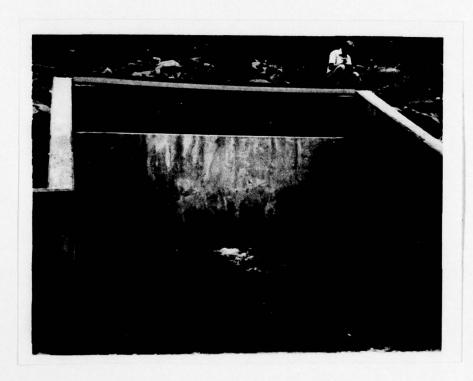
OUTLET OF PRINCIPAL SPILLWAY
@ IMPACT BASIN
