REPORT NO. CG-D-02-79

IDENTIFICATION AND EVALUATION OF DEEPWATER PORT HOSE INSPECTION METHODS

U.S. DEPARTMENT OF TRANSPORTATION
RESEARCH AND SPECIAL PROGRAMS ADMINISTRATION
Transportation Systems Center
Cambridge MA 02142

JANUARY 1979

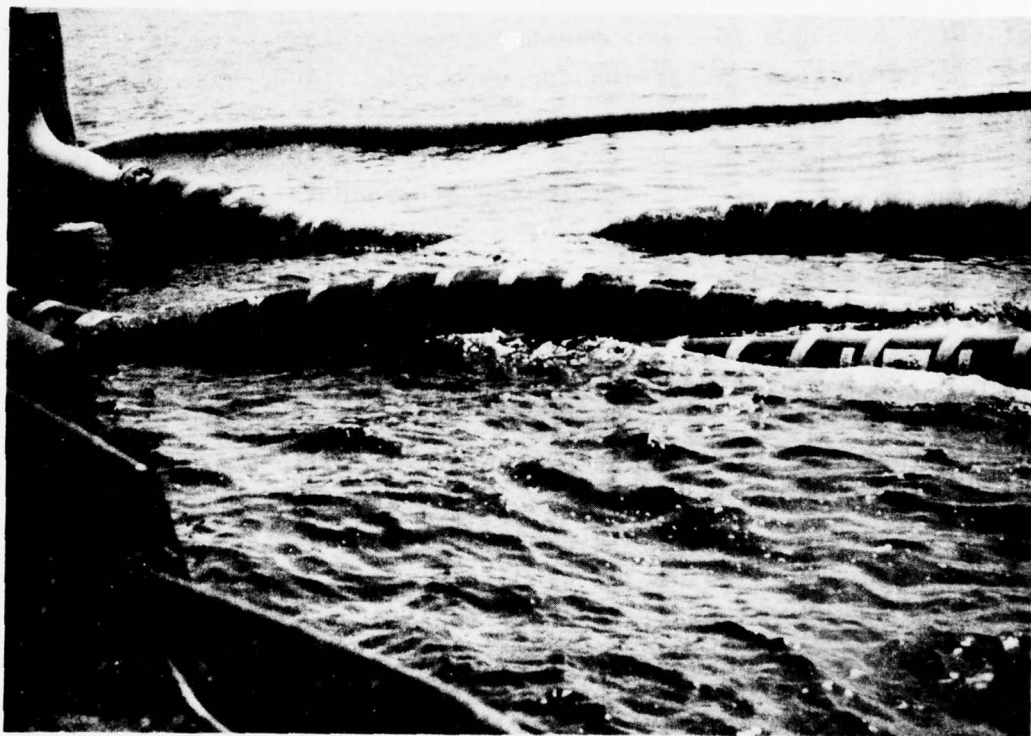
FIGURE 5-4. HOSE OVERLAPPING

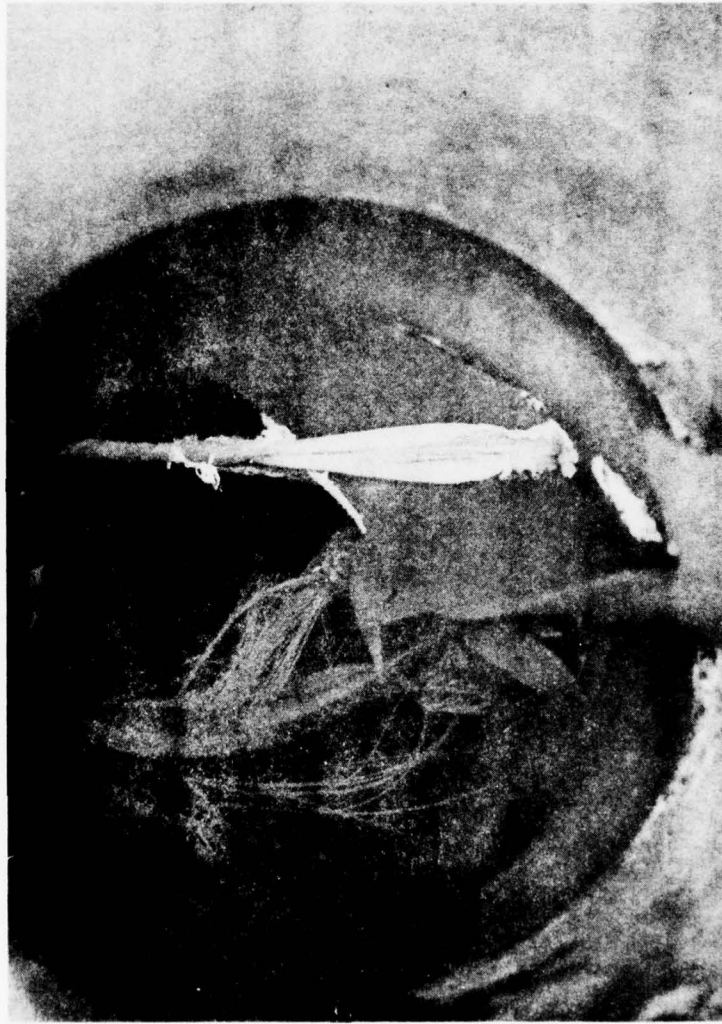
FIGURE 5-6. LINER FAILURE

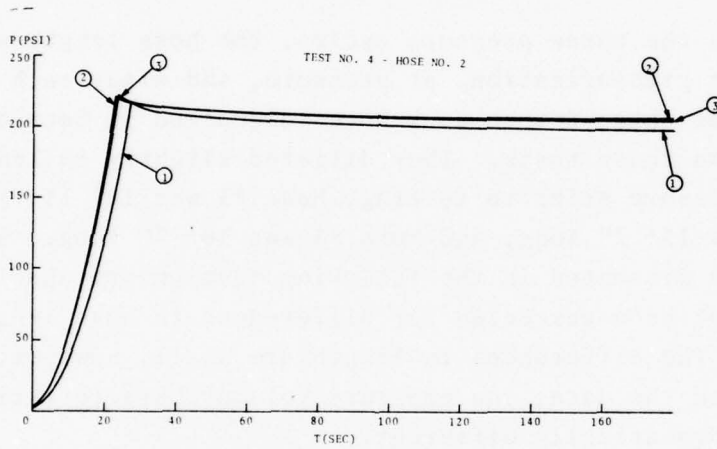
Figure 7-4b (hose #2) is data from the hose whose liner failed and had a small leak of a few drops per minute. The curves exhibit a much shorter pressurization time than the new hose. It was suspected that significant structural design differences existed between the hoses. This was confirmed by examination of the hose

FIGURE 7-4b. DOCK HOSE PRESSURE-VOLUME DATA (HOSE NO. 2)
