HUDSON RIVER BASIN
CAMP HARRIMAN DAM
GREENE COUNTY, NEW YORK
INVENTORY NO. 552

PHASE I INSPECTION REPORT
NATIONAL DAM SAFETY PROGRAM

HUDSON RIVER BASIN
CAMP HARRIMAN DAM
INVENTORY NO. 552
PHASE I INSPECTION REPORT

Name of Dam	CAMP HARRIMAN DAM (I.D. NO. 552)
State Located:	NEW YORK
County Located:	GREENE COUNTY
Stream:	EAST KILL, SCHOHARIE CREEK
Date of Inspection:	AUGUST 30, 1978

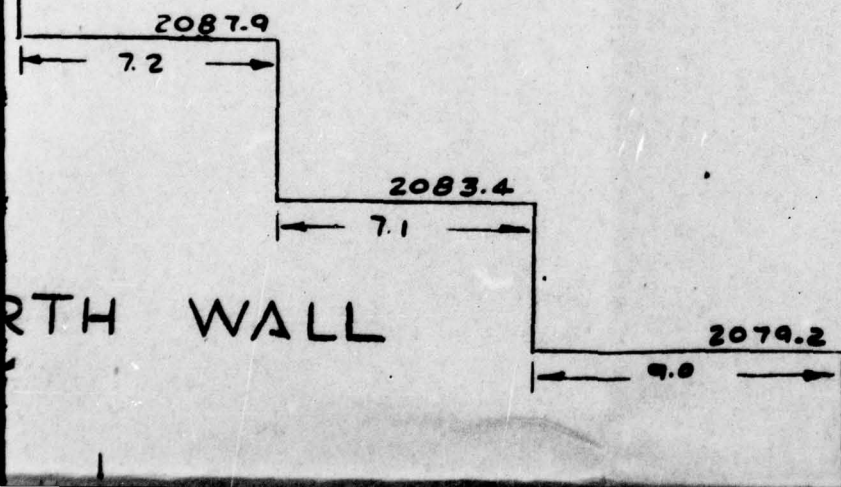
There has been substantial erosion of the apron. The flagstones have been carried away (possibly after having been loosened by freeze-thaw cycles) and some of the underlying concrete fill has also been eroded. A small amount of soil adjacent to the south (outside) face of the south training wall has been eroded, apparently as a result of overtopping.

c. Erosion of the main spillway apron is considered to be an undesirable condition; additional erosion of the apron could cause undermining of the spillway toe and/or training walls.

CONCRETE APRON
BADLY ERODED

b. The apron of the main spillway should be repaired.

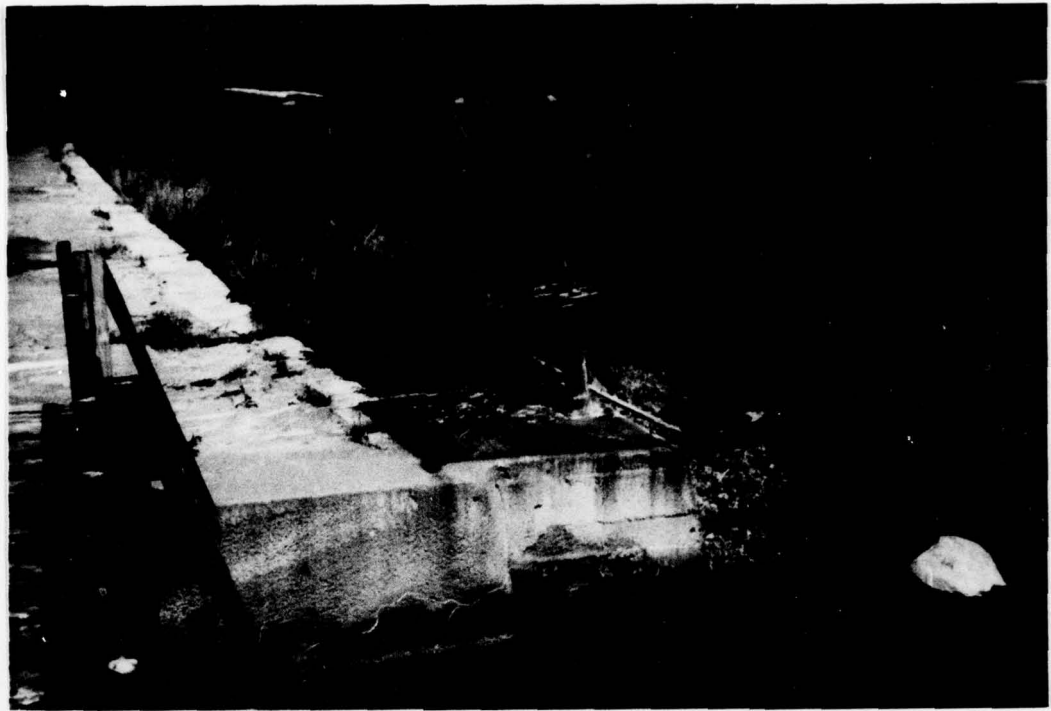
6. Gate operating stand for high level sluice gate, looking northerly

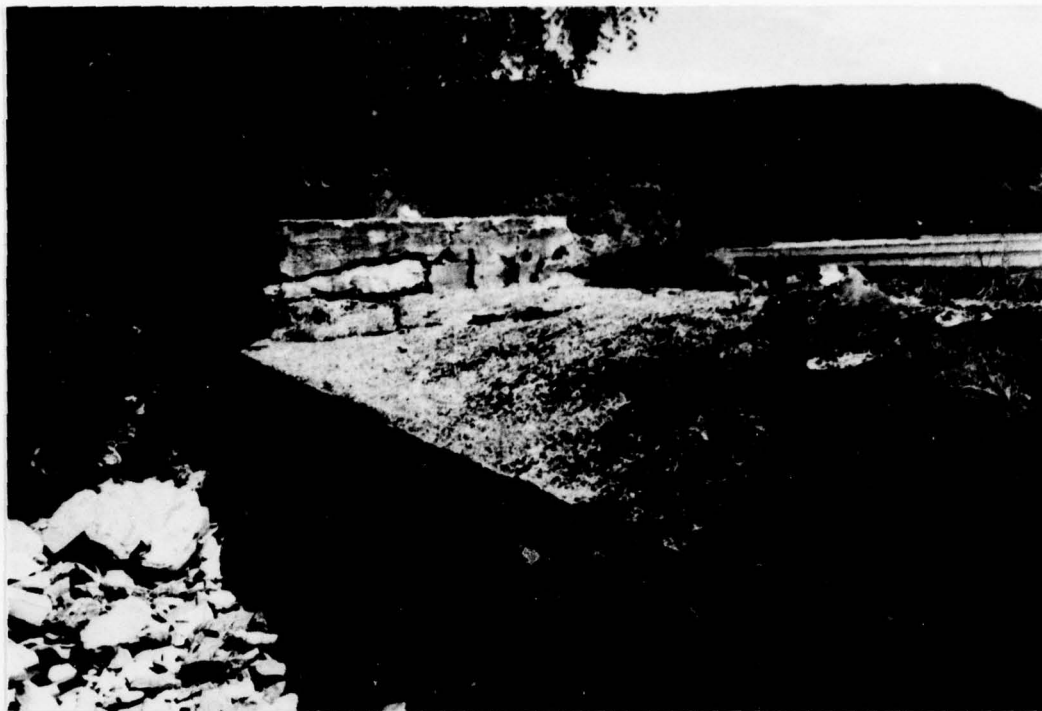
(2) Auxiliary Spillway - The auxiliary spillway has not been resurfaced with gunite; the surface of the parged field stone crest and side walls are cracked and deteriorating. There is a protrusion near the center of the spillway crest which appears to be the remnant of an old bridge pier. At the southern half of the spillway, there exists a separation of as much as 2 inches between the upstream vertical wall and the downstream portion of the spillway crest. Stone in the stream bed below the weir has been eroded such that there are some cavities under the 4-foot high weir and also under the side walls. Some small seepage was audible (not visible) near the left side of the spillway toe.

10. View of Auxiliary Spillway showing crest, north wall and toe

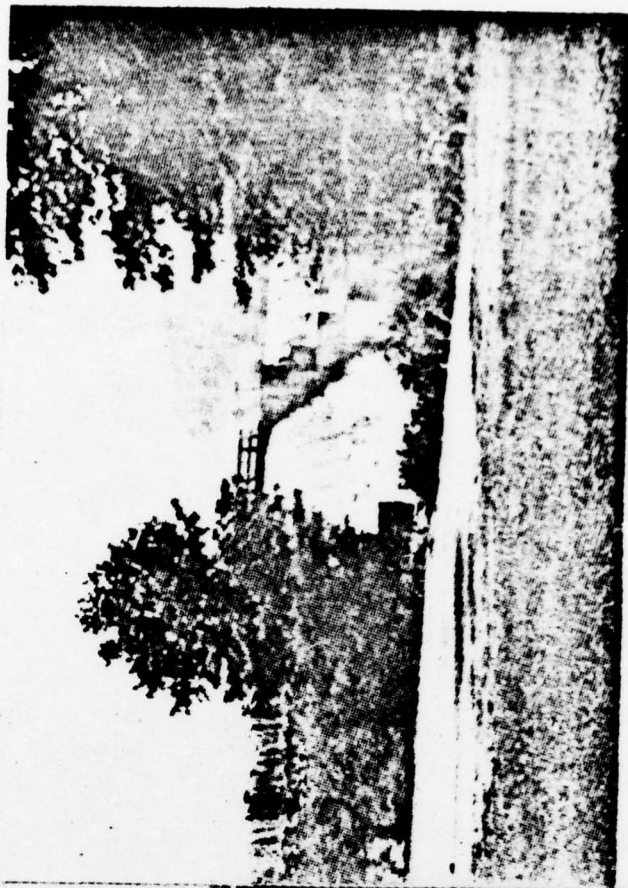
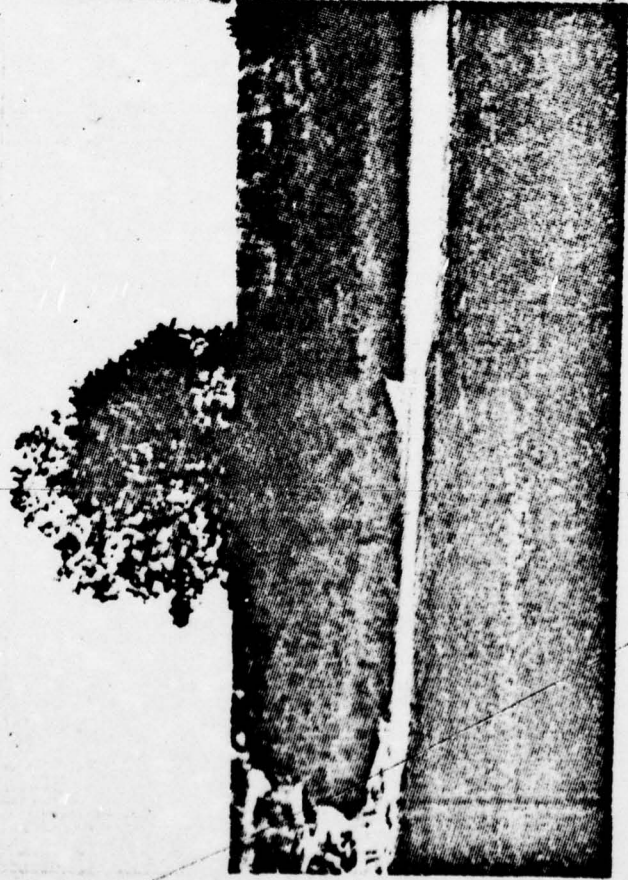
DAM BEING OVERTOPPED WITH 18 INCHES OF WATER

August 10, 1976 7:45 AM
