LOWER TUMBLING RUN DAM

**PHASE I INSPECTION REPORT
NATIONAL DAM INSPECTION PROGRAM**

AUGUST 1978

LOWER TUMBLING RUN DAM
SCHUYLKILL COUNTY, PENNSYLVANIA
NATIONAL I.D. NO. PA 00688

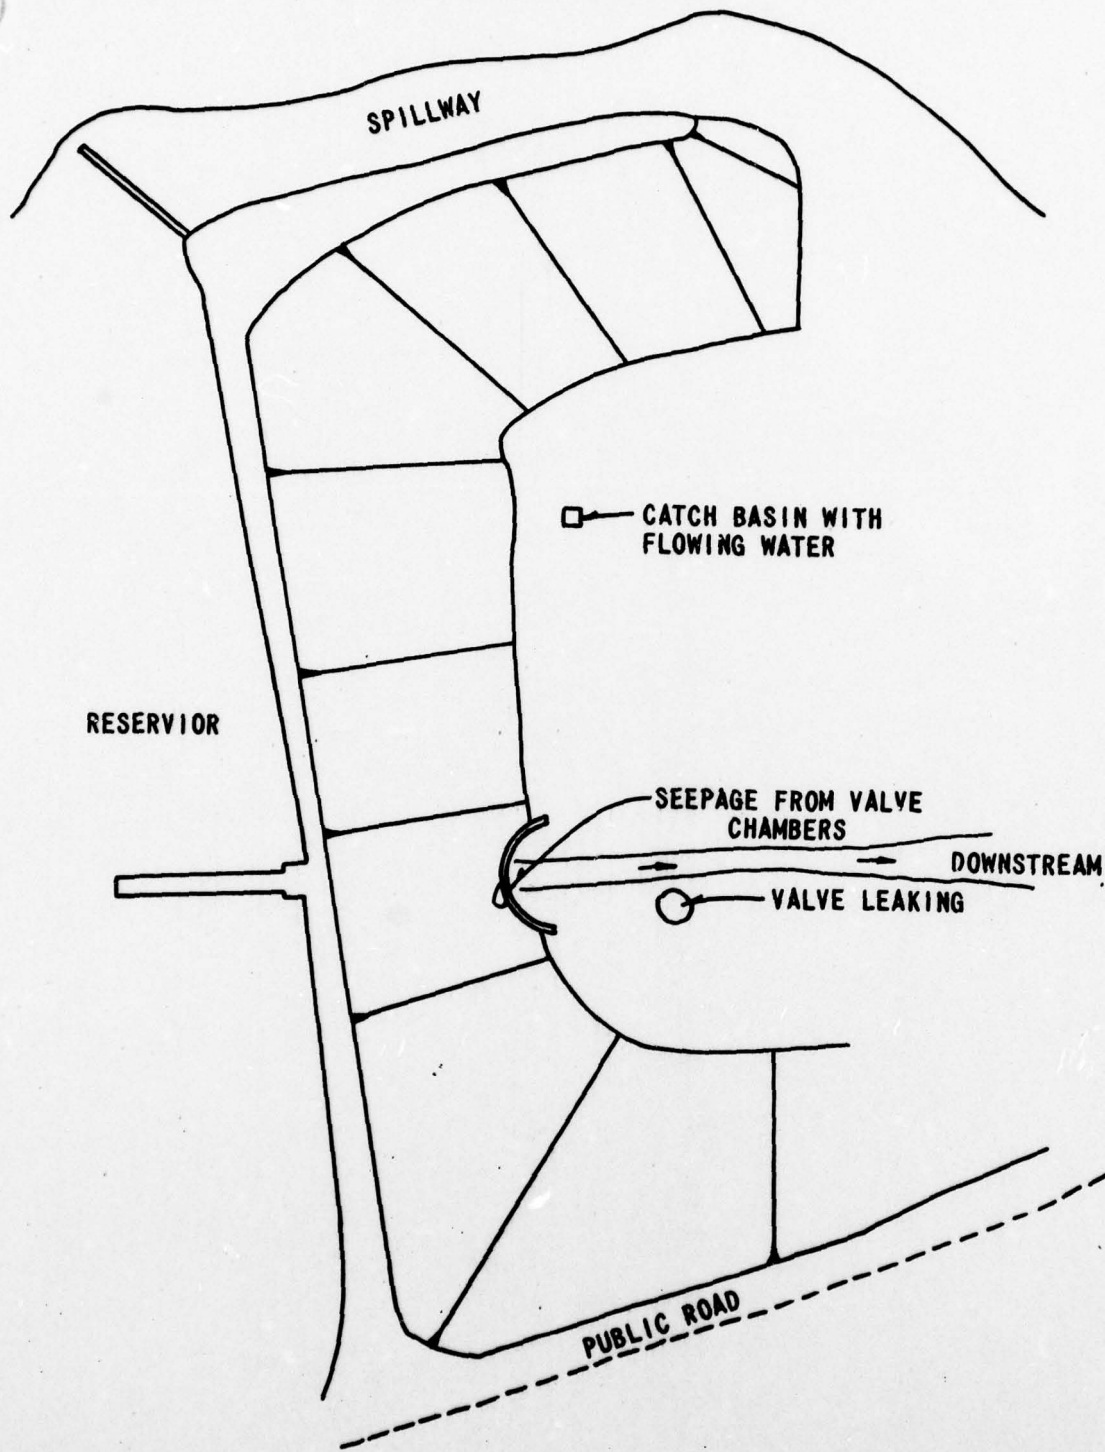
SHEET 5a OF 11

A slight quantity of seepage was observed through the valve chamber located at the downstream toe on the right side of the dam. Seepage was also noted through an observation well at the toe near the left abutment. This flow is probably the seepage through the French (tile) drain system reported by Gilbert Associates, Inc., in 1967. Location of the observed seepage is shown on Sheet 5a, Appendix B.

ANY NOTICEABLE SEEPAGE	<p>Yes. See sheet 5a of 11 for details. A slight amount of seepage was noted at the valve chamber. A catch basin was also observed near the downstream toe which contained water and appears to be connected to a french drain system.</p>	
-------------------------------	--	--

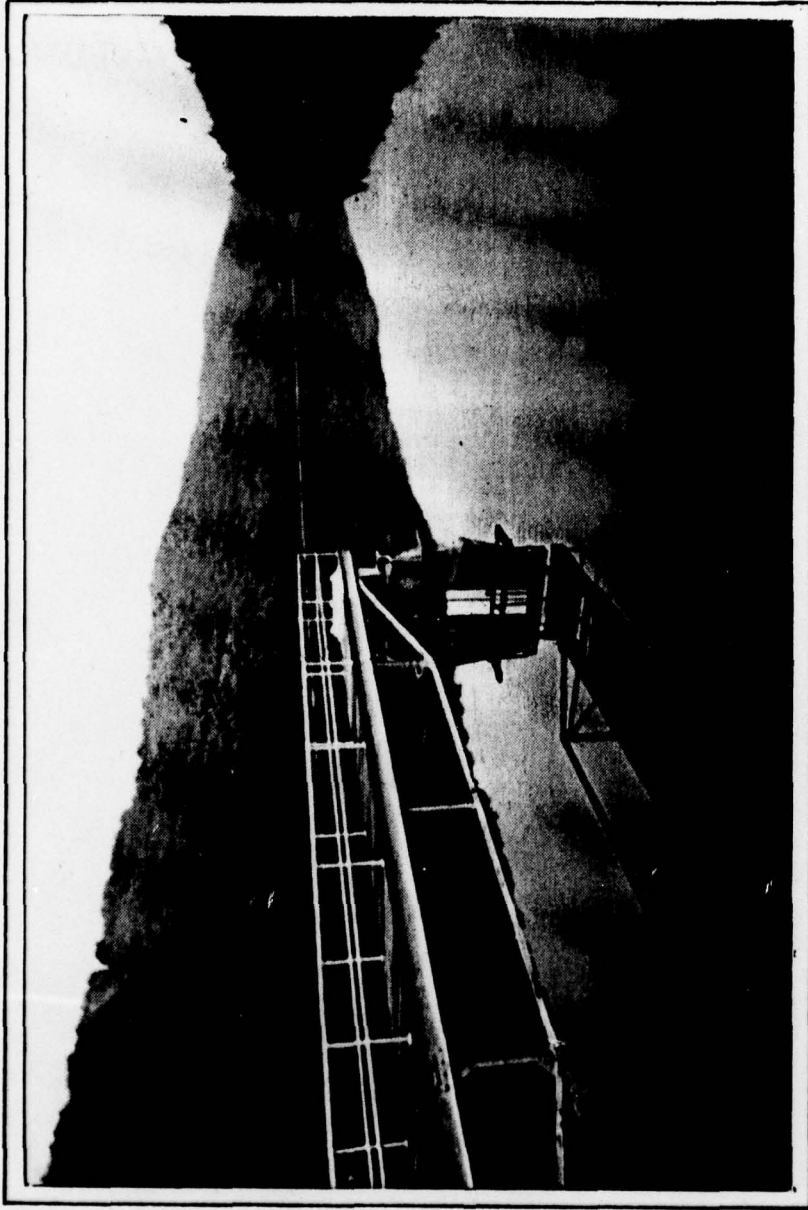
PHOTOGRAPH NO. 1

OUTLET SUPPLY CONTROL TOWER AND
ACCESS BRIDGE.

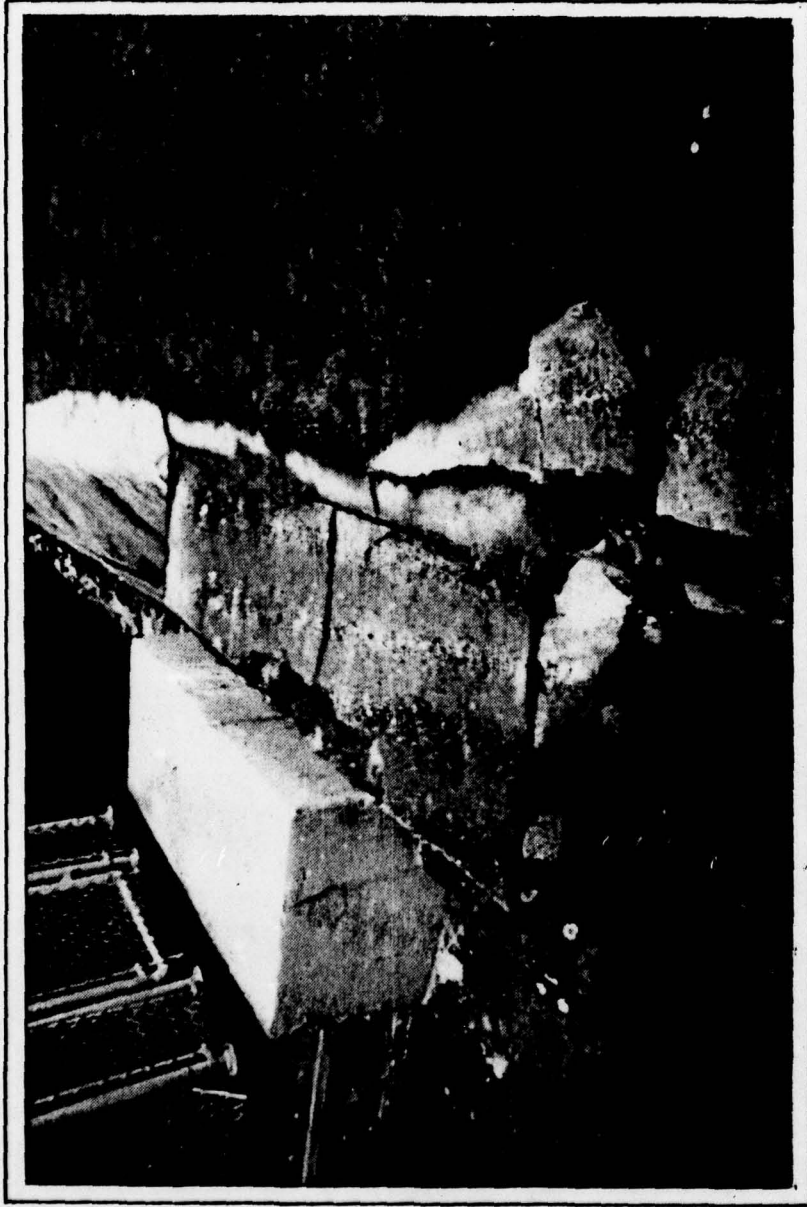
PHOTOGRAPH NO. 10

VIEW OF ACCESS BRIDGE ABUTMENT ON
EMBANKMENT. NOTE CRACKS AND OVERALL
DETERIORATION.

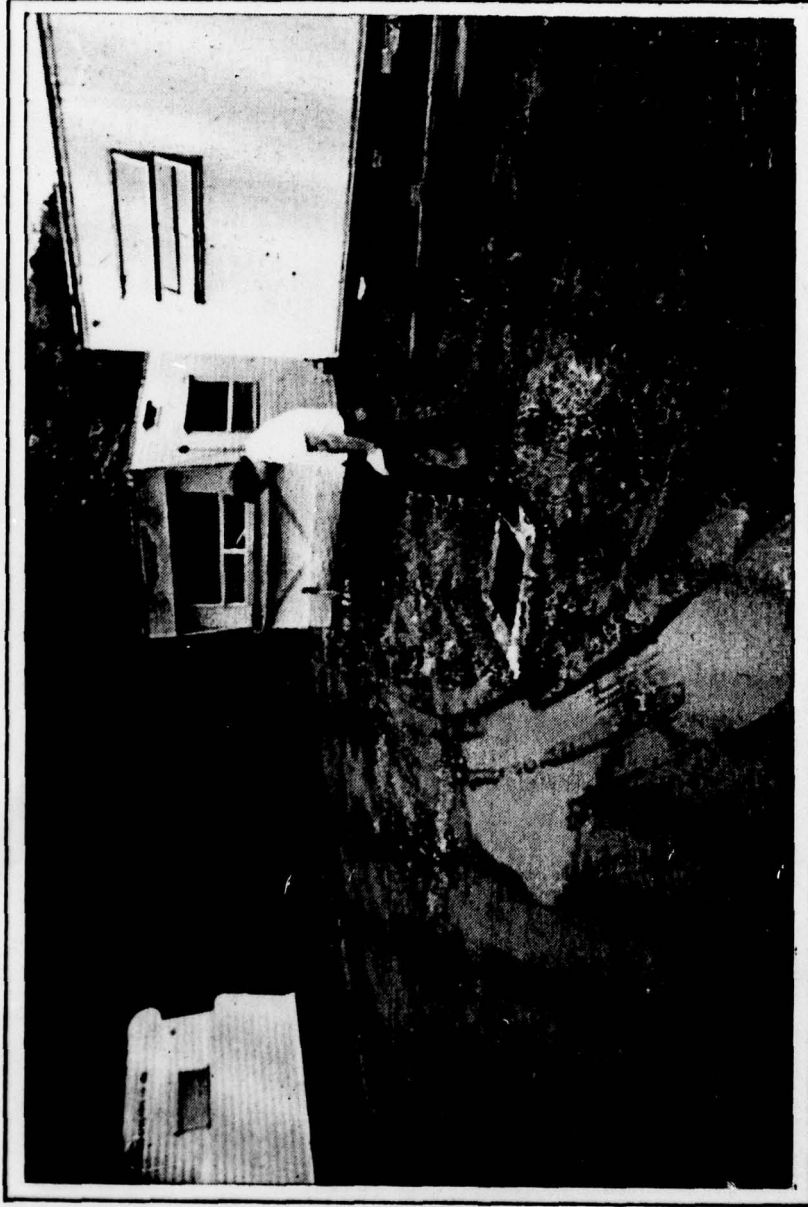
PHOTOGRAPH NO. 12

ACCESS BOX TO TOE DRAIN SEEPAGE.
THE EMBANKMENT IS ON THE LEFT
OF THE PHOTOGRAPH.
