UPPER TUMBLING RUN DAM

PHASE I INSPECTION REPORT NATIONAL DAM INSPECTION PROGRAM

AUGUST 1978

UPPER TUMBLING RUN DAM
SCHUYLKILL COUNTY, PENNSYLVANIA
NATIONAL I.D. NO. PA 00689

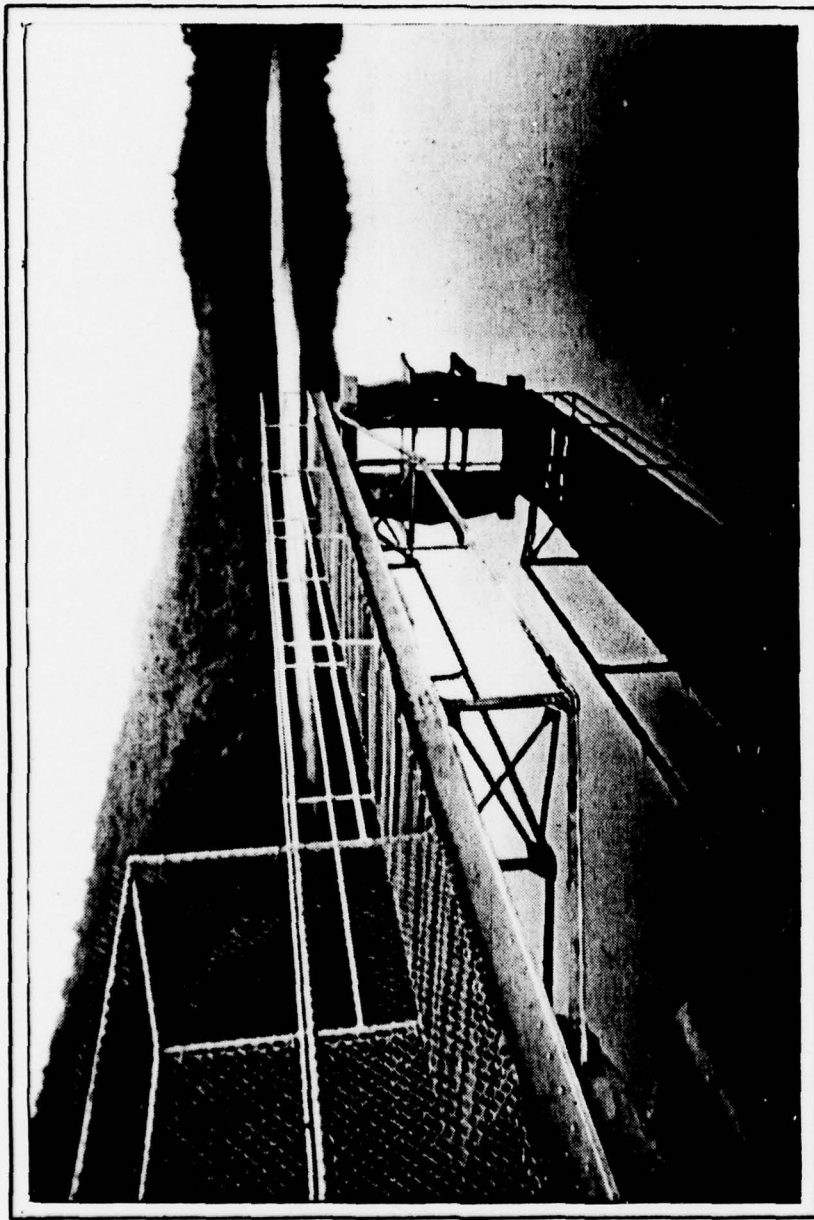
PHOTOGRAPH NO. 1

INTAKE TOWER AND BRIDGE.

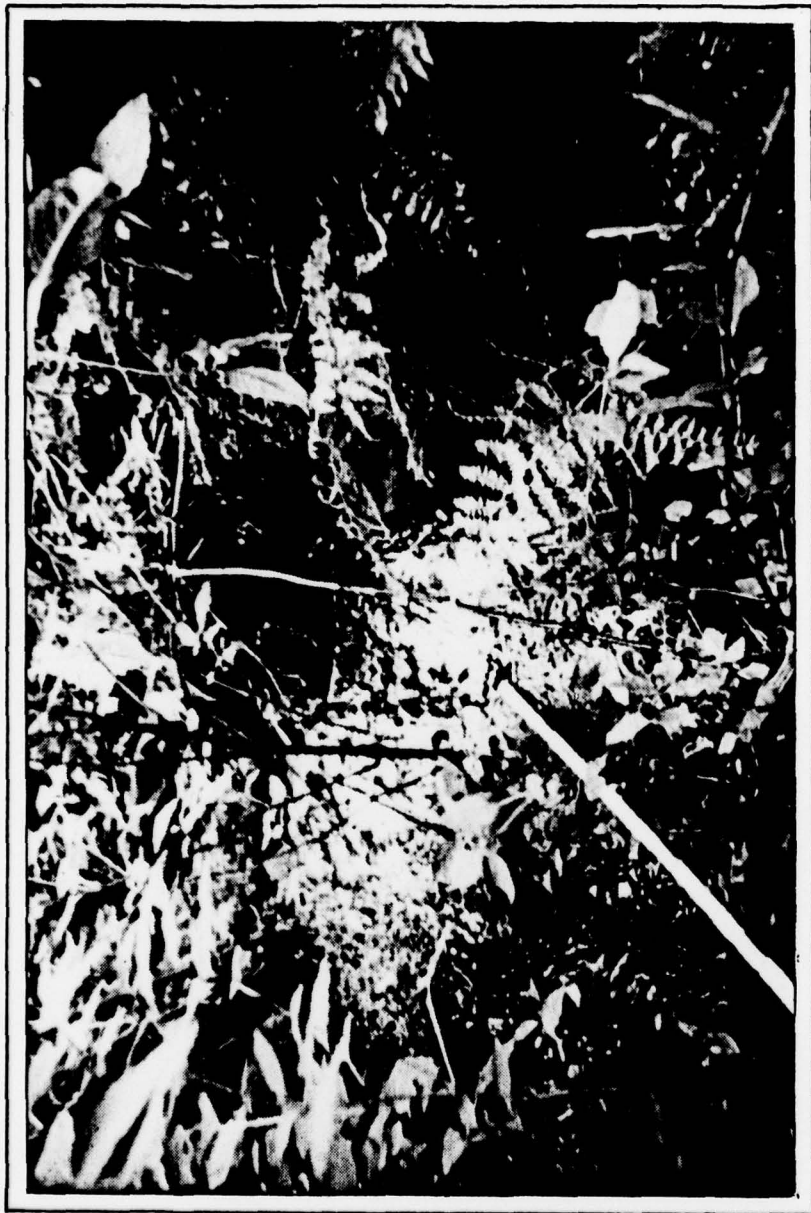
PHOTOGRAPH NO. 13

CLOSE-UP OF SEEPAGE FROM LEFT
ABUTMENT. SEE PHOTOGRAPH NO. 12
FOR OVERVIEW.

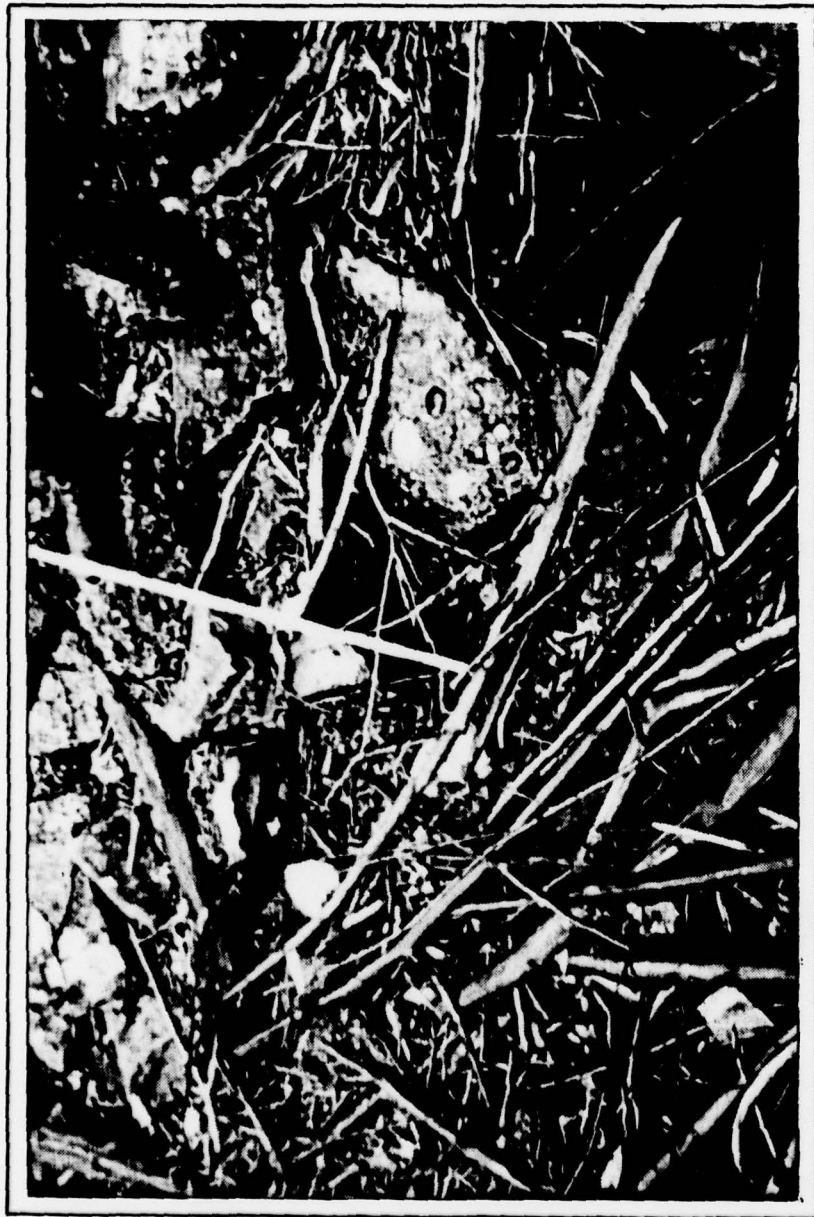
PHOTOGRAPH NO. 14

ANY NOTICEABLE SEEPAGE	Yes. Seepage was observed along the left downstream abutment and it was clear. Seepage was also noted at the toe of the right abutment but it could not be traced due to debris and dense vegetation. The Owner's representative stated that beavers deposited this debris.	
------------------------	---	--

SEEPAGE FROM RIGHT ABUTMENT WITH
FLOW DISCHARGING INTO LOWER
TUMBLING RUN RESERVOIR.
