6 National Dam Inspection Program. Frances Slocum Dam (NDS-ID-PA-00574; DER-ID-40-218), Susquehanna River Basin, Abrahams Creek, Luzerne County, Pennsylvania. Phase I Inspection Report.

FRANCES SLOCUM DAM

NDS ID No. PA-00574  
DER ID No. 40-218

PHASE I INSPECTION REPORT  
NATIONAL DAM INSPECTION PROGRAM

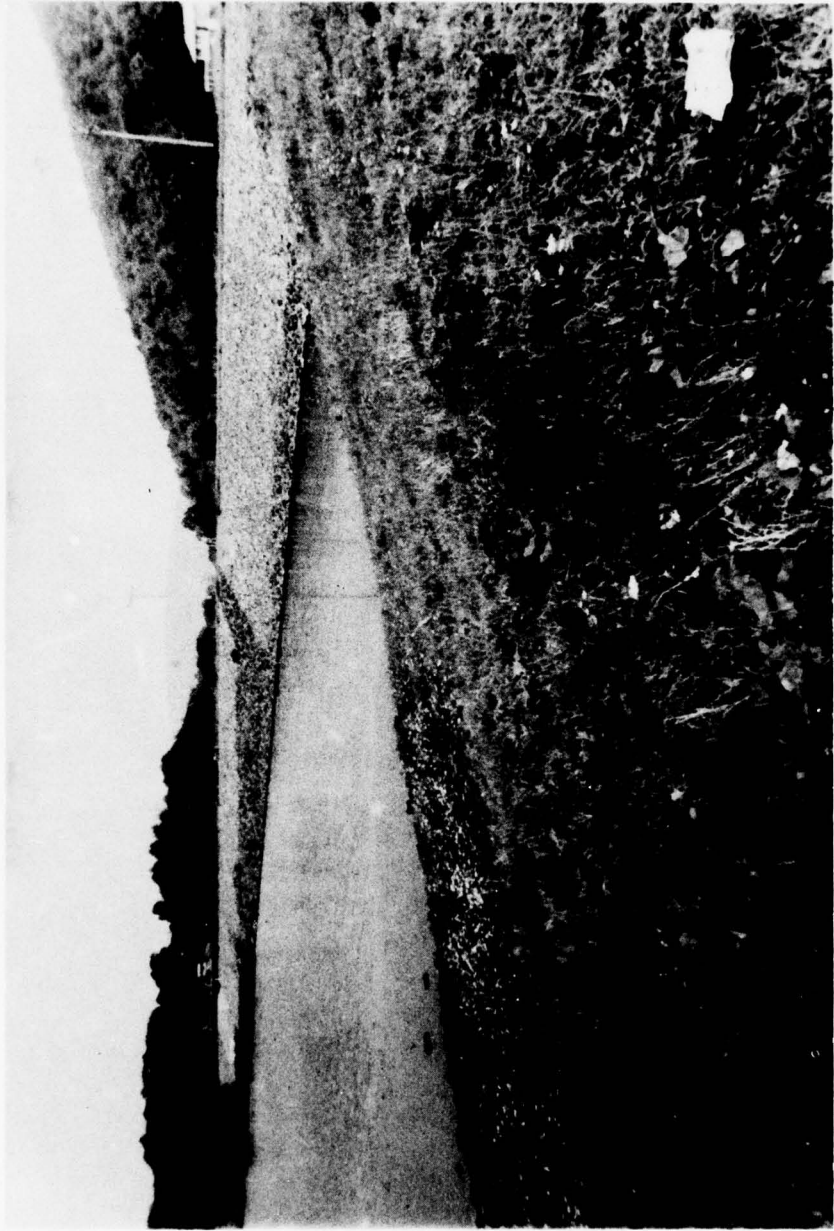
Embankment.  
View from Upstream.

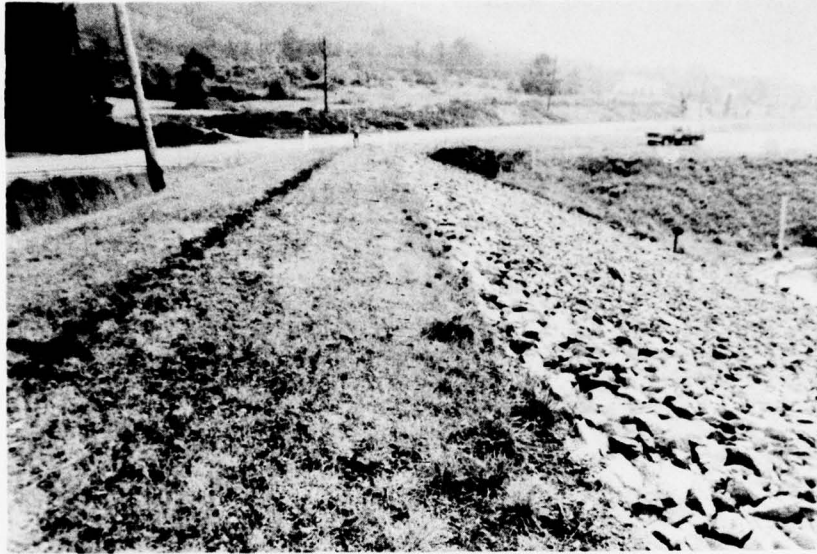
(2) The embankment slopes were in excellent condition (Photographs A, B, C, and D). Riprap on the upstream slope was intact to the top of the dam, and there were no weeds or brush growing in the riprap. The downstream slope is covered with a mixed growth of grass, crown-vetch, and weeds about 2 feet high. There was no brush growing on the downstream slope.

A. Junction of Embankment and Right Abutment.  
Staff Gages at Right.

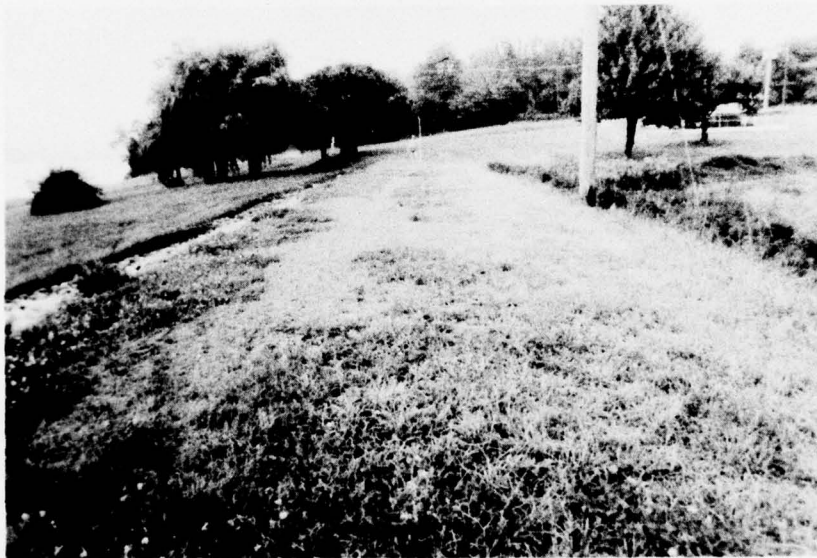
B. Junction of Embankment and Left Abutment.

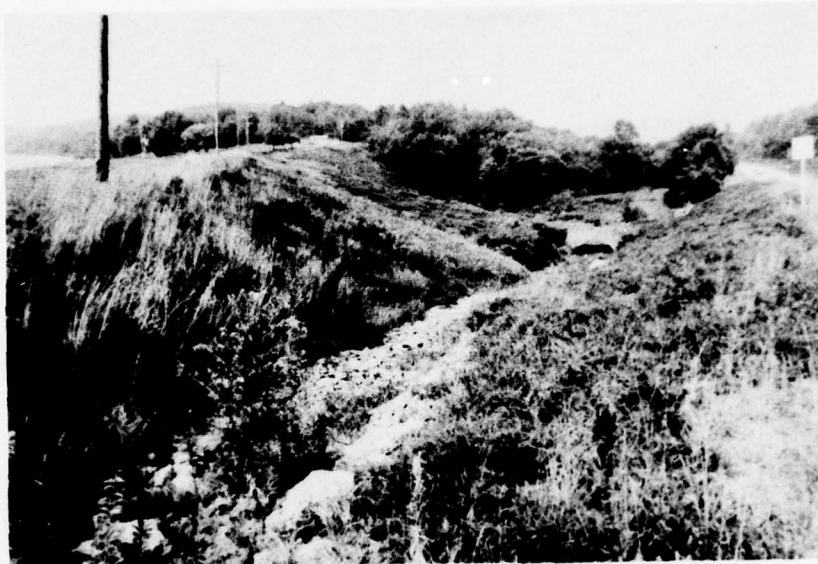
(3) The embankment toe gutters were generally in good condition. The gutter along the right abutment is rock-lined, and there were no signs of erosion (Photograph C). A concrete gutter along the downstream toe had a slight amount of vegetation growing in the joints.

C. Downstream Slope of Embankment.  
View from Right Abutment.

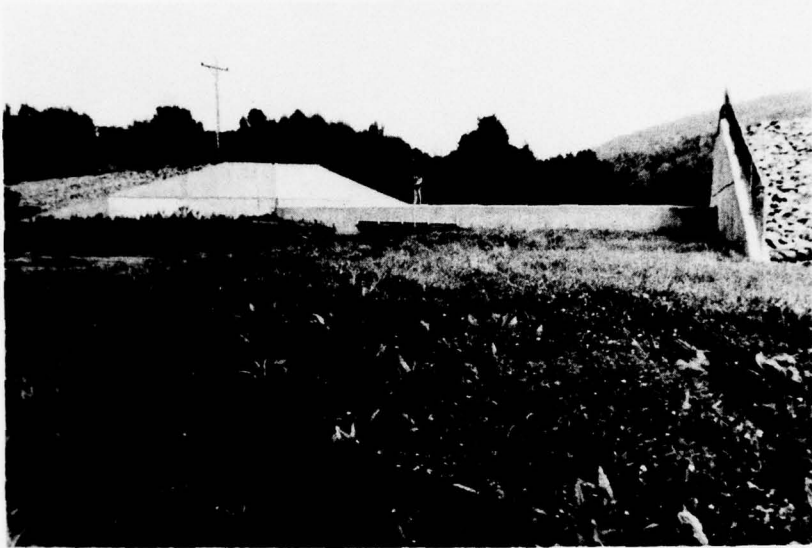
(1) Spillway. The approach area to the spillway was clear (Photograph E). The bar screen over the opening in the spillway weir was well-maintained and free of debris (Photograph F). Some cracks in the concrete were visible on the downstream side of the spillway weir where the opening in the spillway weir transitions to a channel along the centerline of the spillway chute (Photographs G and L). Attempted surface repairs by the Park personnel using an epoxy cement have not been successful. Except for the aforementioned cracks in the vicinity of the opening in the spillway weir, the ogee weir was in good condition (Photographs G and J).

E. Spillway Approach Channel.

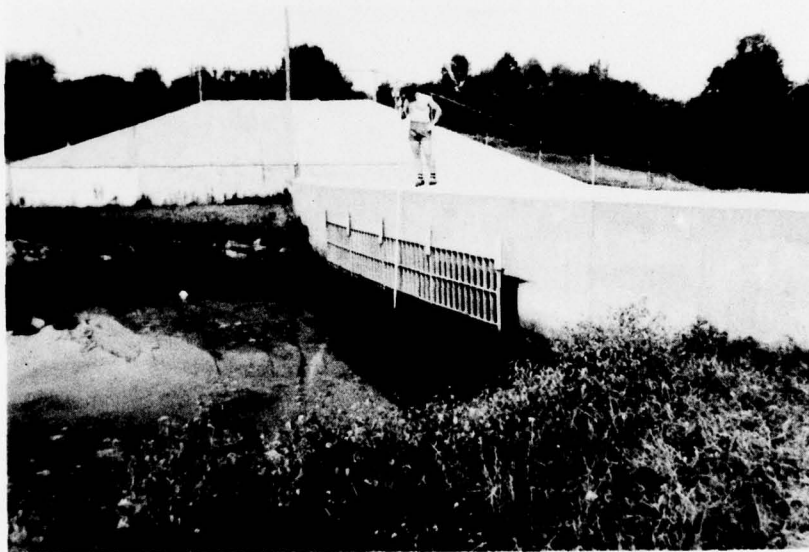
F. Bar Screen Over Low-Flow Opening in Spillway.

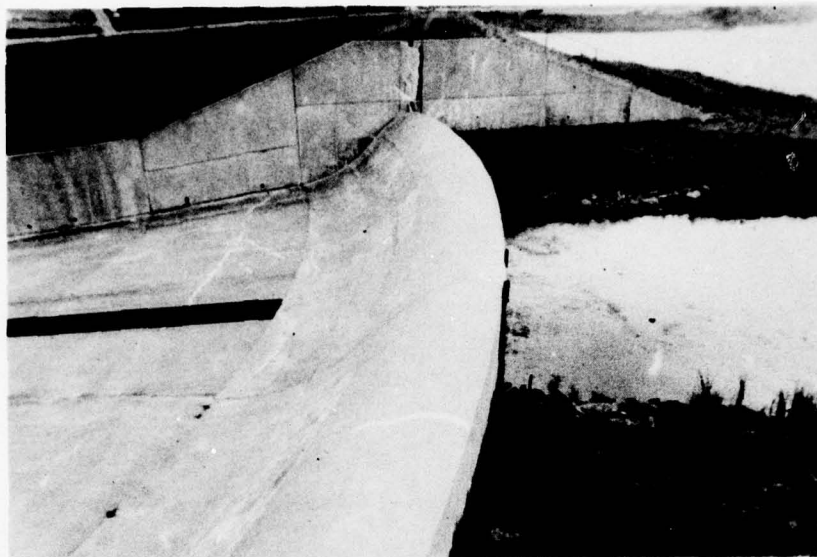
(4) Spillway Chute Slab and Flip Bucket. The spillway chute slab had no major deficiencies. Several fine transverse cracks were apparent, but most of them did not go all the way across the slab monoliths. One slab monolith has settled slightly, but there were no apparent adverse effects. The chute slab and flip bucket are shown on Photographs G, M, and N.

G. Concrete Ogee and Right Training Wall.

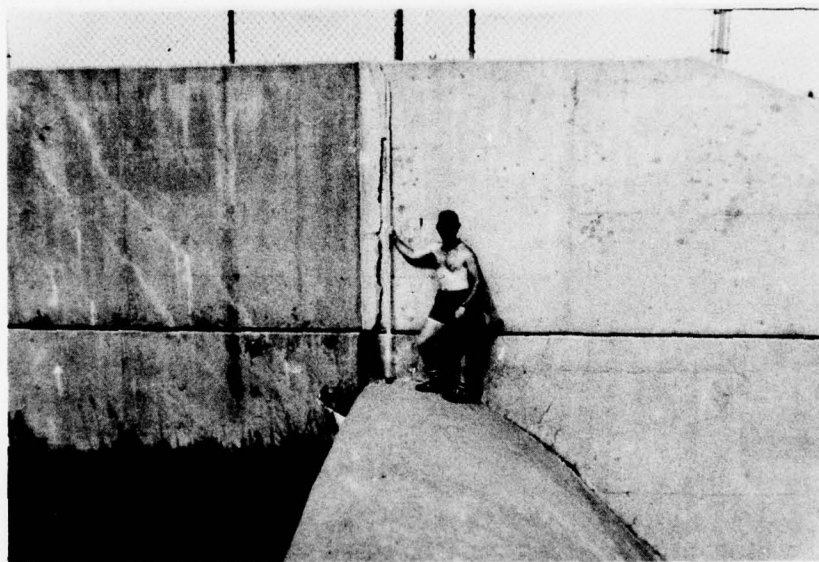
(3) Spillway Left Training Wall. The condition of the left training wall of the spillway is similar in character to the right training wall but not nearly as severe (Photograph H). The first and second monoliths are in good condition. The third monolith has 2 fine diagonal cracks, and the fourth monolith is in good condition. The joint between the third and fourth monoliths is badly cracked and ready to spall (Photograph H). Differential movement at the tops of the monoliths at the joint was 0.25 inch. The rest of the monoliths along the chute and flip bucket are in good condition except for one surface spall on one of the monoliths.

(2) Spillway Training Walls. The condition of the right training wall of the spillway is unsatisfactory. The ends of the waterstop are exposed, and the effectiveness of the waterstop is doubtful. During periods of high pool levels, seepage could develop through the joint that might cause piping of embankment materials. Loss of embankment materials could cause a condition that might result in overtopping of the embankment. While the condition of the left training wall is not as severe as the right wall, it is considered to be part of the same problem. The similarities between the deficiencies of the right and left walls suggest that the problems arose as a result of the design of the walls. Review of previous inspection reports clearly indicates that the deficiencies had become apparent by 1973, and possibly began as early as 1969, at which time the project was 4 years old. The inspection reports also indicate substantial worsening of the condition between 1973 and 1975. Without additional study, it is not possible to determine whether the problem is still active or whether it has stabilized. It should be recognized that a great flood would impose loads on the walls that would exceed those have been experienced to date.

H. Concrete Ogee and Left Training Wall  
Showing Cracking at Joint and on Upstream Monolith.

(2) Perform investigations required to determine the cause of unsatisfactory performance of the spillway training walls and make repairs.

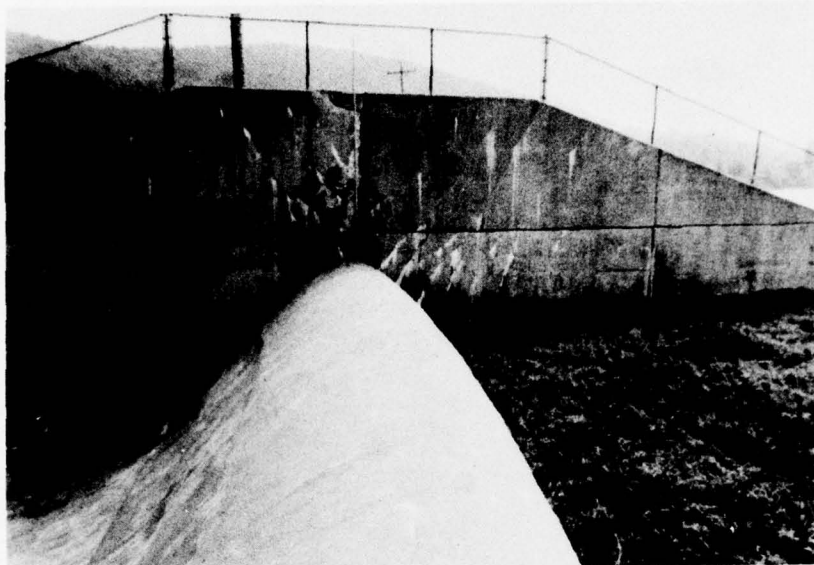
(2) Spillway Right Training Wall. The right training wall of the spillway has several deficiencies. The most upstream monolith, or first monolith, has one vertical crack at its upstream end that extends through the wall. The third monolith, which is the monolith just upstream of the concrete ogee weir, has 7 fine diagonal cracks on its face (Photograph J). Similarly, the fourth monolith has 3 fine diagonal cracks and one fine vertical crack. The joint between the third and fourth monoliths is spalled to a depth of 4 inches and the waterstop is exposed (Photographs J and K). About one inch of differential movement was measured between the tops of the third and fourth monoliths. The inside face of the third monolith has an inward inclination of about 77V on LH, while the inside face on the fourth monolith has an inward inclination of about 96V on LH. Downstream from the fourth monolith, the monoliths along the chute and flip bucket are in good condition.

J. Concrete Ogee and Right Training Wall Showing Monolith Cracking and Spalling at Joint.

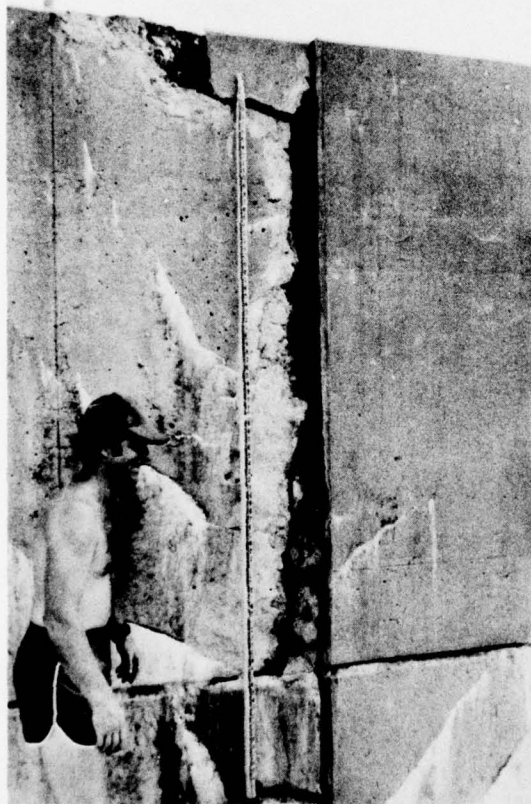
K. Detailed View of Cracking and Spalling at Joint.

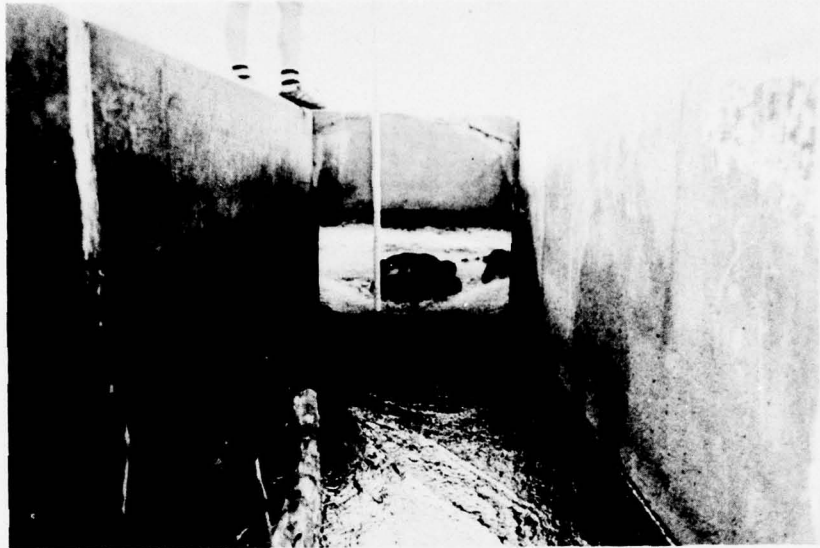
L. Low-Flow Outlet at Downstream Side of Spillway Weir.

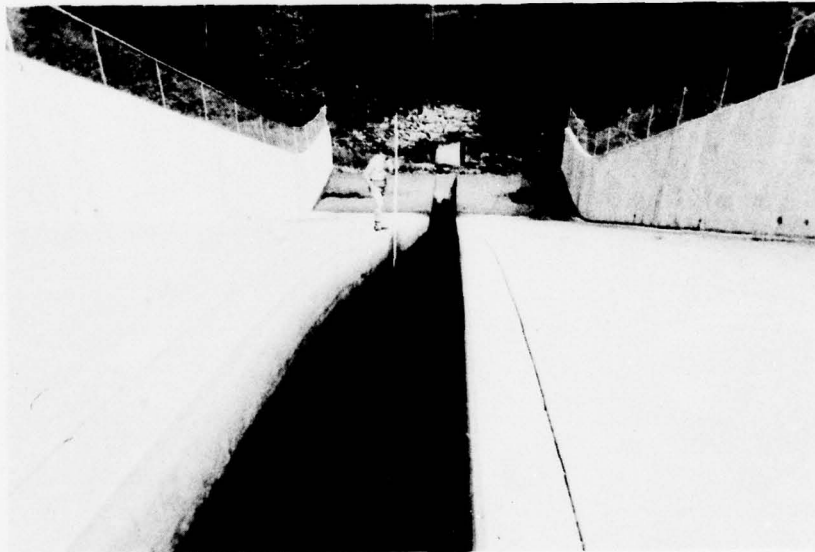
(3) Spillway Chute Slab. The fine transverse cracks on the spillway chute slab and the minor settlement of one slab do not present hazard to the dam. However, the concrete might deteriorate in the future to the extent that repairs would be warranted.

M. Concrete Chute and Flip Bucket.

(4) Monitor condition of spillway slab concrete where cracks exist. If conditions worsen, repairs should be undertaken.

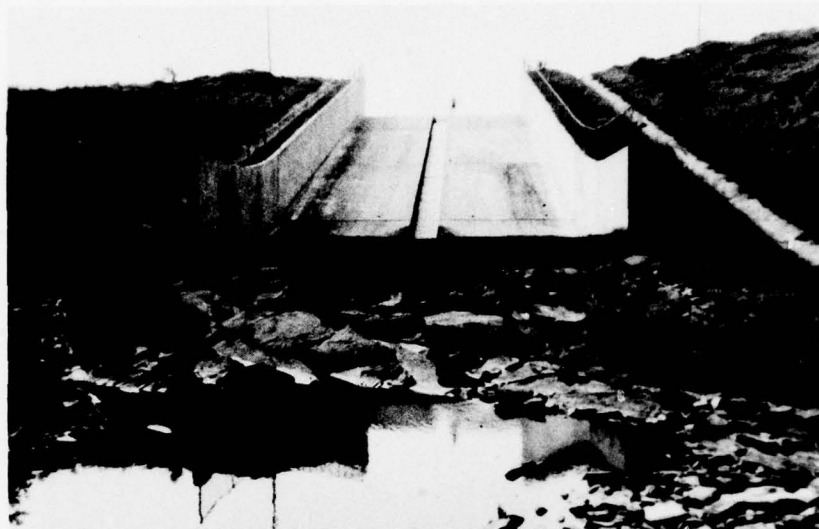
N. Concrete Chute, Flip Bucket,  
and Paved Gutters.

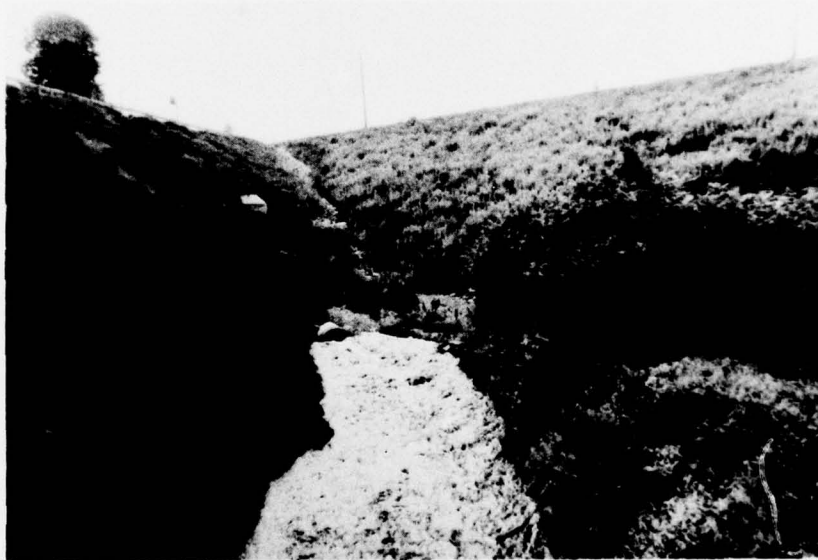
O. Flow from Outlet Works during Valve Operation.
