6 National Dam Inspection Program.
Lackawanna Dam (NDS-ID-PA-00913, DER-ID-35-139), Susquehanna River Basin, South Branch Tunkhannock Creek, Lackawanna County, Pennsylvania. Phase I Inspection Report.

LACKAWANNA DAM

PHASE I INSPECTION REPORT
NATIONAL DAM INSPECTION PROGRAM

SEPTEMBER 1978

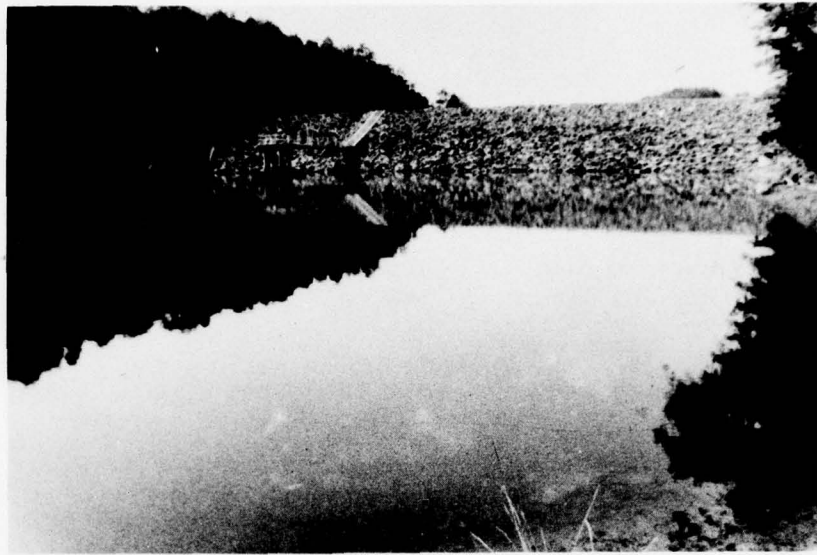
(2) The rockfill on the upstream slope of the embankment was in good condition except at the top of the dam adjacent to the spillway (Photographs A, B, and F), where vandals have thrown stones into the spillway chute. The rockfill on the upstream slope is sound, well-graded red and gray sandstone. It varies in size from 6 to 24 inches.

A. Embankment.
View from Upstream.

(1) Replace riprap on upstream slope and restore embankment to design elevation.

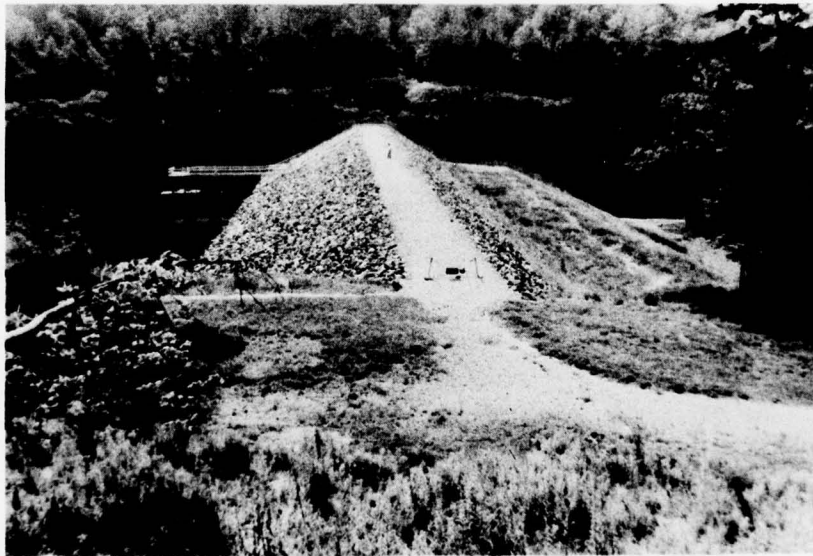
B. Embankment.
View from Right Hillside.

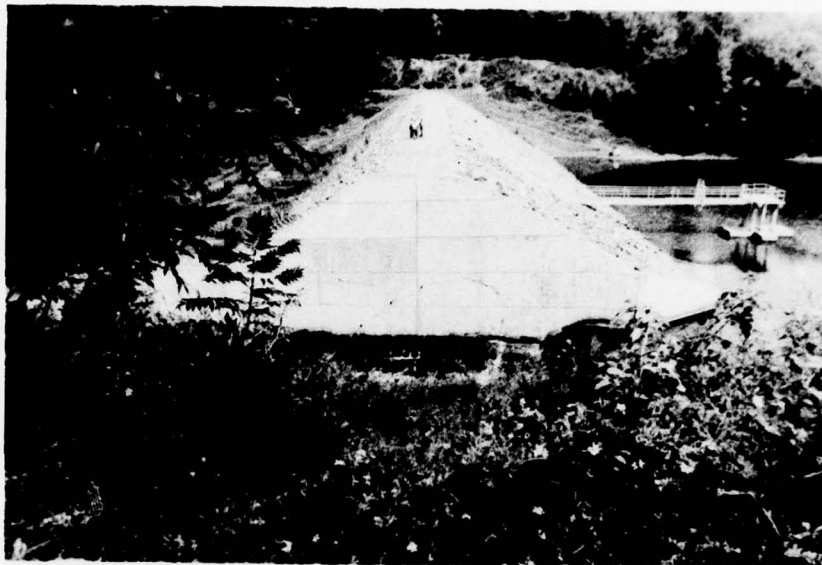
(1) Spillway. The spillway had no apparent deficiencies. All concrete structures were in good condition (Photographs C, G, and J). Backfill concrete that was placed by the Corps of Engineers to repair erosion damage that occurred during the June 1972 flood was also in good condition. The exposed rock surfaces in the chute section were irregular and some fractures were visible (Photograph H). It was noted that the combination of the location of the weir and the height of the spillway training wall will probably produce flow across the upstream slope of the embankment parallel to the axis of the dam at high pool levels (Photographs C and F).

C. Spillway and Embankment.
View from Left Hillside.

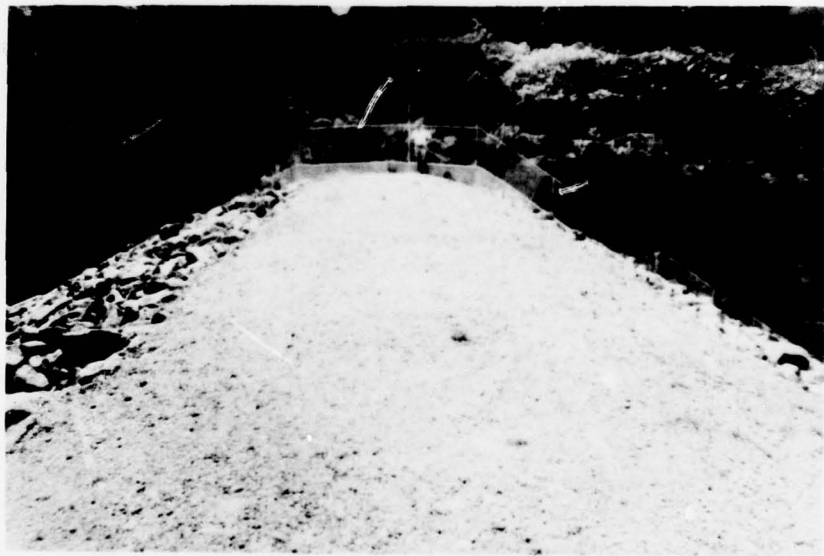
(2) The loss of stone on the upstream slope at the top of the embankment adjacent to the spillway has caused the aforementioned low area to develop. Unless the stone is replaced, the limits of the low area will probably become larger.

| VISUAL EXAMINATION OF | OBSERVATIONS | REMARKS OR RECOMMENDATIONS |
|---|---|---|
| JUNCTION OF EMBANKMENT WITH: Abutment Spillway Other Features | 1. Right abutment: no abnormalities. 2. Spillway: low area and missing riprap. | |

D. Low Area at Spillway Training Wall.

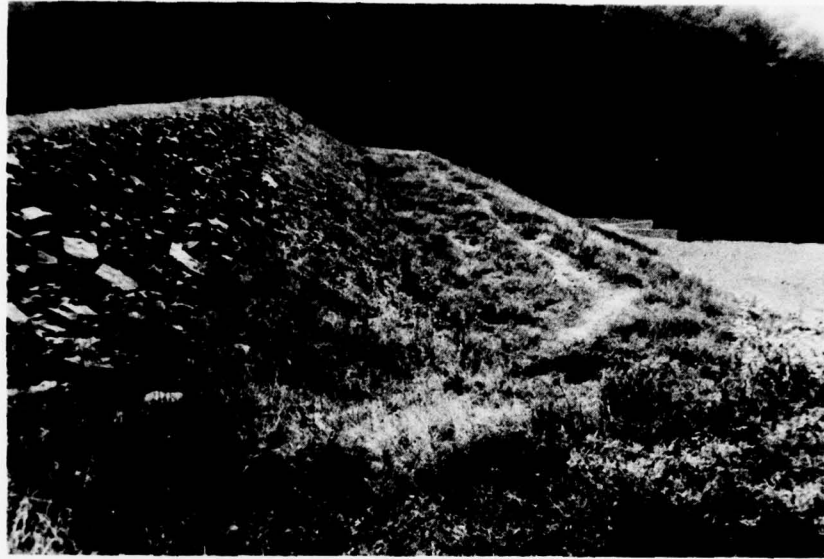
E. Downstream Slopes of Embankment.
View from Right Abutment.

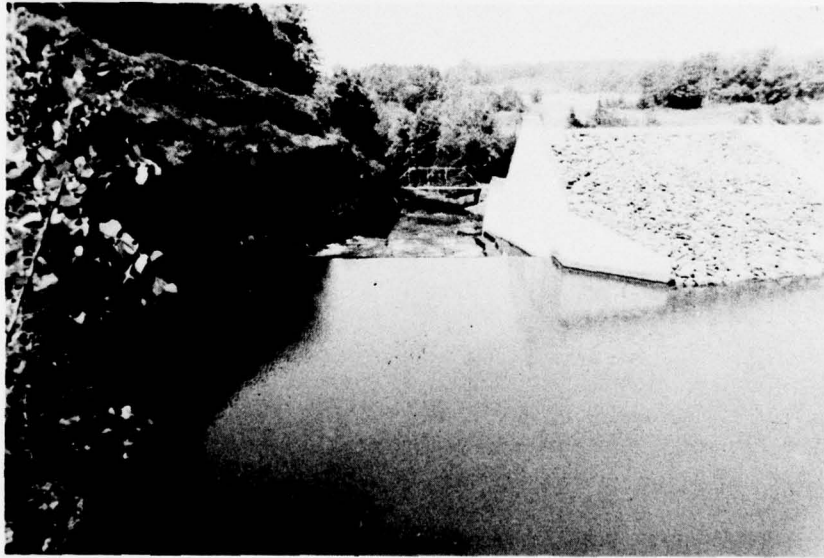
F. Spillway Approach Channel.

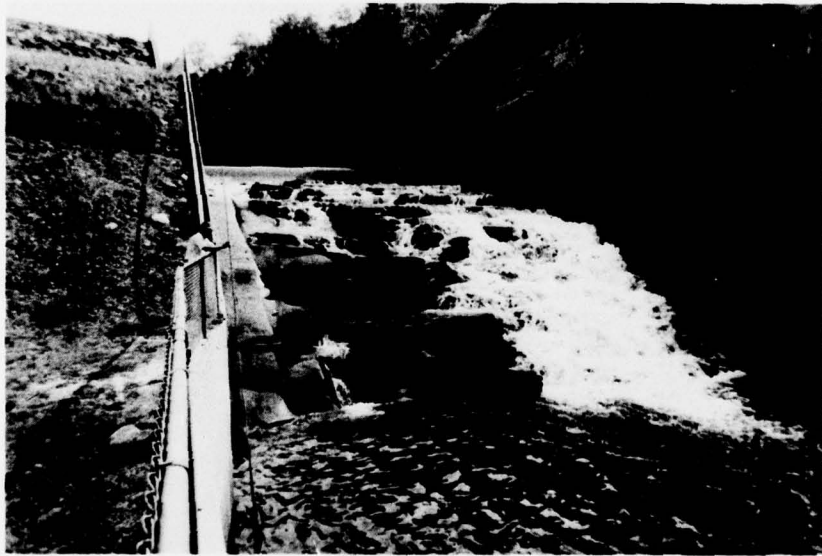
H. Spillway Outlet Channel and Stilling Basin.

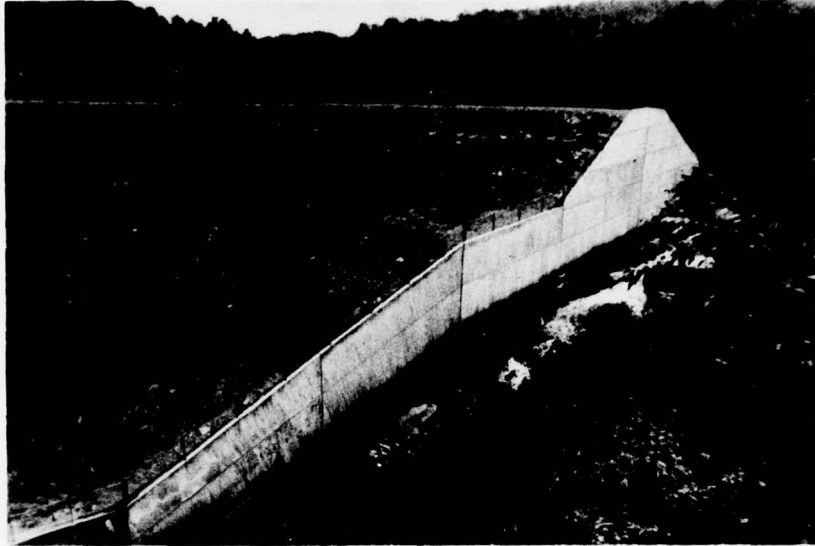
J. Embankment and Spillway Outlet Channel.
View from Left Hillside.

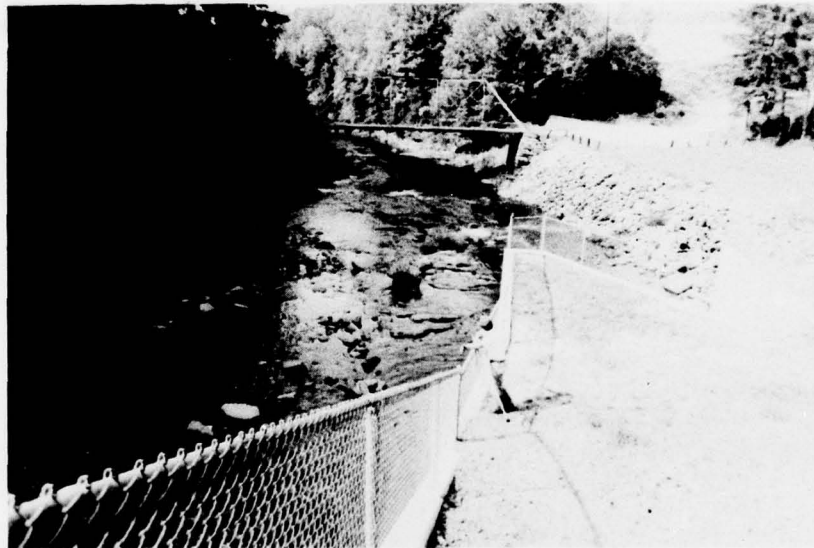
K. Downstream Channel.

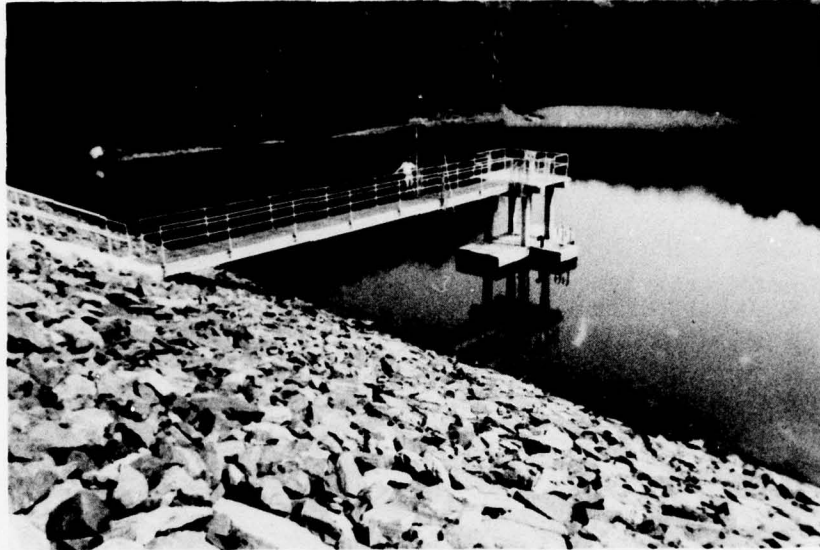
(2) Intake Structure. The drop inlet intake structure had no apparent deficiencies (Photograph L). Concrete was in good condition, all metalwork was painted, and the slide gate and gate valve stems were lubricated. The slide gate and gate valve opened easily during the inspection.

L. Intake Structure.

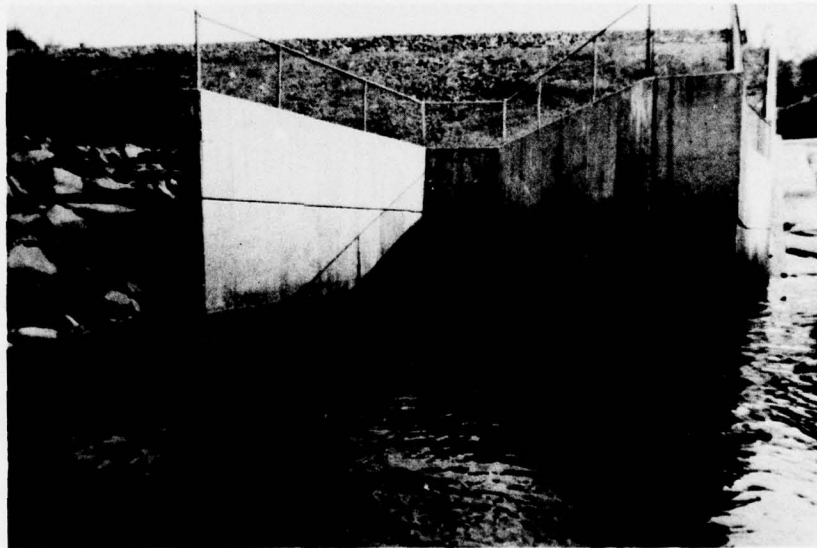
(4) Outlet Works Stilling Basin. The outlet works stilling basin had no apparent deficiencies (Photograph M).

M. Outlet Structure.
