Bear Creek Dam (PA-00607),
Schuylkill River Basin, Bear Creek,
Carbon County, Pennsylvania.
Phase I Inspection Report.

BEAR CREEK DAM
CARBON COUNTY, PENNSYLVANIA
NATIONAL I.D. NO. PA 00607

PHASE I INSPECTION REPORT NATIONAL DAM INSPECTION PROGRAM

AUGUST 1978

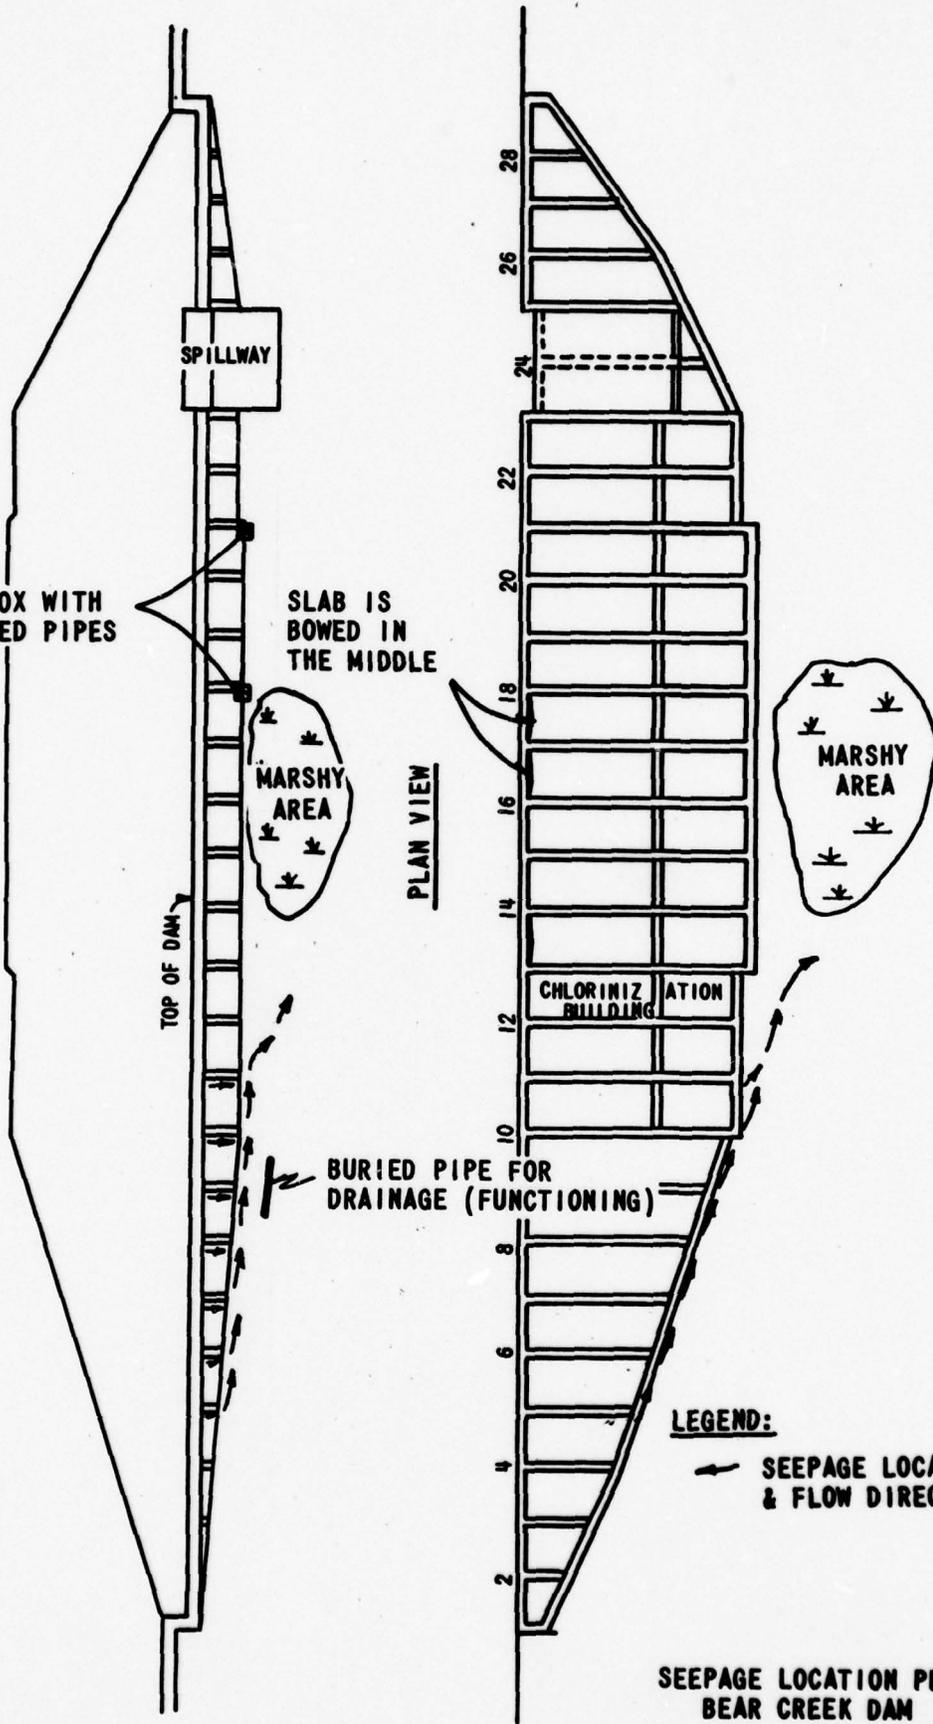
SHEET 5a OF 11

Seepage was emanating through the foundation along many buttress walls as shown on Sheet 5a, Appendix B. A spring, noted during a 1962 inspection, approximately 20 feet downstream of Buttress 18, was noted as a marshy zone during the 1978 inspection.

As previously described in Section 3, seepage was noted along most of the downstream section. As shown on Sheet 5a of Appendix B, the seepage covers a fairly significant area and is emanating through many portions of the structure. Specifically, these seepage zones are located at the base and along the buttress walls through the upstream slab, through joints and cracks, and possibly under the foundation. This latter could not be assessed during this inspection in that it would require several days to trace each of the seepage channels. It was reported that an evaluation had been made stating that seepage comes from the hills. However, Mr. Joseph Ellam, Department of Environmental Resources (DER) Hydraulic Engineer, has reported that seepage rates decrease when the reservoir level is lowered, indicative of seepage through the dam or foundation. Since weir measurements taken in March 1929 and May 1929 are expressed in inches, and the record does not contain a rating curve, there is no means of comparing seepage rates with measurements taken in 1951. In 1951 seepage was on the order of 367,000 gallons per day.

3. Underseepage and seepage through cracks should be evaluated and monitored, and the effect of underseepage on the long term stability of the dam determined.

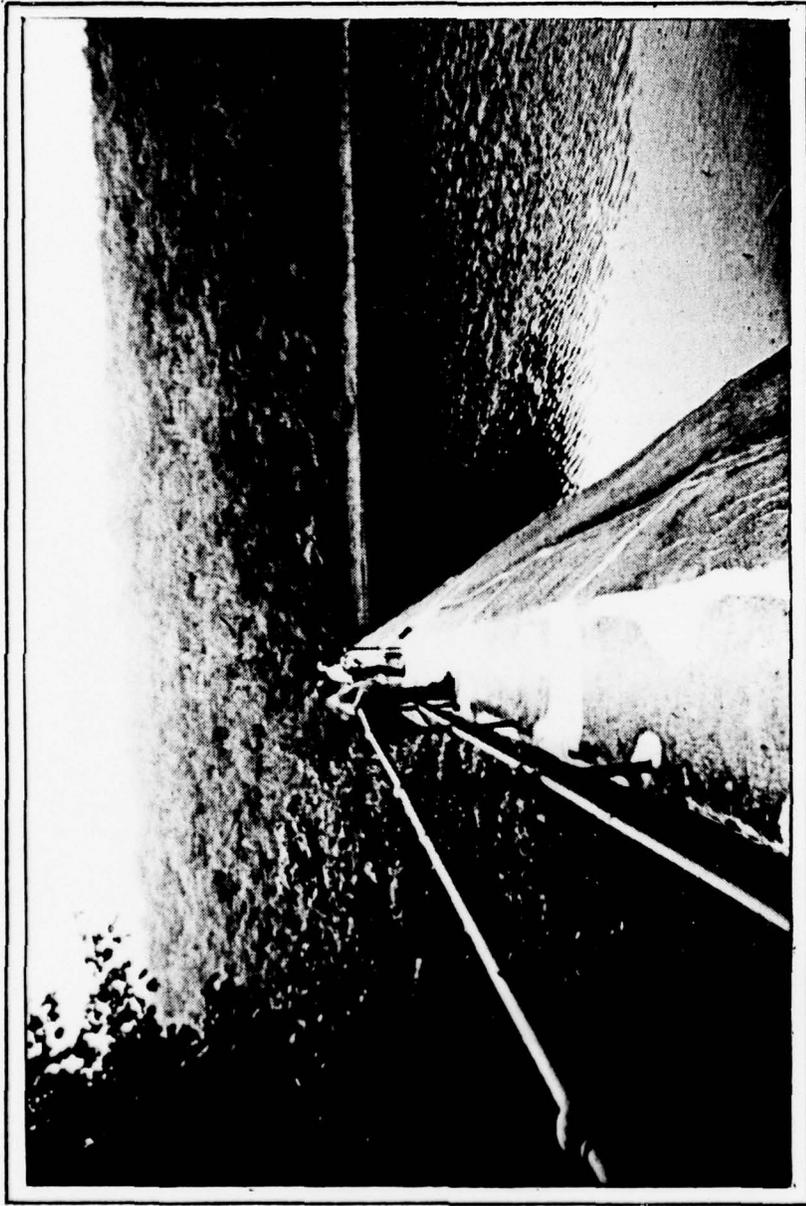
PHOTOGRAPH NO. 1

VIEW LOOKING FROM LEFT ABUTMENT ALONG
CREST.

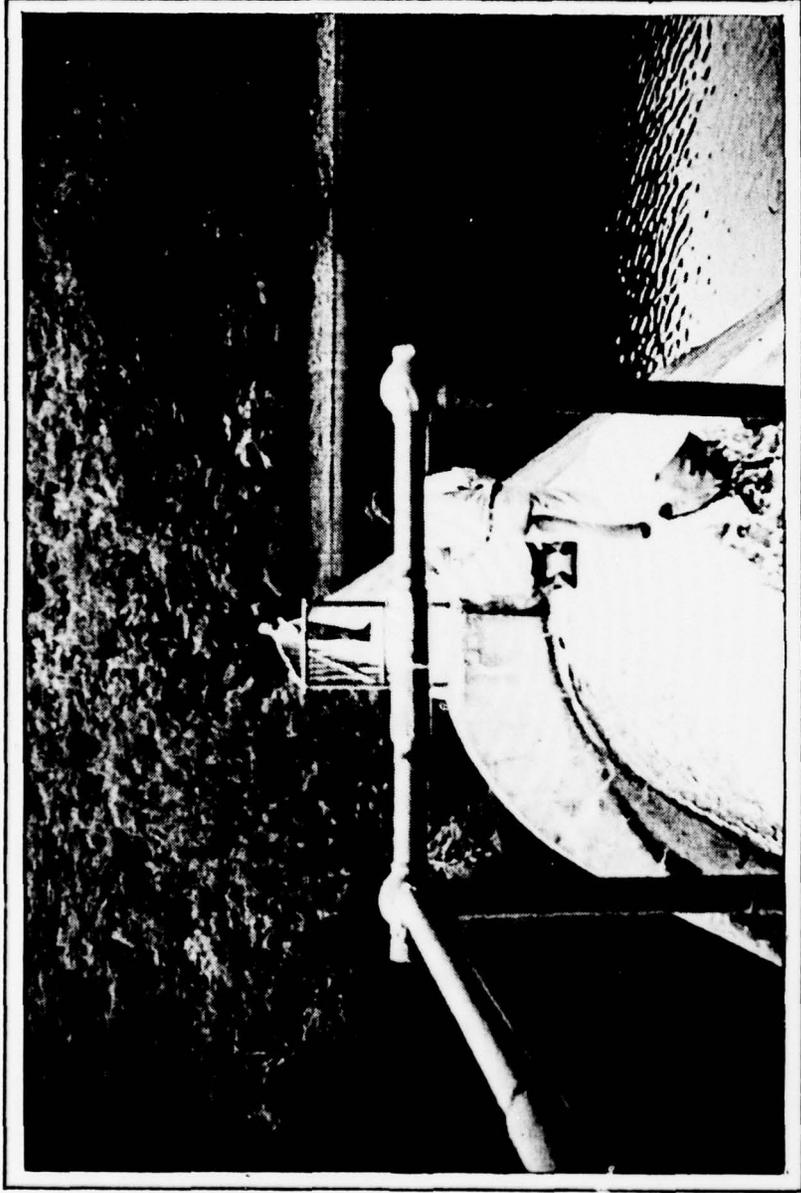
PHOTOGRAPH NO. 2

2. Spillway. The spillway was inspected and observed to be in good condition. There was some minor spalling and concrete deterioration and areas that had been patched. The stilling basin was observed to be dry, in fair condition, with some concrete deterioration. The spillway channel to the first pond downstream was in fair condition with some deterioration noted.

VIEW OF SPILLWAY. NOTE SPALLING AND
PATCH WORK ON SURFACE.

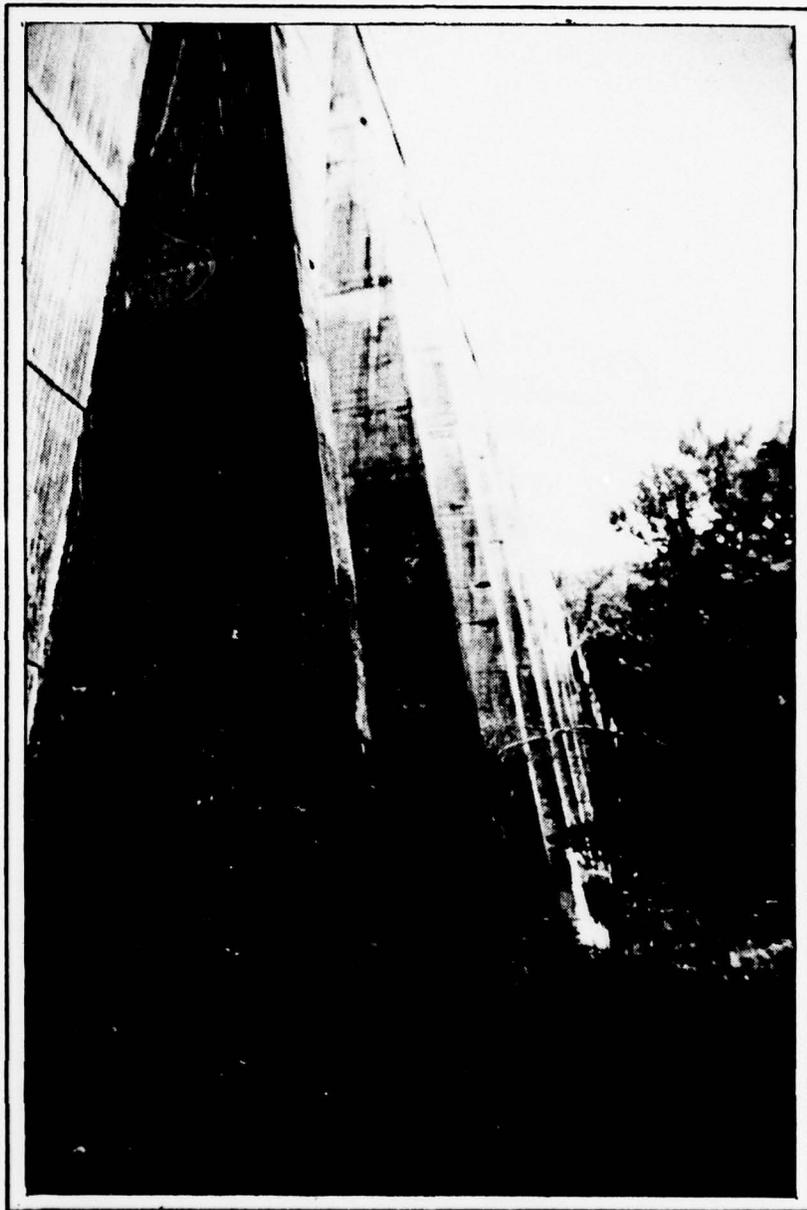
VIEW OF DOWNSTREAM BUTTRESS
LOOKING TOWARD RIGHT ABUT-
MENT.

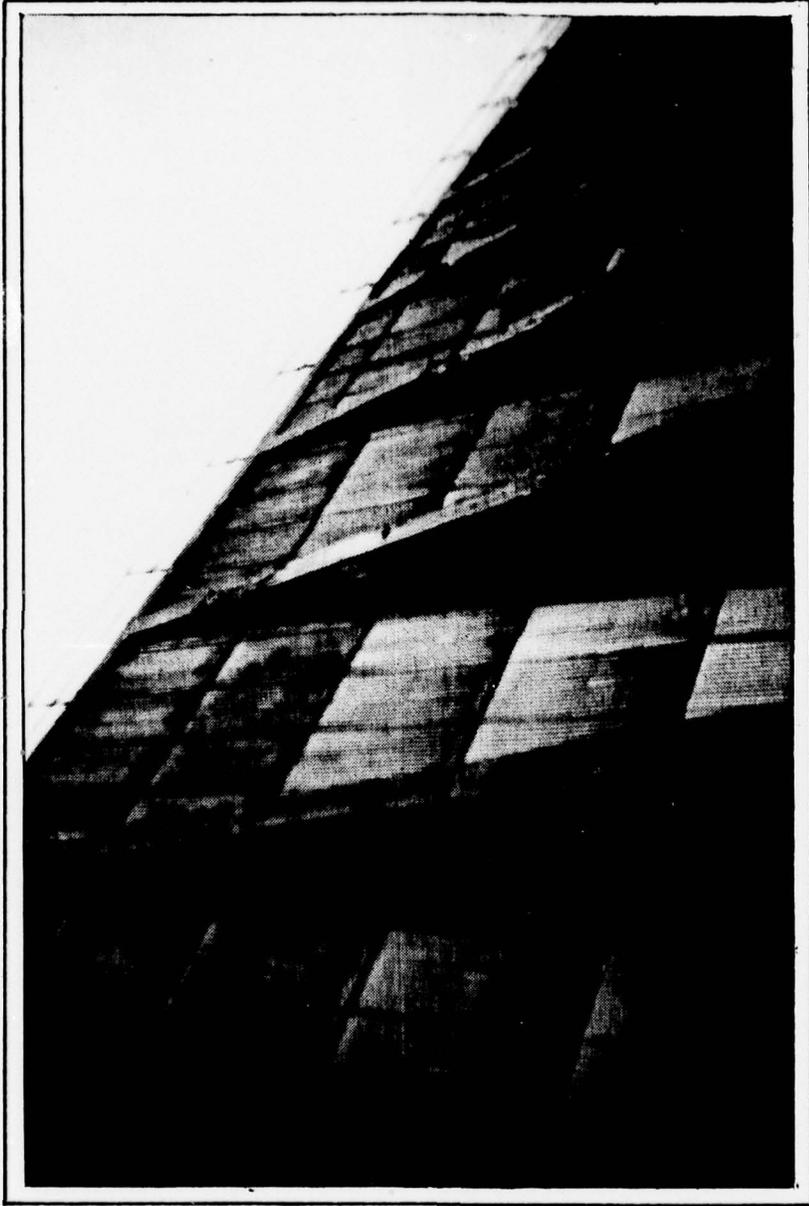
PHOTOGRAPH NO. 4

During the next several years, cyclic freezing and thawing caused severe spalling beneath the concrete slab on the dam. As a result, an application to install an asbestos facing on the downstream side of the dam was submitted 23 July 1927, and the permit issued 17 August 1927. The asbestos siding produced by the John Mansfield Company called "Transite" asbestos, was installed. The purpose of the facing was to seal off the downstream side to minimize the effect of temperature changes on the upstream face of the dam.

DOWNSTREAM BUTTRESSES WITH ASBESTOS
FACIAL PLATES.

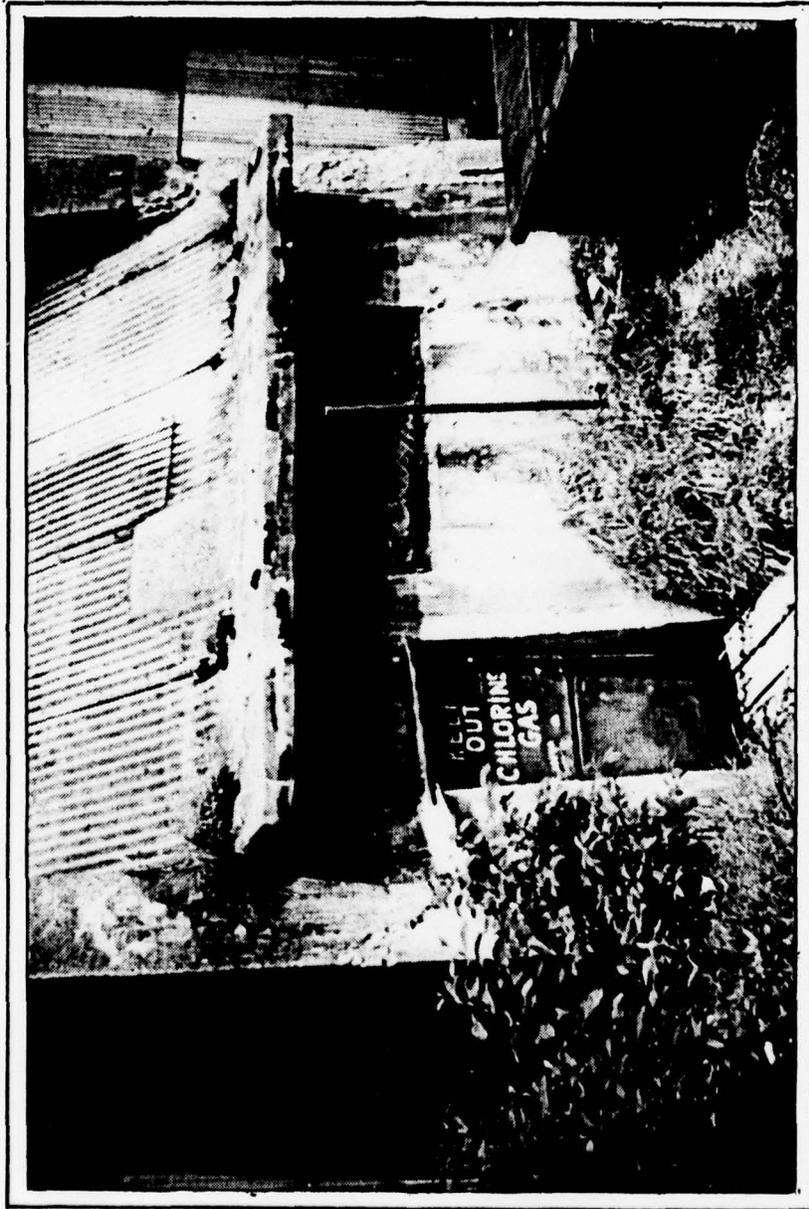
PHOTOGRAPH NO. 5

WATER TREATMENT (CHLORINE) BUILDING.
NOTE BUTTRESS DETERIORATION.

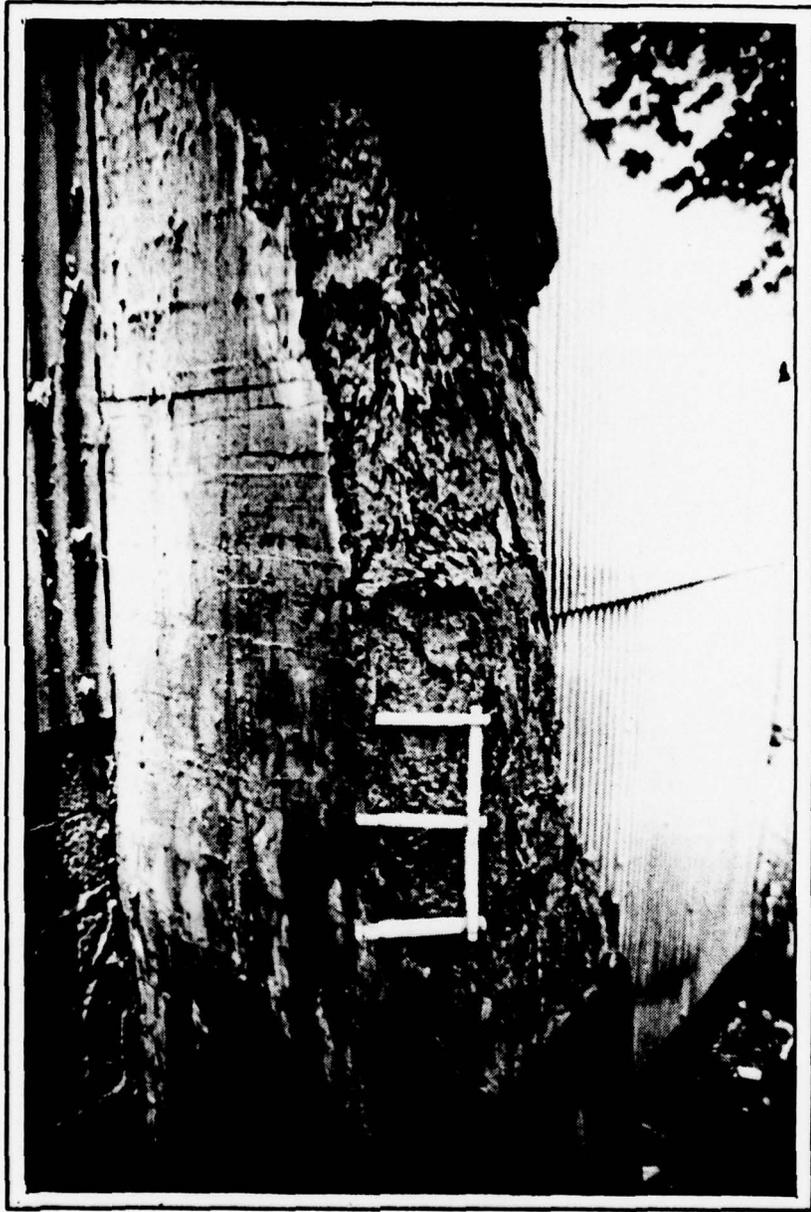
PHOTOGRAPH NO. 8

In summary, the visual survey of the dam disclosed that the concrete is in poor condition with significant spalling and deterioration. Typical photographs of this deterioration are shown in Appendix D as Photographs 8 through 12. Seepage was noted at several locations along the structure, along buttress walls and, occasionally beneath the foundation.

Visual inspection of the buttress walls disclosed that the concrete was spalled and, in some cases, the reinforcing steel was exposed and deteriorated. A close inspection of the concrete showed that much of the coarse aggregate consisted of crushed coal and not high quality stone. Therefore, it is concluded that additional structural evaluations are required. Considering the condition of the structure and the materials used for the construction, there is a good possibility that overtopping could induce structural collapse of the dam. This possibility can only be determined after a detailed structural evaluation is completed.

SPALLED CONCRETE OF BUTTRESS
NUMBER 3. SEE PLATE 2 APPEN-
DIX E FOR BUTTRESS LOCATION.

2. A registered professional engineer should be retained to evaluate the structural integrity of the dam.
3. Underseepage and seepage through cracks should be evaluated and monitored, and the effect of the underseepage on the long term stability of the dam determined.

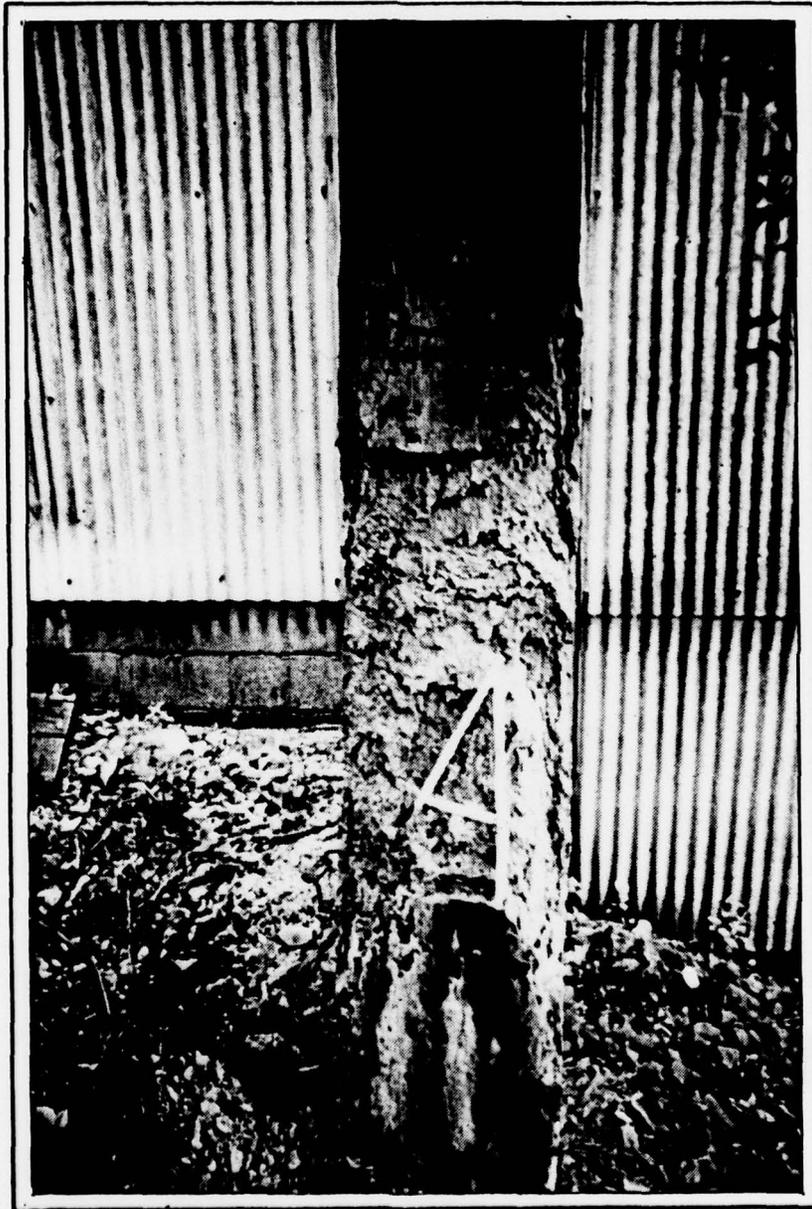
SPALLED CONCRETE OF BUTTRESS
NUMBER 4. SEE PLATE 2 APPEN-
DIX E FOR BUTTRESS LOCATION.

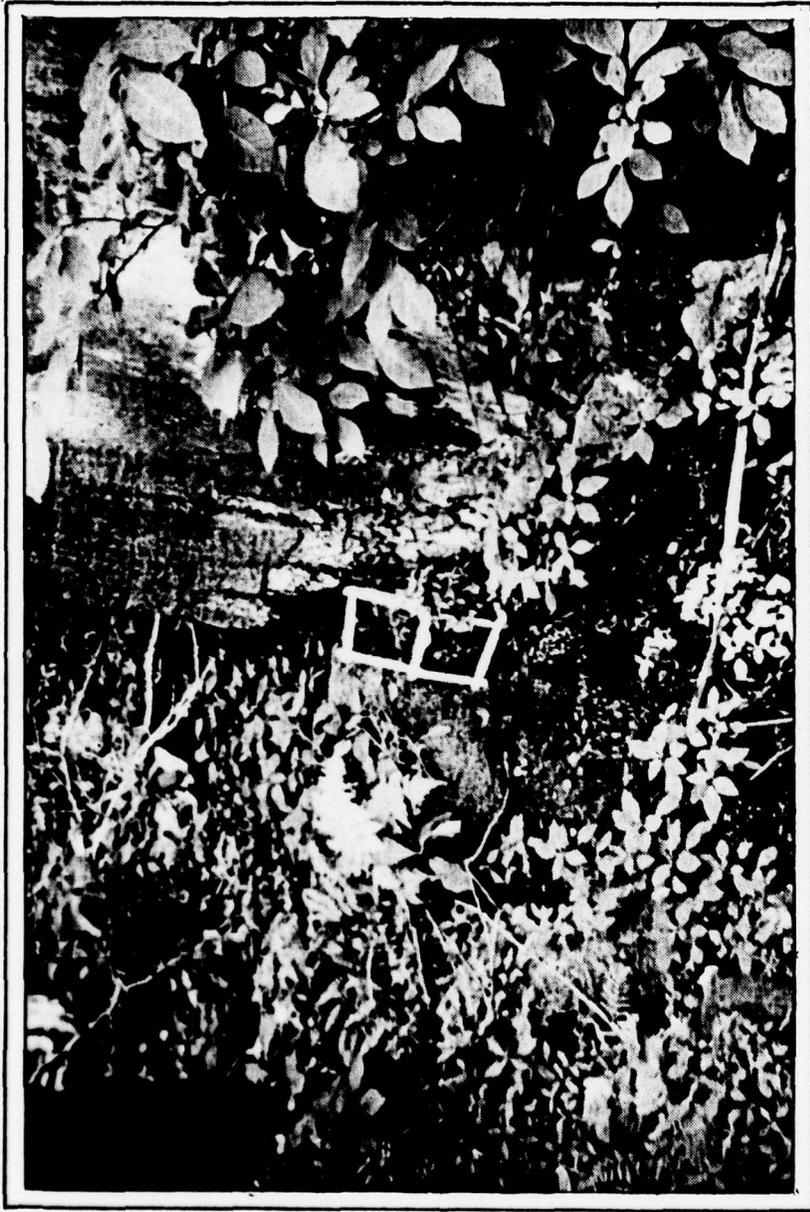
PHOTOGRAPH NO. 10

SEEPAGE BENEATH BUTTRESS NUMBER 8.
FLOW WAS CLEAR.

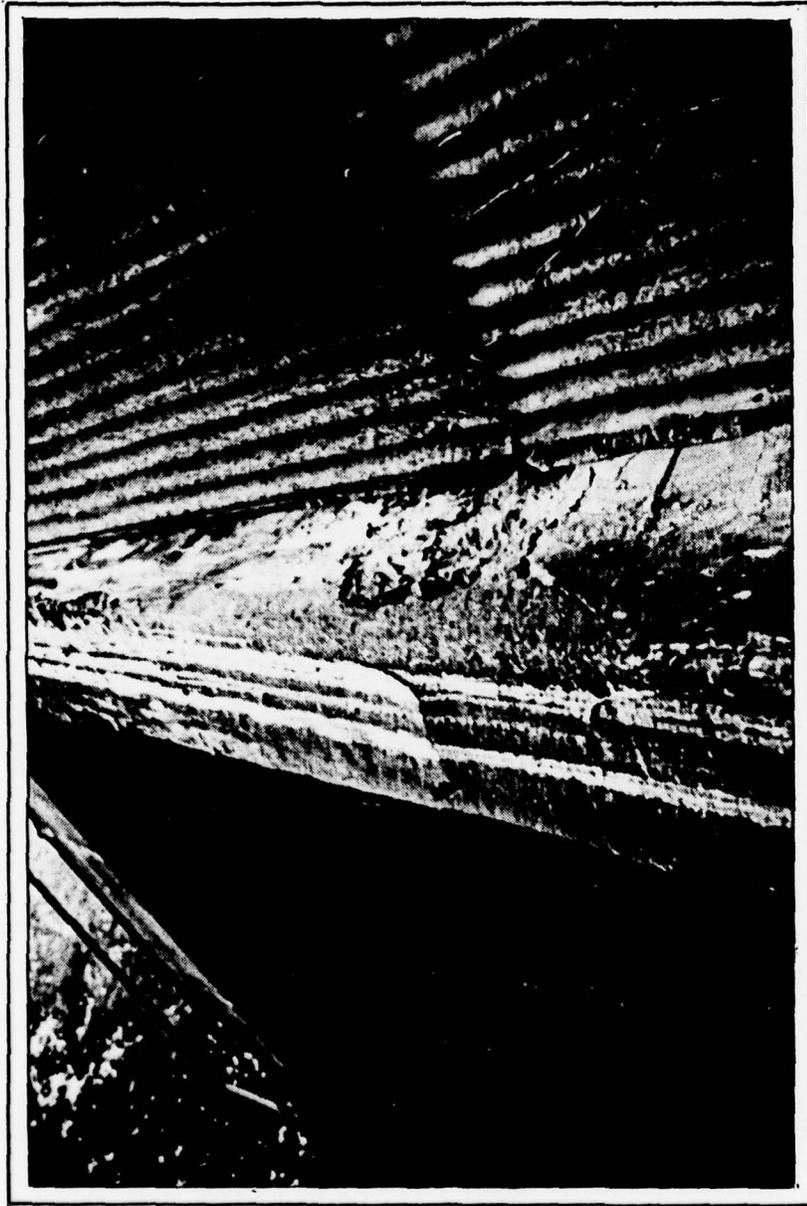
PHOTOGRAPH NO. 11

SPALLED CONCRETE OF BUTTRESS NUMBER 4.

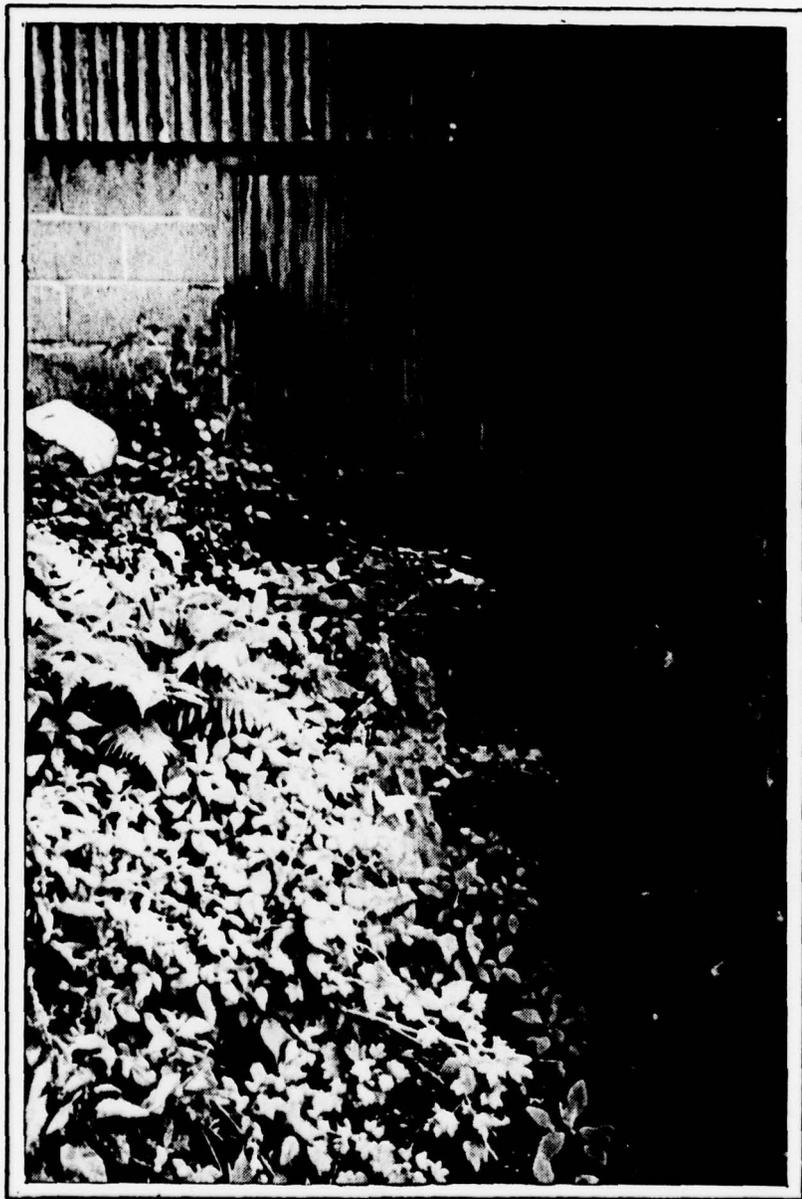
PHOTOGRAPH NO. 15

TYPICAL SEEPAGE ADJACENT
TO BUTTRESSES. ALL SEEP-
AGE WAS CLEAR.

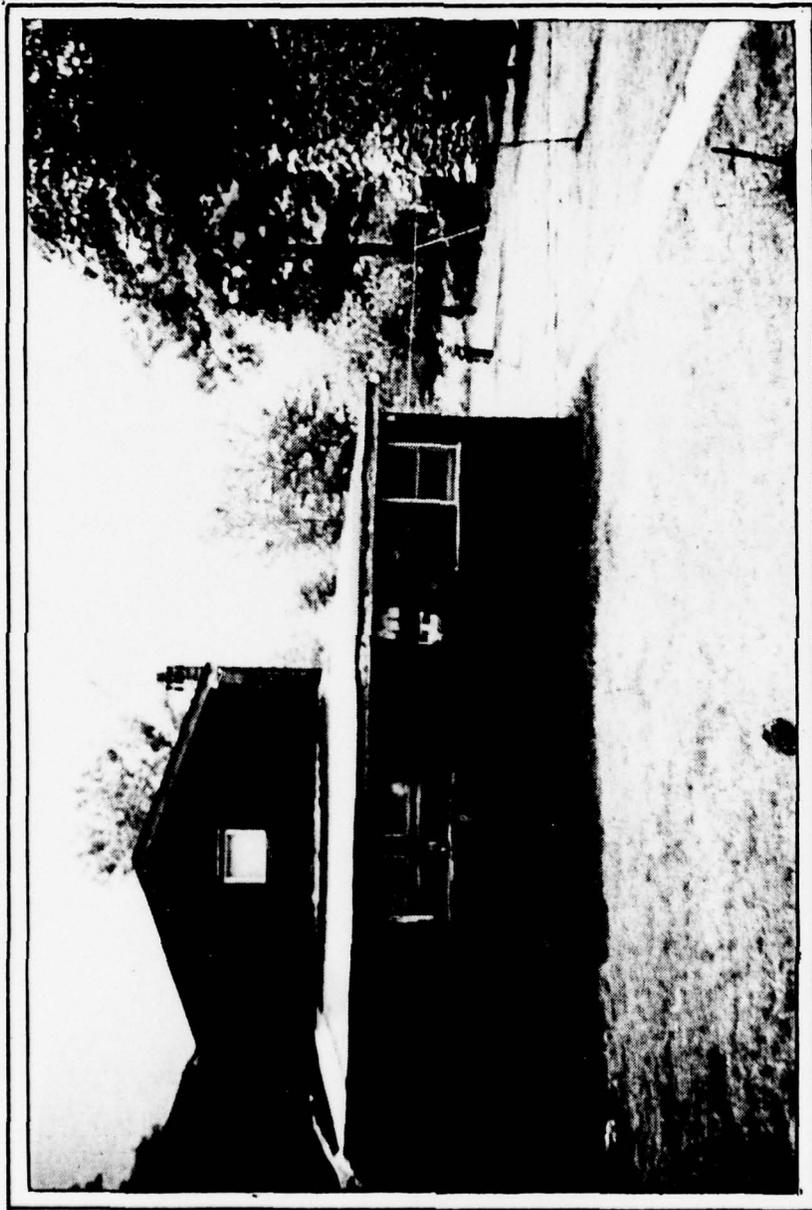
PHOTOGRAPH NO. 18

f. Downstream Conditions. Near the confluence of Bear Creek and Nesquehoning Creek, there is one house and a factory which are subject to damage and possible loss of life in the event of failure of the dam. There are 4 or 5 houses downstream along Nesquehoning Creek which would also be subject to damage in the event of failure.

VIEW OF ONLY HOUSE DOWNSTREAM IN
DIRECT PATH OF FLOOD WAVE IN EVENT
OF FAILURE. DWELLING IS USED AS A
SUMMER HOME.

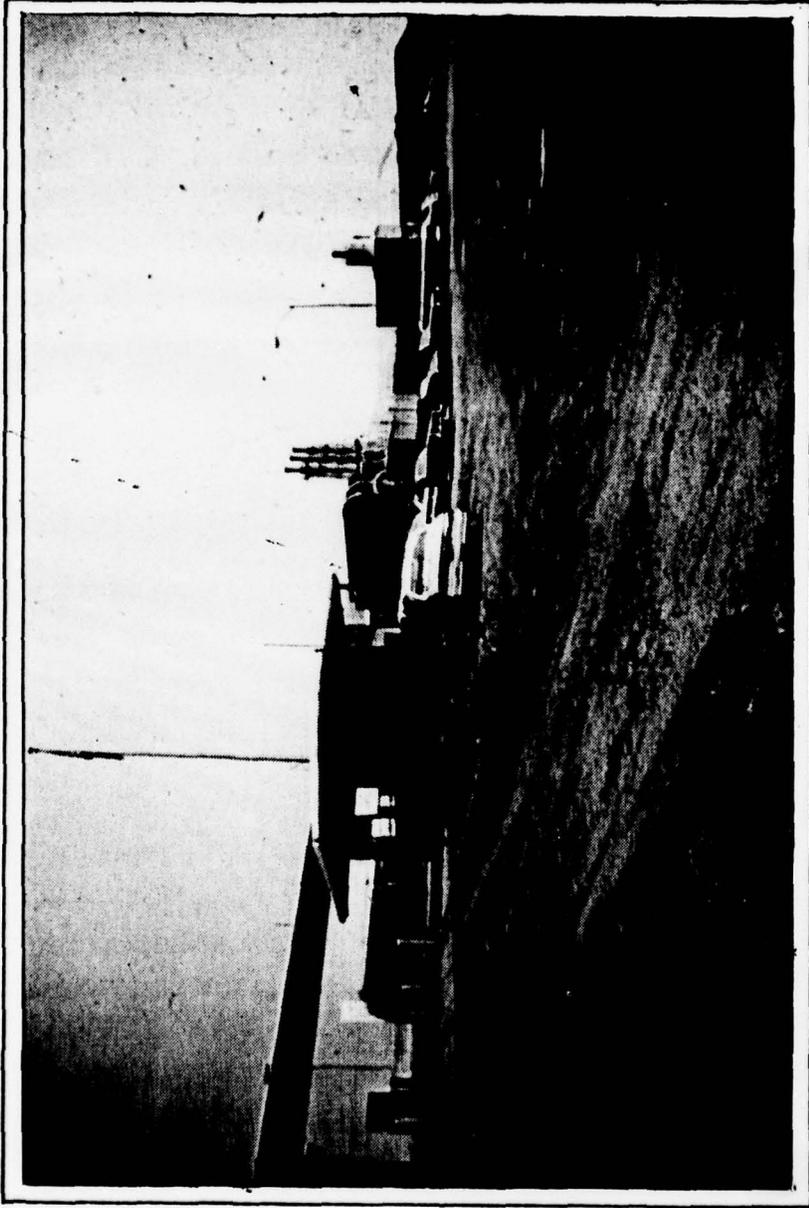
PHOTOGRAPH NO. 19

CASTING FACTORY DOWNSTREAM OF DAM
THAT WOULD BE AFFECTED IN EVENT OF
DAM FAILURE.
