**PENNSYLVANIA
ID NO. PA.00059**

ROCK RUN DAM

PHASE I INSPECTION REPORT NATIONAL DAM INSPECTION PROGRAM

AUGUST 1978

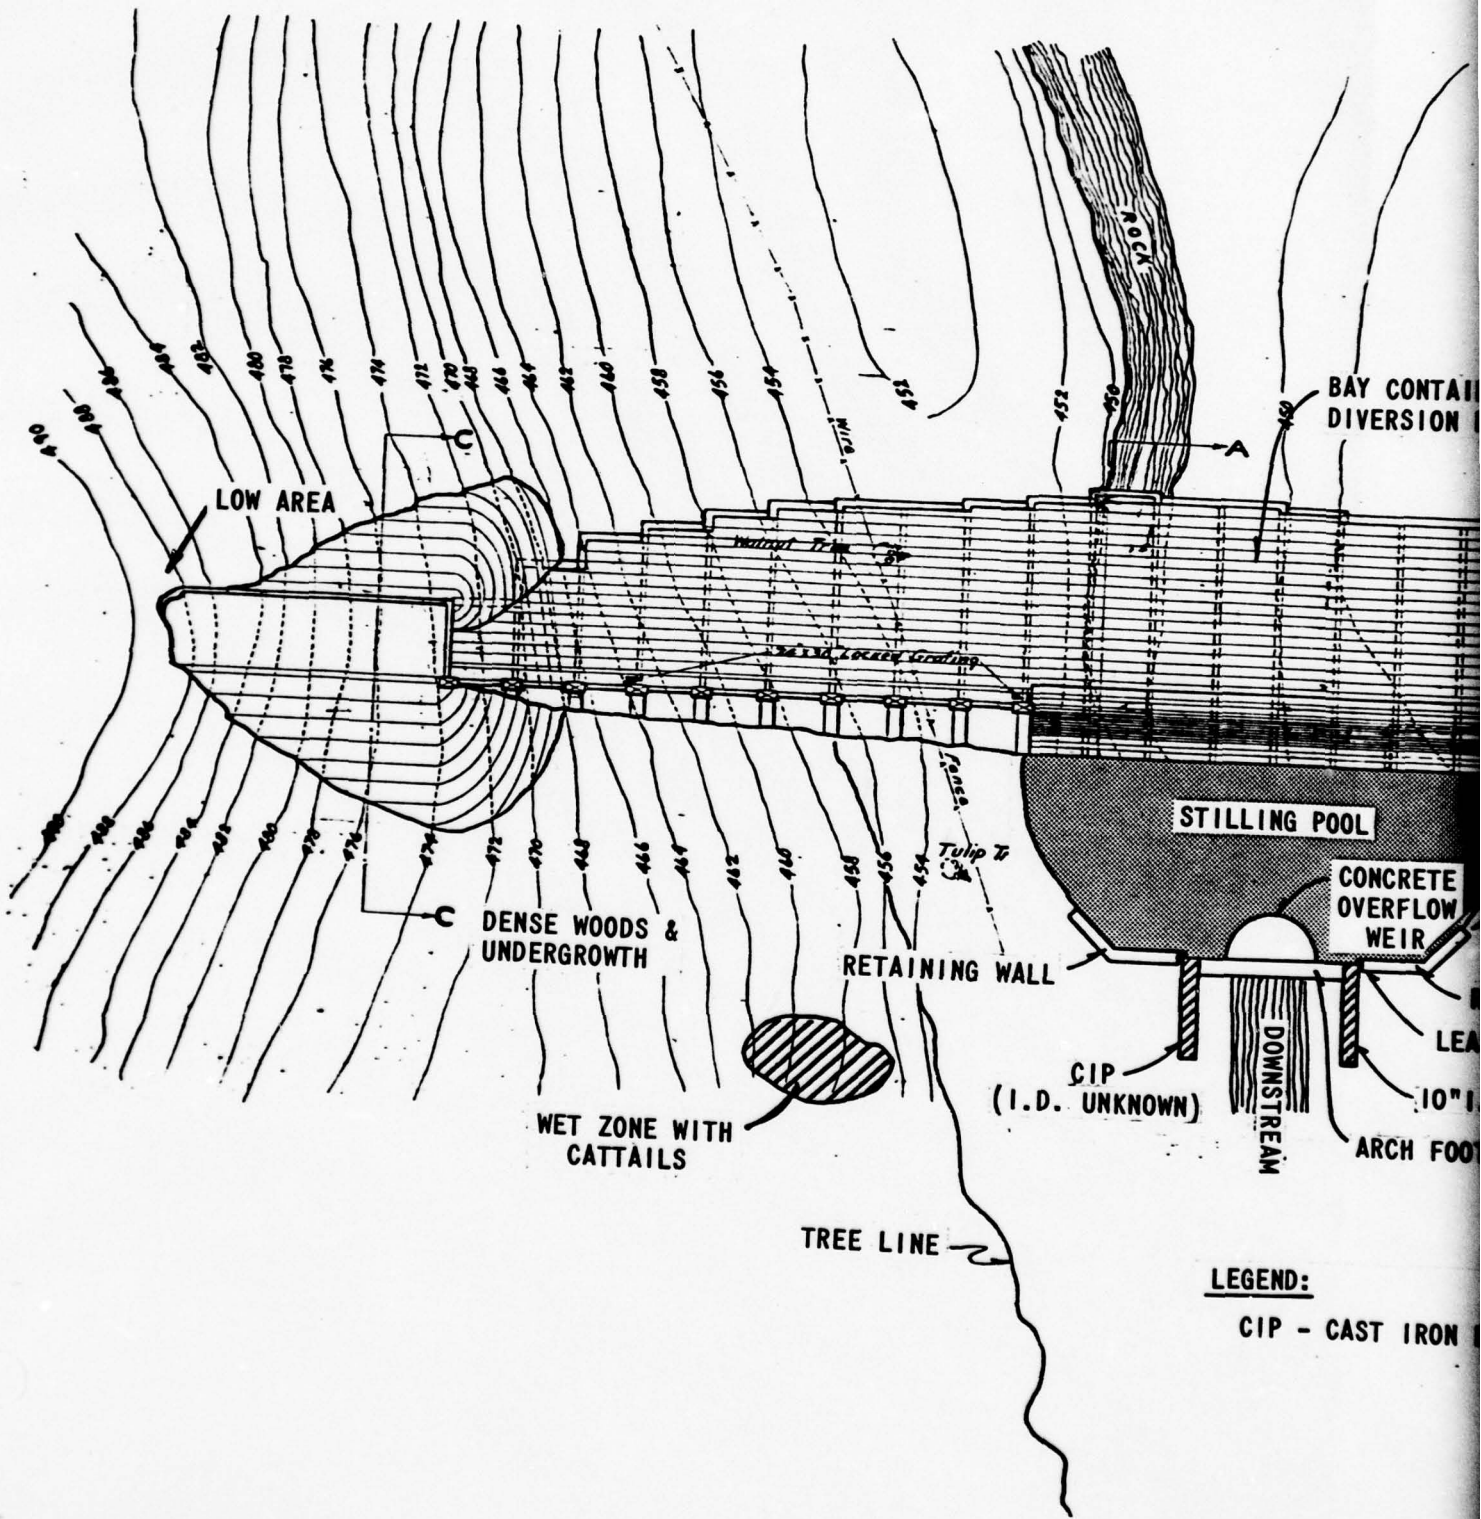
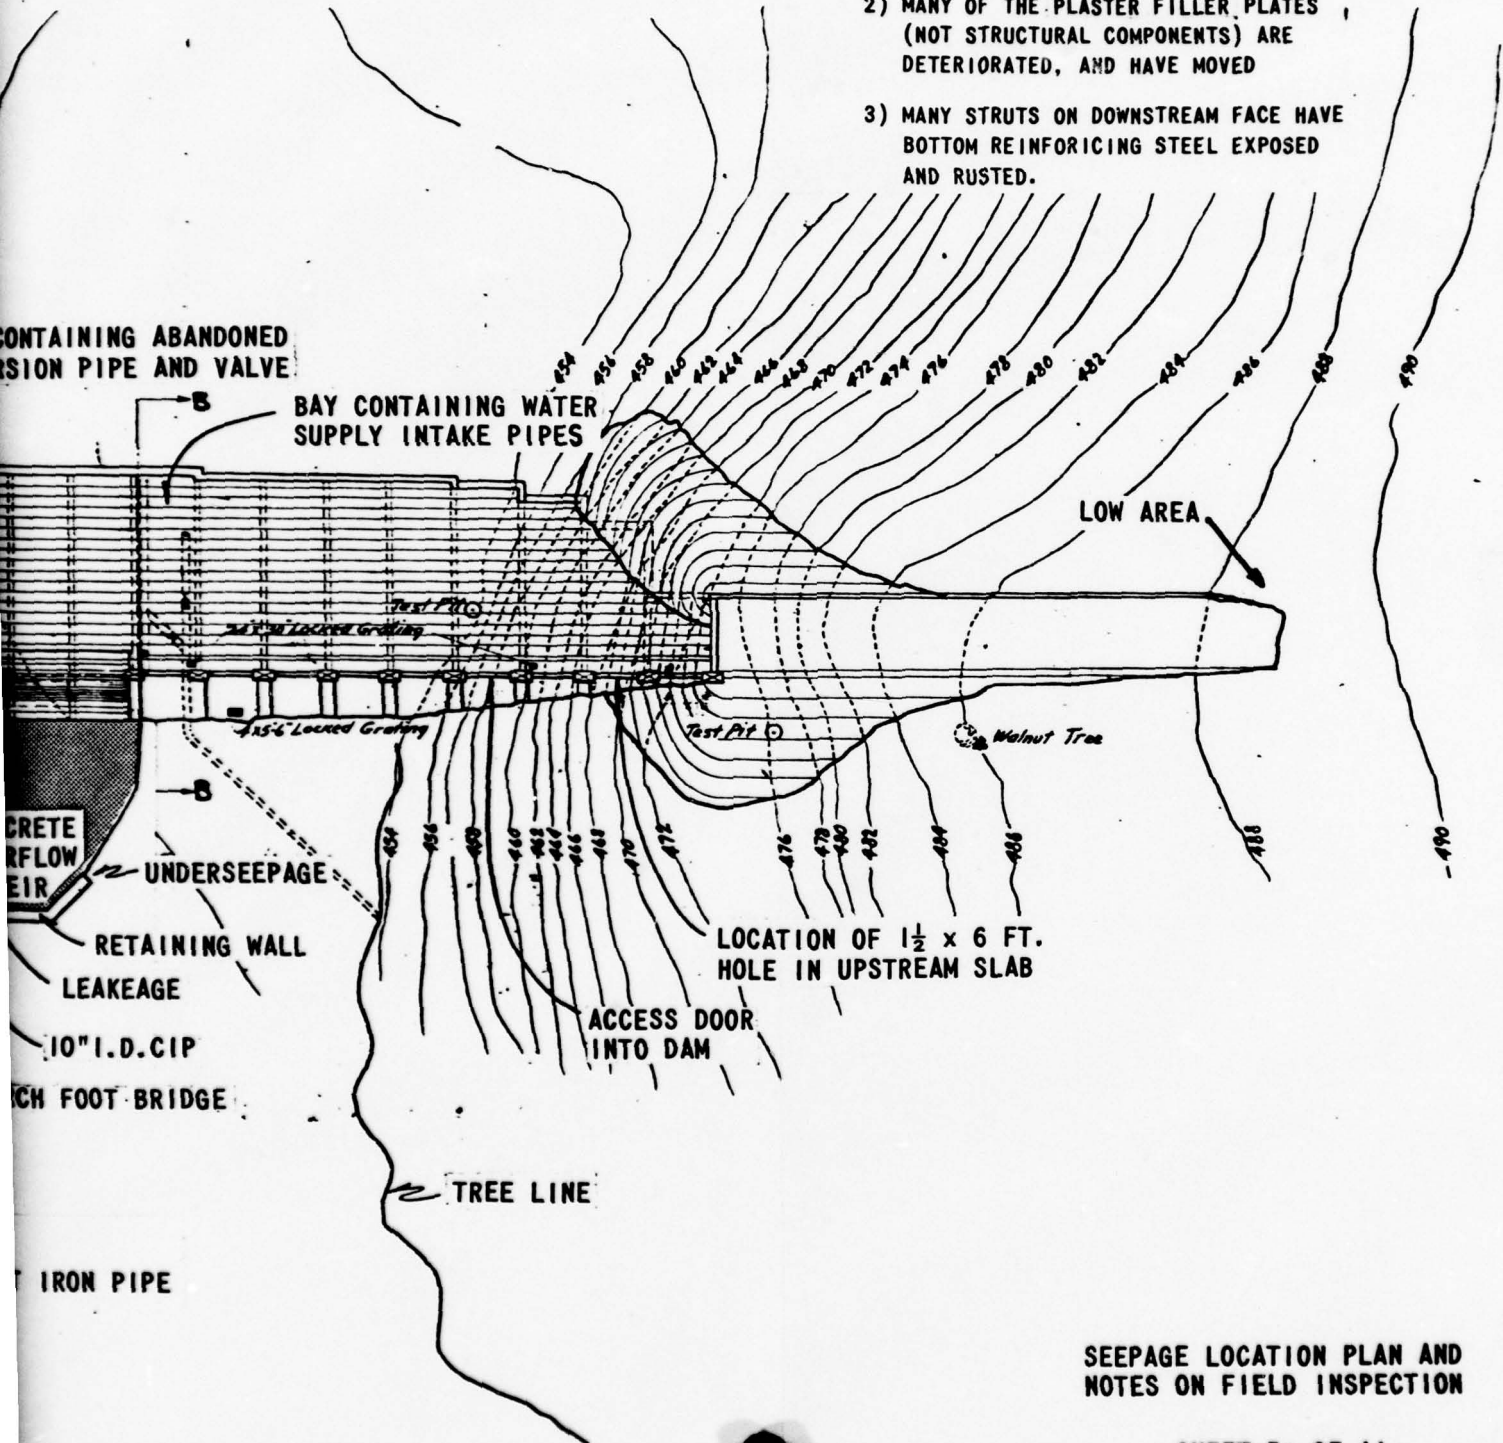
SEEPAGE LOCATION PLAN AND NOTES ON FIELD INSPECTION

NOTES: 1) MANY UPSTREAM CONSTRUCTION JOINTS LEAK. SOME HAVE HAIRLINE CRACKS.

2) MANY OF THE PLASTER FILLER PLATES (NOT STRUCTURAL COMPONENTS) ARE DETERIORATED, AND HAVE MOVED

3) MANY STRUTS ON DOWNSTREAM FACE HAVE BOTTOM REINFORCING STEEL EXPOSED AND RUSTED.

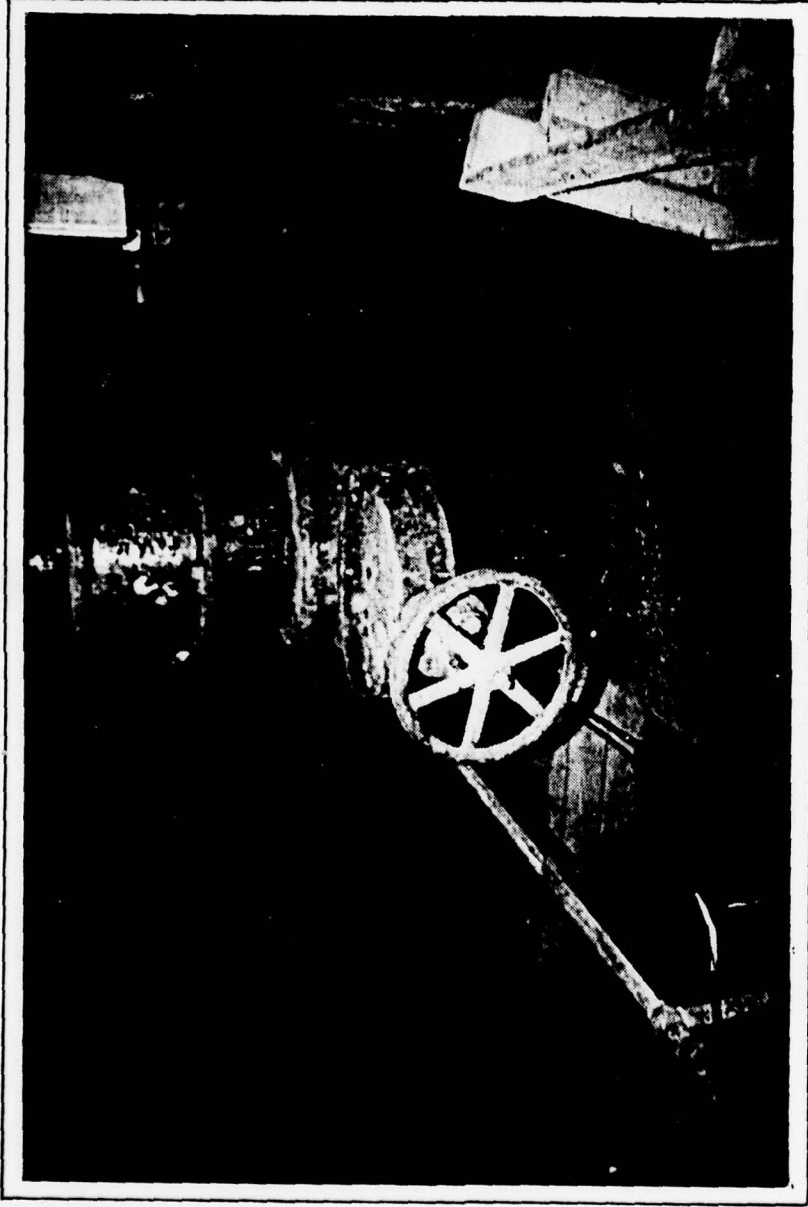
PHOTOGRAPH NO. 1

UPPER INTAKE VALVE WITH FLOW GAGE
ATTACHED TO WALL. THIS IS A NEW
VALVE WHICH IS ALWAYS OPEN.

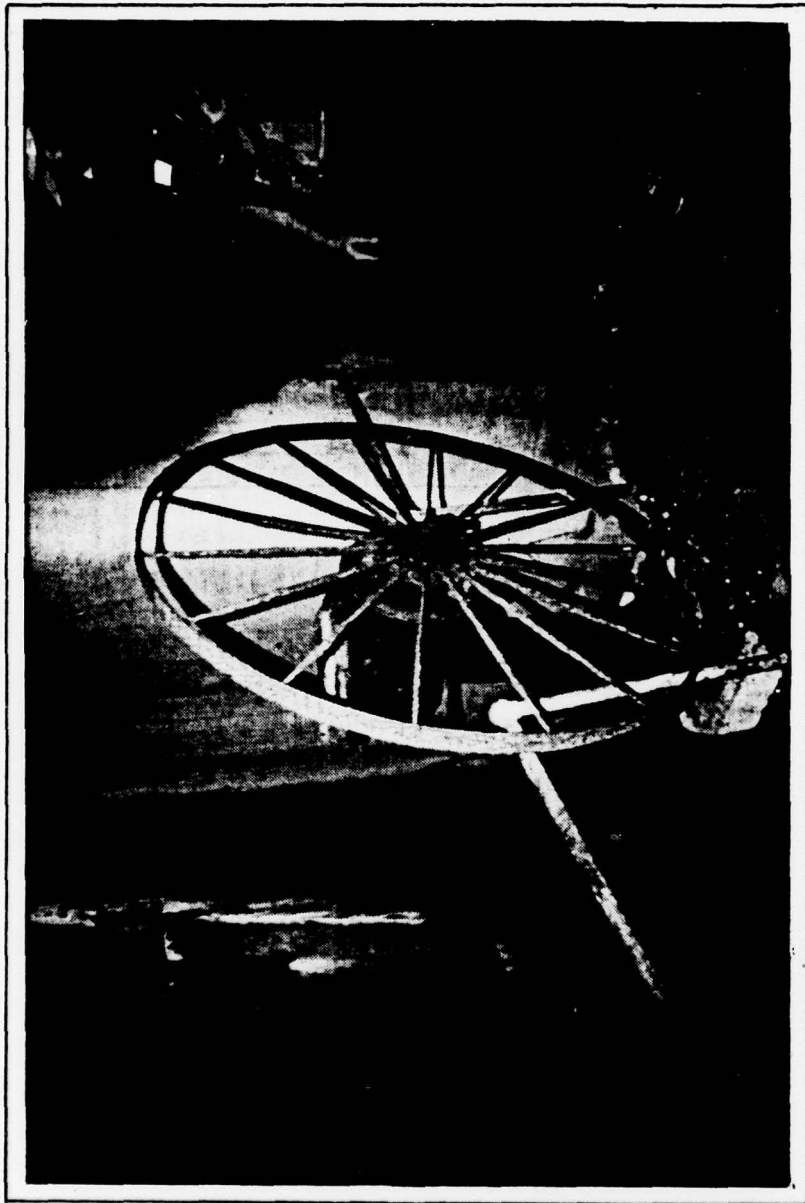
PHOTOGRAPH NO. 2

The lower 24-inch pond drain pipe could not be inspected since it was covered with soil. Exposed portions of the gate valve were observed and it was leaking at the stem. An attempt was made to exercise this valve, but the leakage became excessive and further exercising of the system was terminated.

ABANDONED POND DRAIN VALVE THAT
LEAKS AND IS LOCKED (FROM RUST)
IN THE CLOSED POSITION. INTAKE
PIPE IS REPORTEDLY FILLED WITH
SEDIMENT.

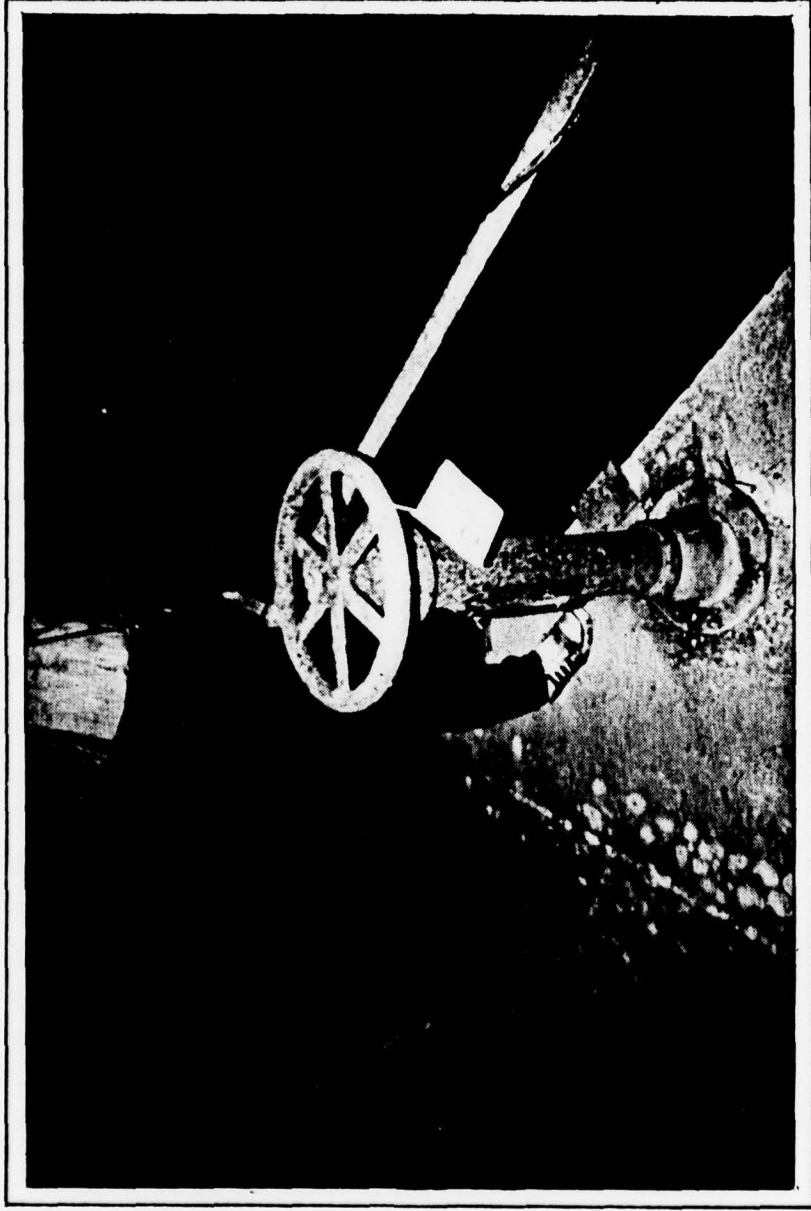
1. Intake Pipes. The intake pipes are assessed to be in good condition, but the valves in the pipes are assessed to be in poor condition. It is noted that only the upper intake pipe is functioning, and it is reported by the plant operator that that valve is essentially locked in the open position. It is reported by the Owner's representative that the middle intake pipe, although observed to be in good condition, is silted-in and the valve is rusted shut.

ABANDONED VALVE FOR MIDDLE INTAKE PIPE.

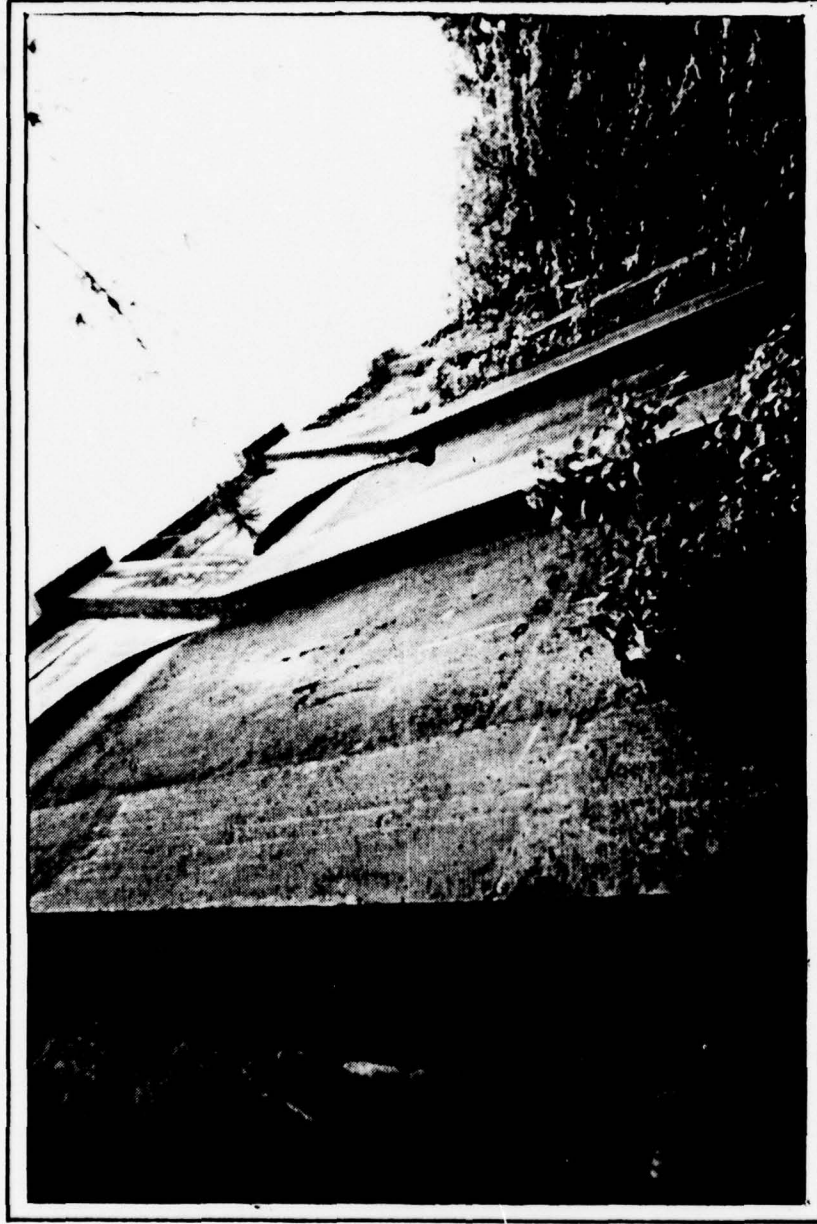
PHOTOGRAPH NO. 6

The plaster filler walls on the downstream face between buttresses were often cracked, buckled, and generally in poor condition. It is noted, however, that these are not structural components, but only facial components. Although the reason for installation of the plaster filler walls was not found in these files, analysis of other similar dams indicates that the downstream facing was installed for two purposes. The first and primary purpose was to minimize temperature changes on the underside of the upstream slab, thus minimizing spalling and deterioration of the slab. As a secondary purpose, the downstream facial wall was placed for aesthetic reasons.

VIEW OF DOWNSTREAM BUTTRESSES AND
FACIAL WALLS BETWEEN BUTTRESSES.
FACIAL WALLS ARE NON-LOAD BEARING
WALLS.

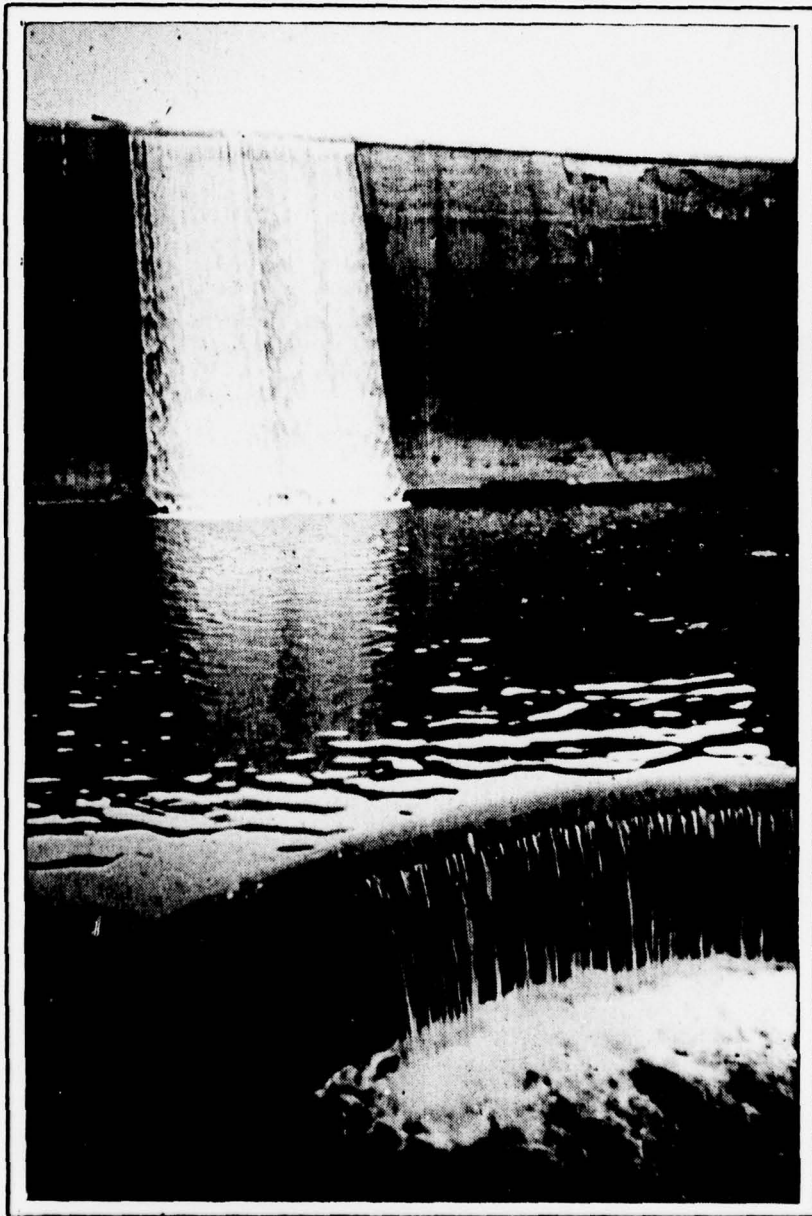
PHOTOGRAPH NO. 7

DOWNSTREAM STILLING BASIN
AND OVERFLOW WEIR.

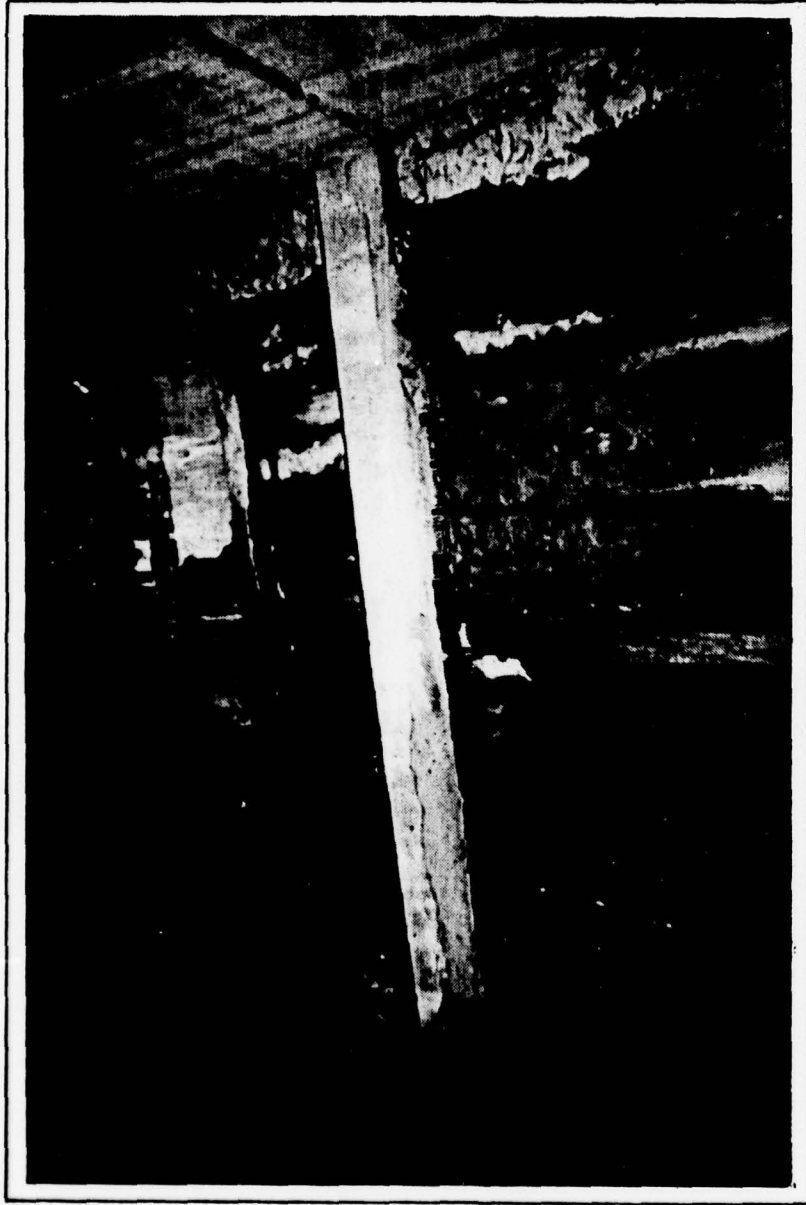
PHOTOGRAPH NO. 8

VIEW FROM INSIDE OF DAM LOOKING
DOWNSTREAM TOWARDS FACIAL WALLS
AND BUTTRESS TIE BEAM. NOTE WALL
DETERIORATION AND MOVEMENT. MANY
OF THE TIE BEAMS ARE ALSO DETERIOR-
ATED.

1. A registered professional engineer should evaluate the downstream struts between buttresses. As necessary, these struts should be rehabilitated or recoated with suitable materials to prevent further deterioration of the reinforcing steel.
2. Rehabilitation should also include the downstream plaster filler walls and repair of the spalled concrete along the spillway and the parapet wall.

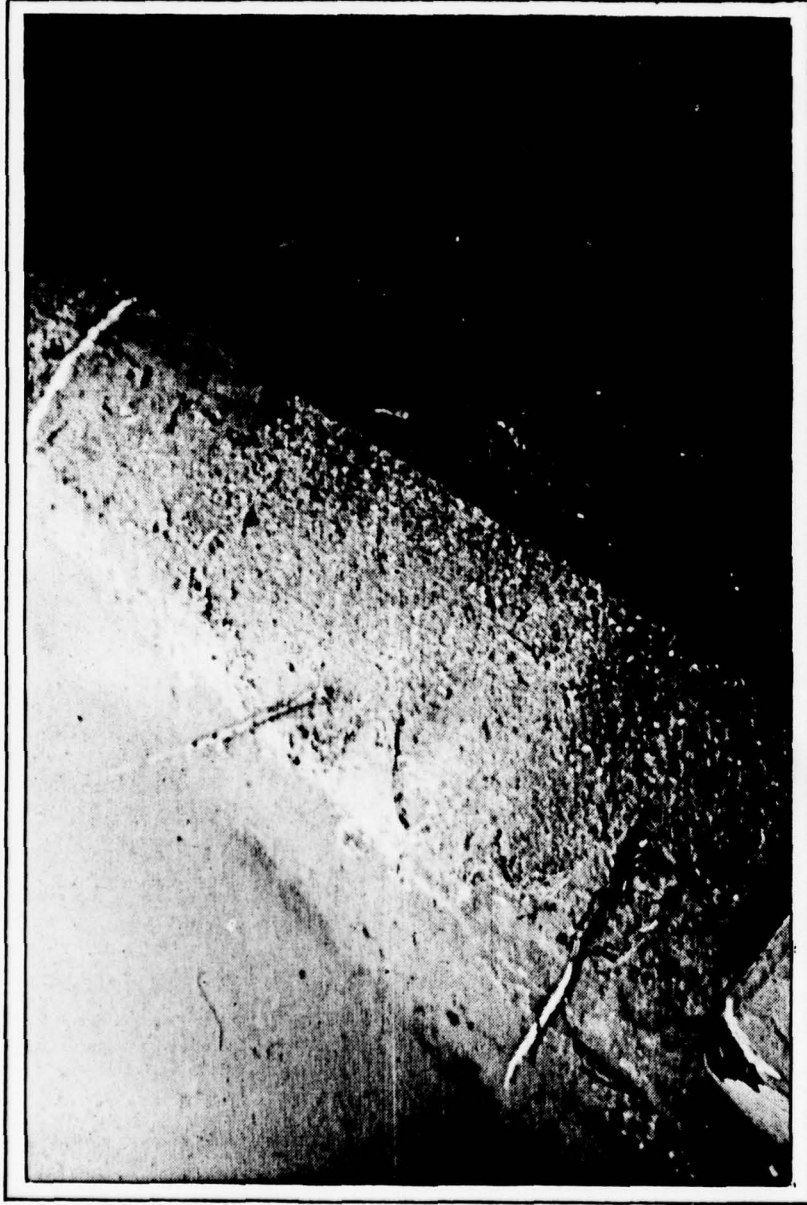
2. Spillway. The spillway was inspected and observed that the crest was in good condition. However, the spillway chute below the cap was observed to be spalled and some displacement was noted between the downstream chute and the weir cap. The stilling basin immediately below the spillway is rock lined and relatively stable. Water flows over a notched 25-foot diameter semi-circular weir, and then discharges into the downstream channel.

CLOSEUP VIEW OF SPILLWAY CREST.
NOTE SEPARATION (1 TO 2 INCHES)
BETWEEN CAP AND CHUTE.

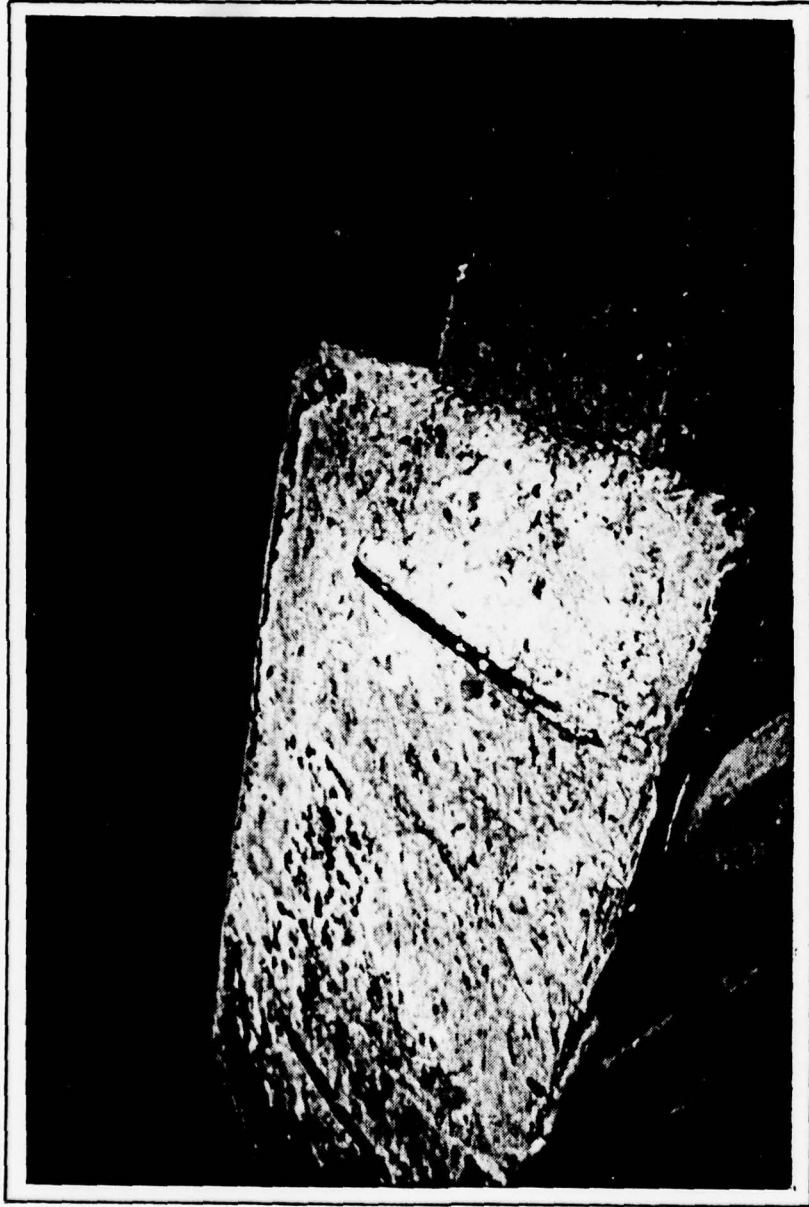
PHOTOGRAPH NO. 10

TOP OF A TYPICAL BUTTRESS. NOTE SPALLING, DETERIORATION AND EXPOSED REINFORCING BARS.

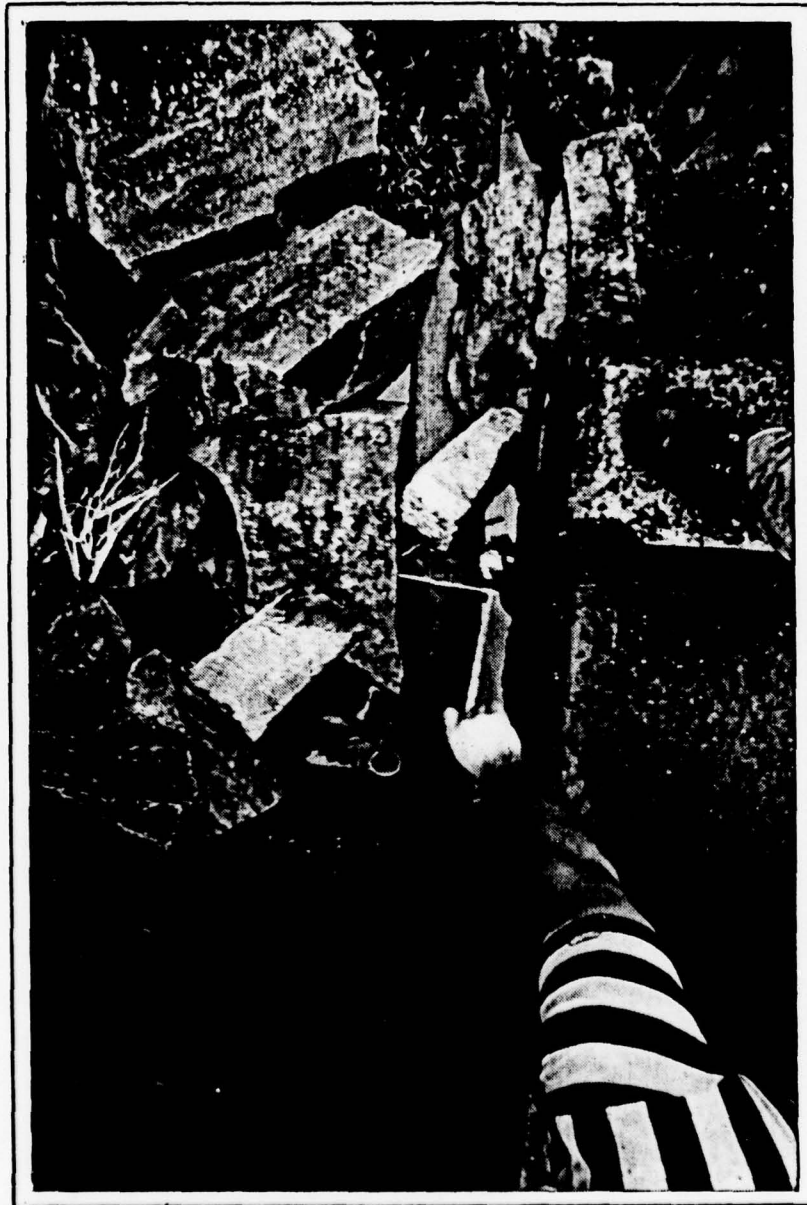
PHOTOGRAPH NO. 11

Seepage was emanating through the foundation, but this seepage was clear and assessed to be relatively small in quantity. Due to the location of the seepage, and the insignificant quantity, an assessment of the rate of flow was not determined.

SEEPAGE WAS NOTED THROUGH
JOINTS OF STILLING BASIN.
NOTE ABANDONED STILLING
BASIN DRAIN PIPE.
