LOCUST CREEK DAM
SCHUYLKILL COUNTY, PENNSYLVANIA
NATIONAL I.D. NO. PA 00699

⑥ PHASE I INSPECTION REPORT
NATIONAL DAM INSPECTION PROGRAM

PHASE I INSPECTION REPORT
NATIONAL DAM INSPECTION PROGRAM
LOCUST CREEK DAM
(TUSCARORA STATE PARK DAM)
NATIONAL ID NO. PA 00699
DER NO. 54-170

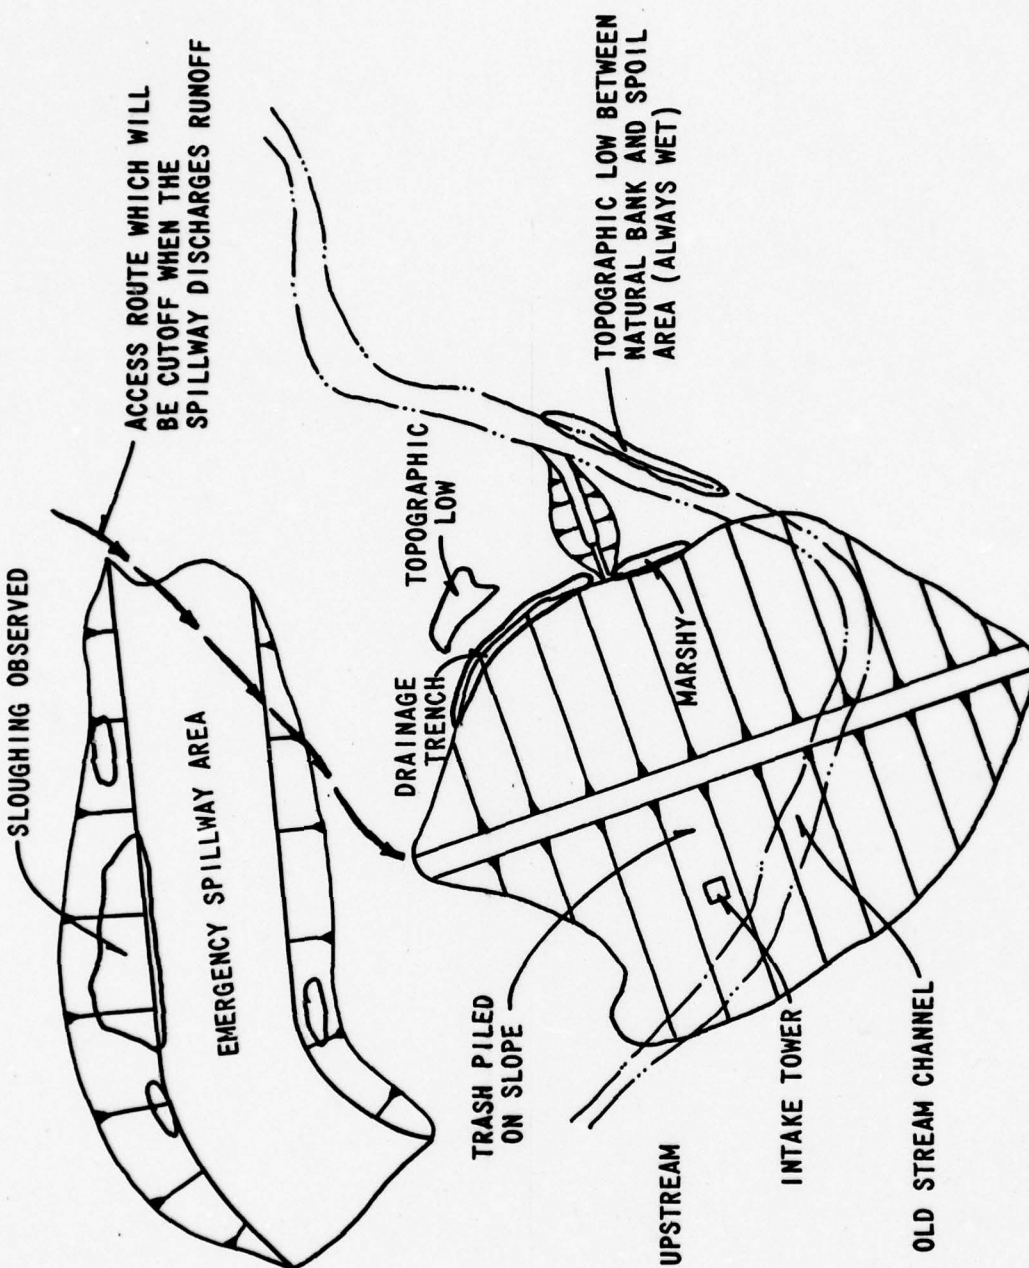
SEEPAGE LOCATION PLAN AND
NOTES FROM FIELD INSPECTION
TUSCARORA STATE PARK DAM

A careful inspection of the marshy areas located as shown on Sheet 5a of Appendix B reveal that these zones were topographic lows which temporarily retain run-off water. Inspection reports located in DER files further confirm that the topographic lows were created during the construction of the dam and during repair work to the discharge conduit.

See Sheet 5a. Cattails were noted along the toe of the dam right of the discharge plung pool. Other areas of standing water were observed as noted on the sketch.

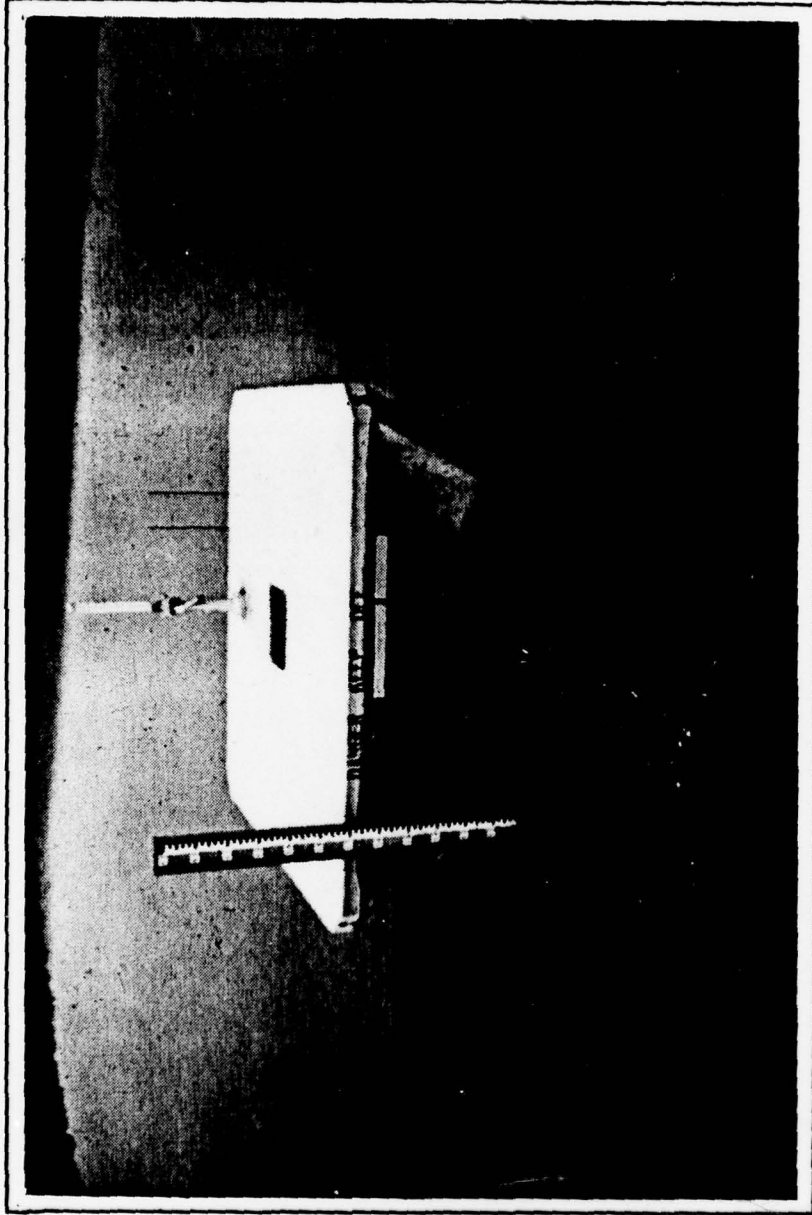
PHOTOGRAPH NO. 1

PINCIPAL SPILLWAY. NOTE POND
DRAIN VALVE AND STAFF GAGE.

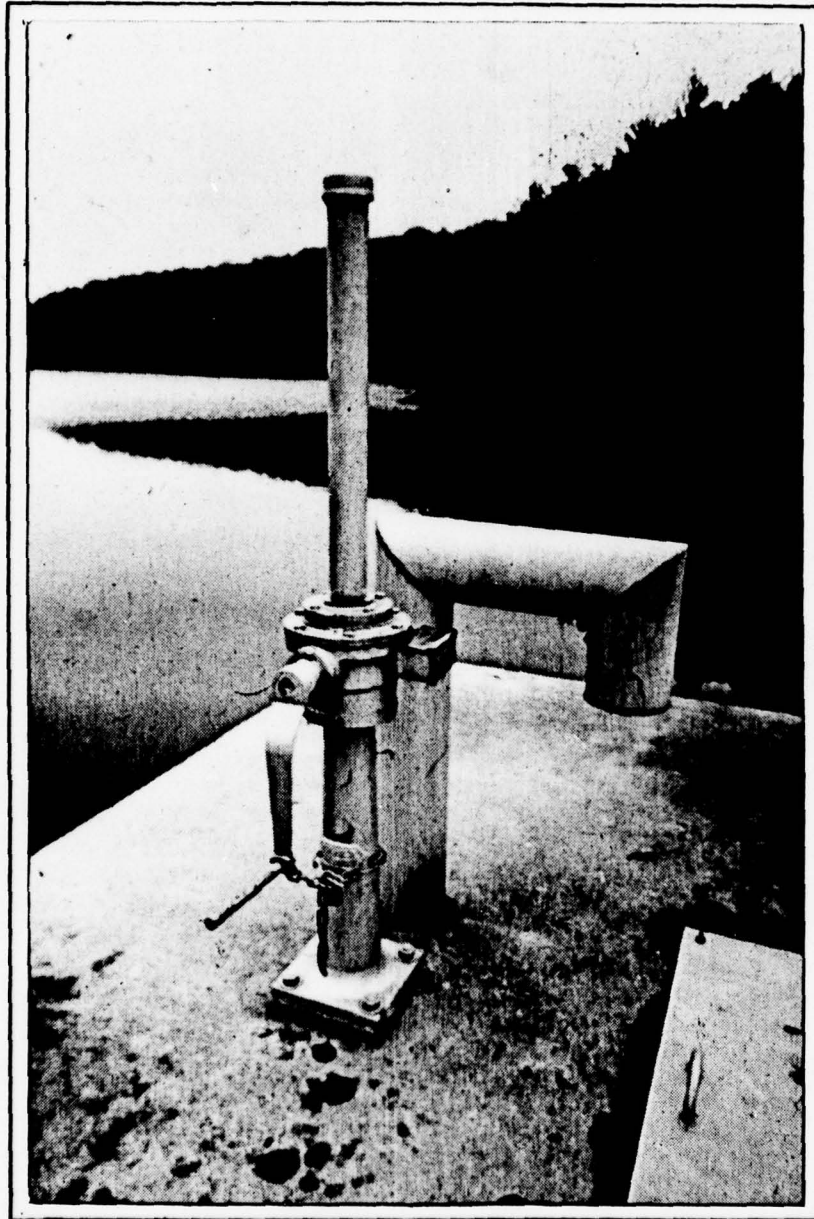
PHOTOGRAPH NO. 2

CLOSEUP VIEW OF POND DRAIN
AND AIR VENT.

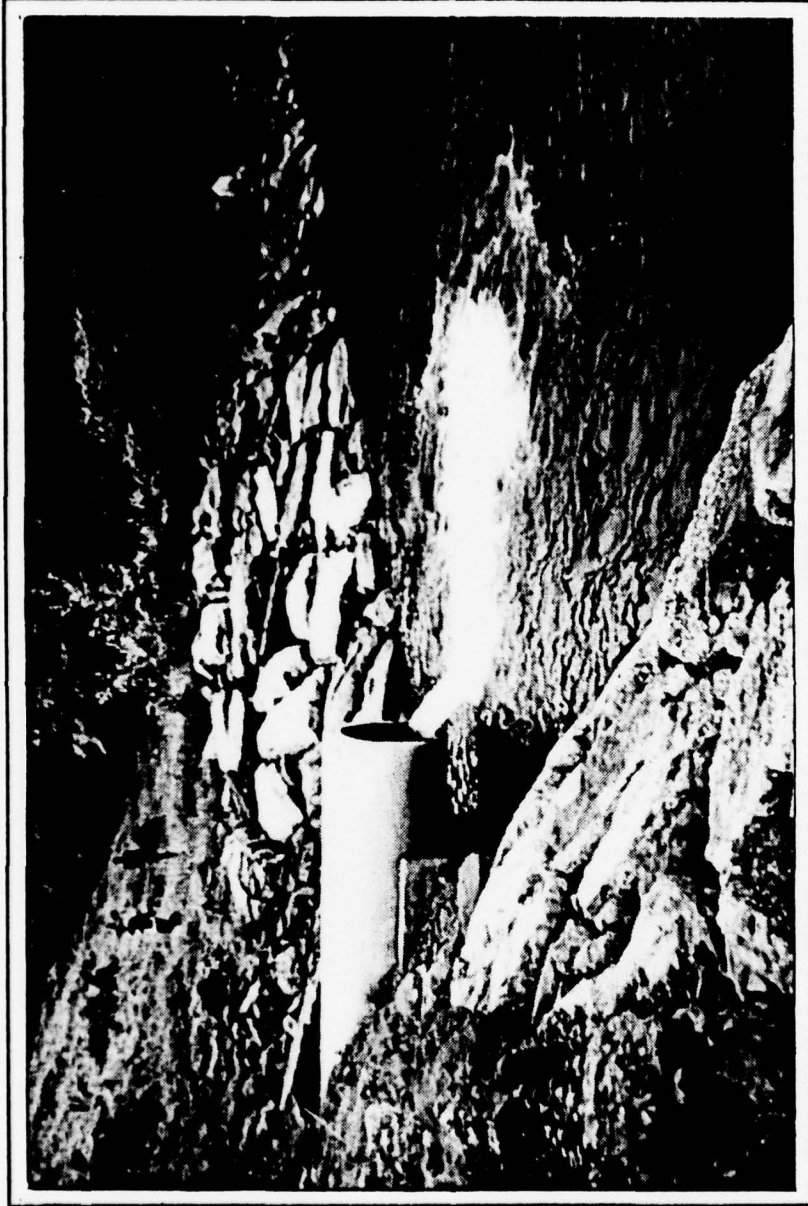
PHOTOGRAPH NO. 4

The discharge pipe could not be inspected because of water flowing over the principal spillway. It is noted that representatives from the Department of Environmental Resources (DER) periodically inspect this pipe.

PRINCIPAL SPILLWAY DISCHARGE
PIPE.

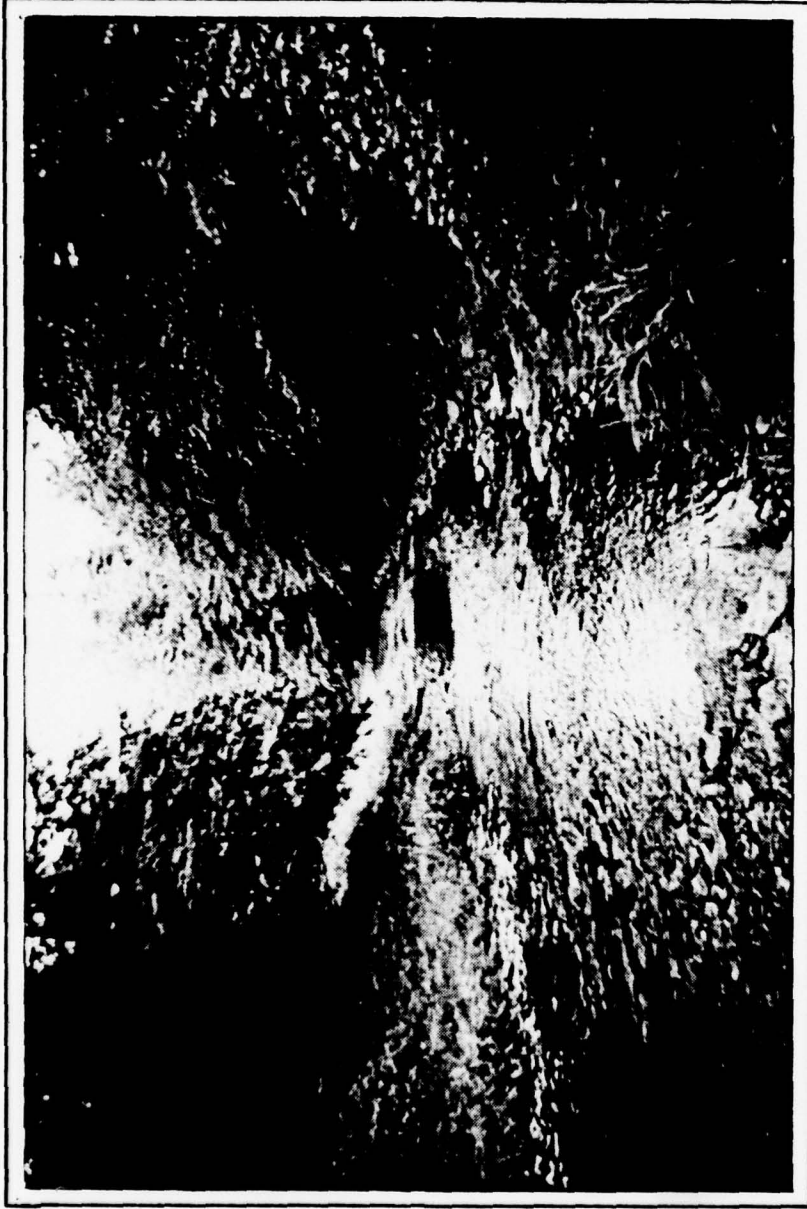
PHOTOGRAPH NO. 5

VIEW OF DOWNSTREAM CHANNEL
BELOW PRINCIPAL SPILLWAY
STILLING BASIN.

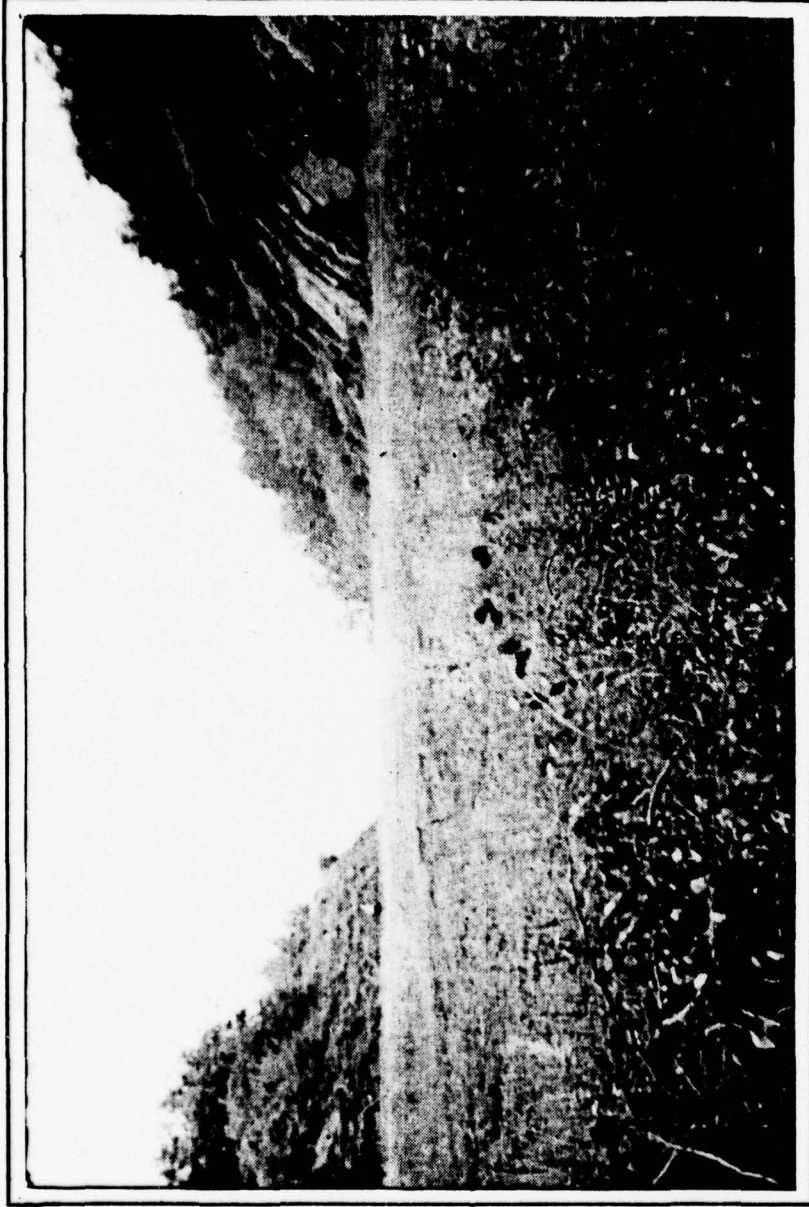
PHOTOGRAPH NO. 6

The emergency spillway located left of the embankment was inspected and observed to be in good condition. Scars from previous slides principally along the left wall of the channel were observed. Some minor accumulations of rock talus were observed along the base of both sides of the channel. Surface degradation of the rock is also evident. Some vegetation is beginning to grow in the crevices and will further degrade these materials. It is not expected that this degradation will significantly affect the performance of the spillway within the near future. However, additional slope sloughing should be expected during the life of this structure. The drop-off at the end of the emergency spillway was inspected and some recent cutting of trees was observed. The channel bottom is fairly stable and in good condition.

EMERGENCY SPILLWAY LOOKING
UPSTREAM.

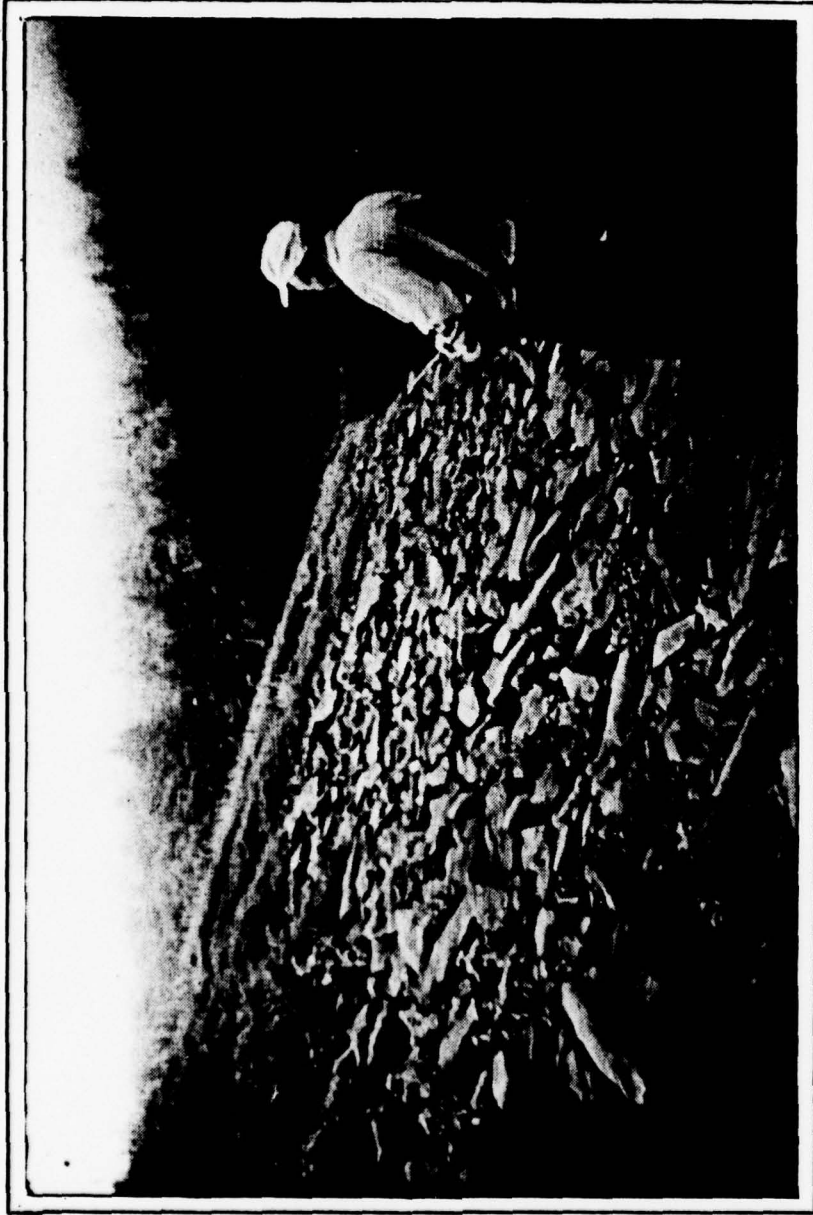
PHOTOGRAPH NO. 9

There were no signs of riprap distortion, movement, or deterioration. The quality of the rock is good; however, the rock is principally composed of shale materials which are expected to weather and decompose over the years. Signs of decomposition in the form of slaking and crumbling are already in evidence.

UPSTREAM RIPRAP SLOPE RIGHT
OF PRINCIPAL SPILLWAY.

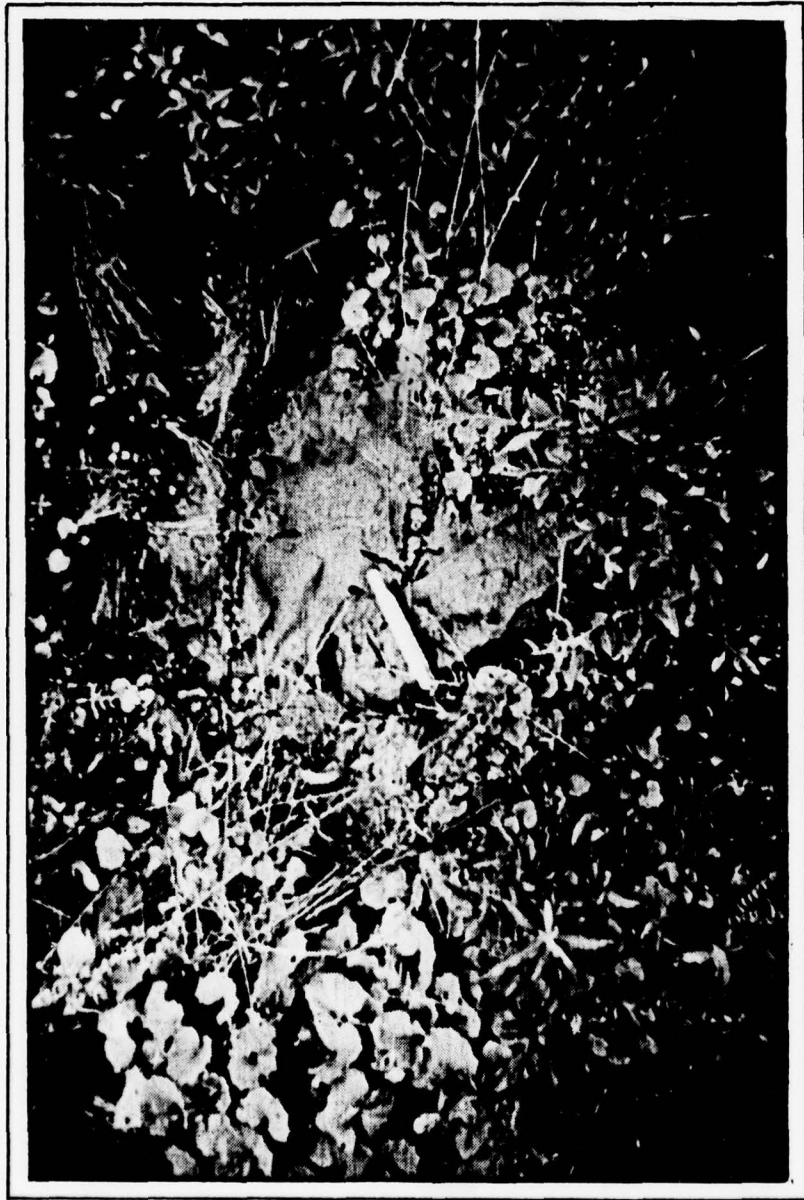
PHOTOGRAPH NO. 14

SEEPAGE WATER AT DOWNSTREAM
TOE RIGHT OF OUTLET PIPE.

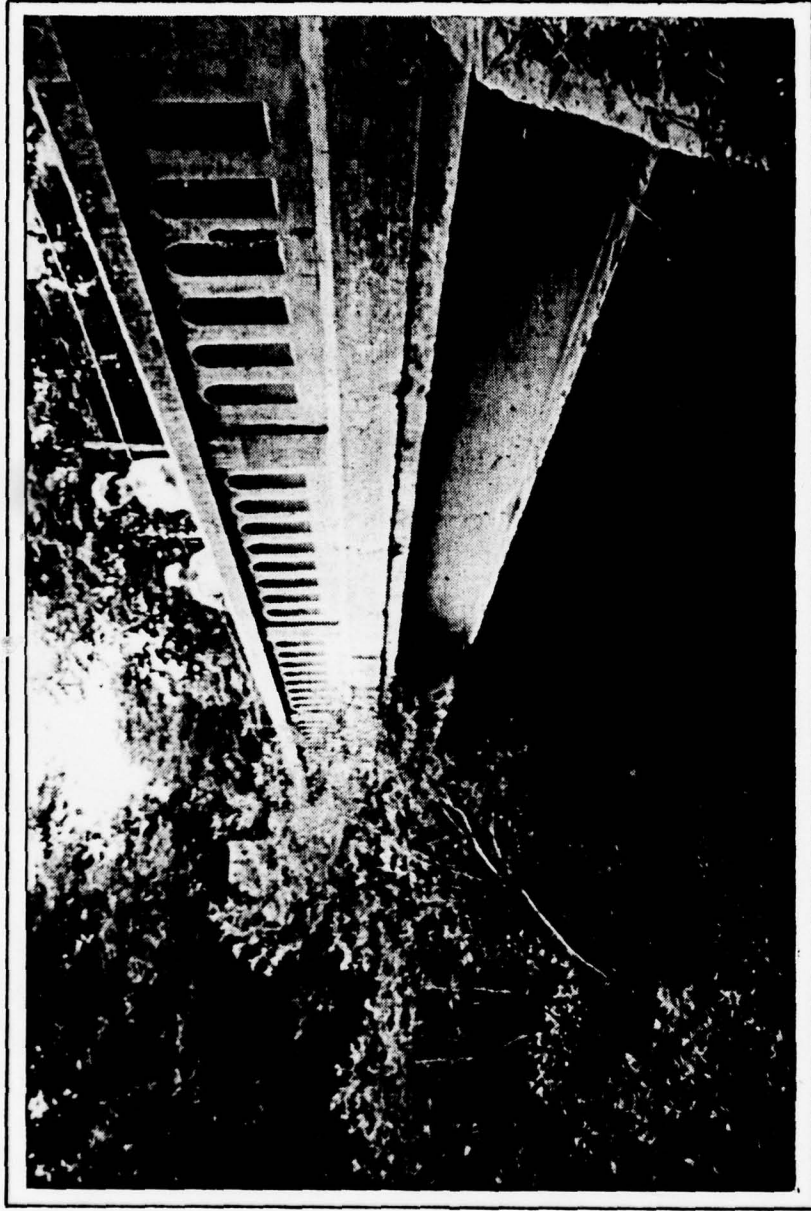
PHOTOGRAPH NO. 15

f. Downstream Conditions. Approximately 3,700 feet downstream of the dam, Locust Creek joins the Little Schuylkill River. Immediately upstream of the confluence, a highway bridge crosses Locust Creek, which is subject to flooding. The bridge is expected to flood at discharges of between 5,400 cfs and 9,100 cfs, depending on the water surface elevation in Little Schuylkill River.

VIEW OF ONLY BRIDGE DOWNSTREAM
OF DAM.

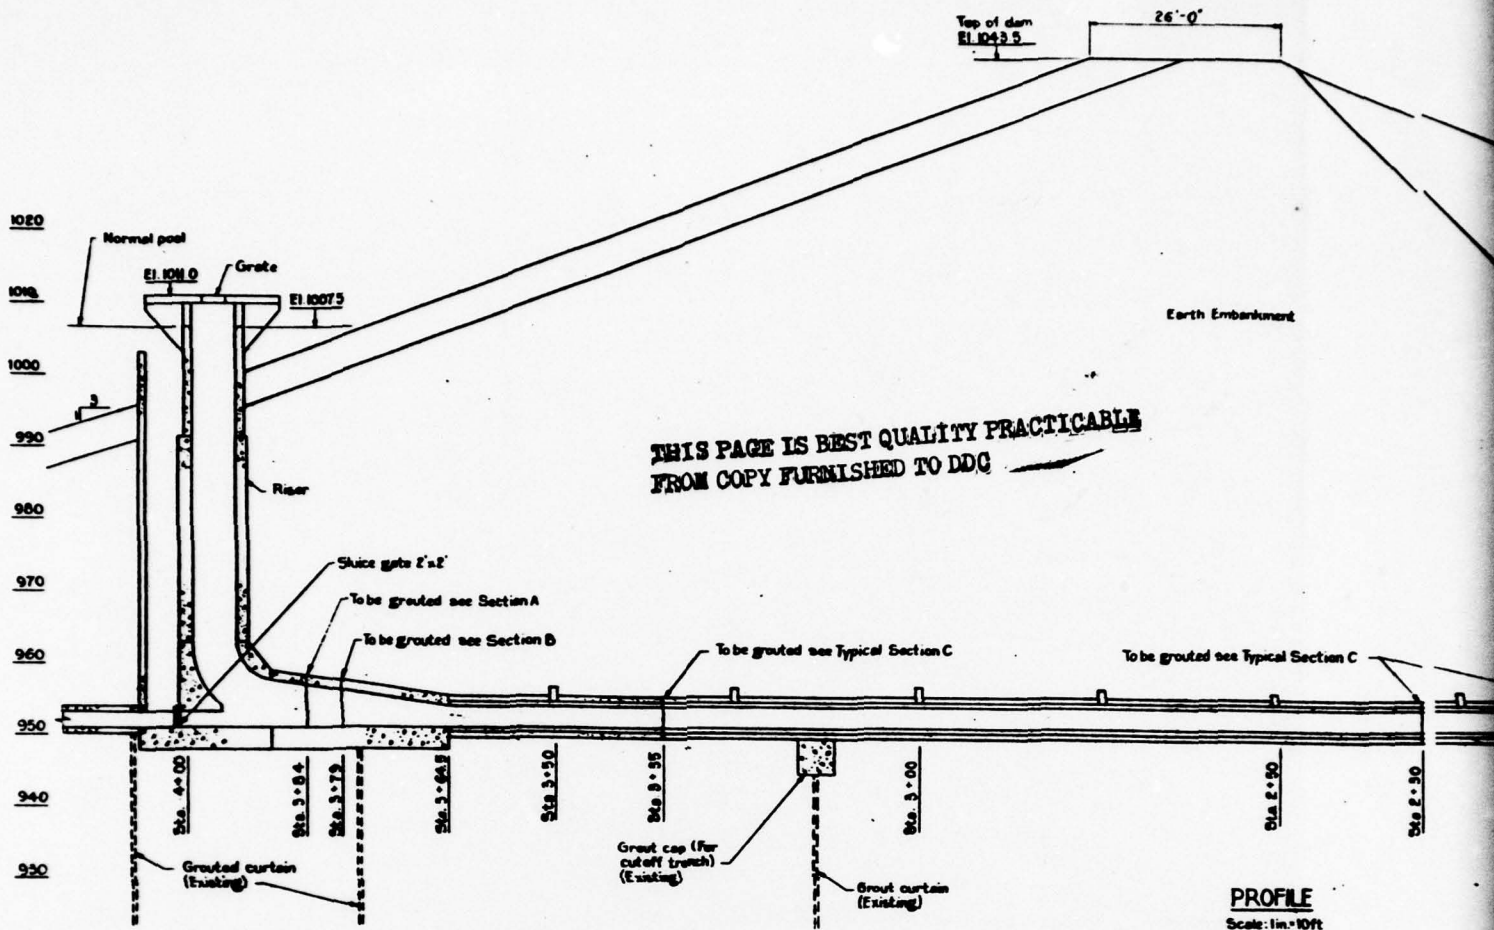
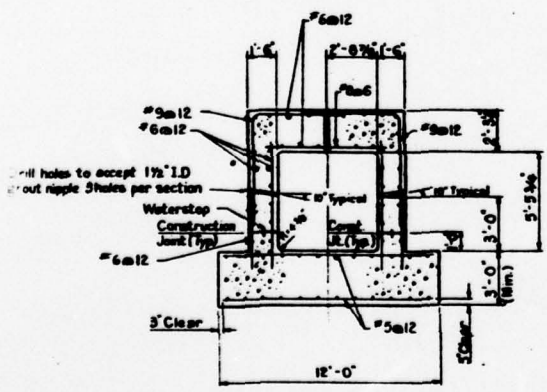
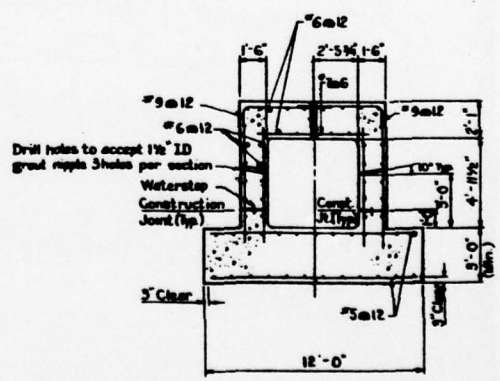
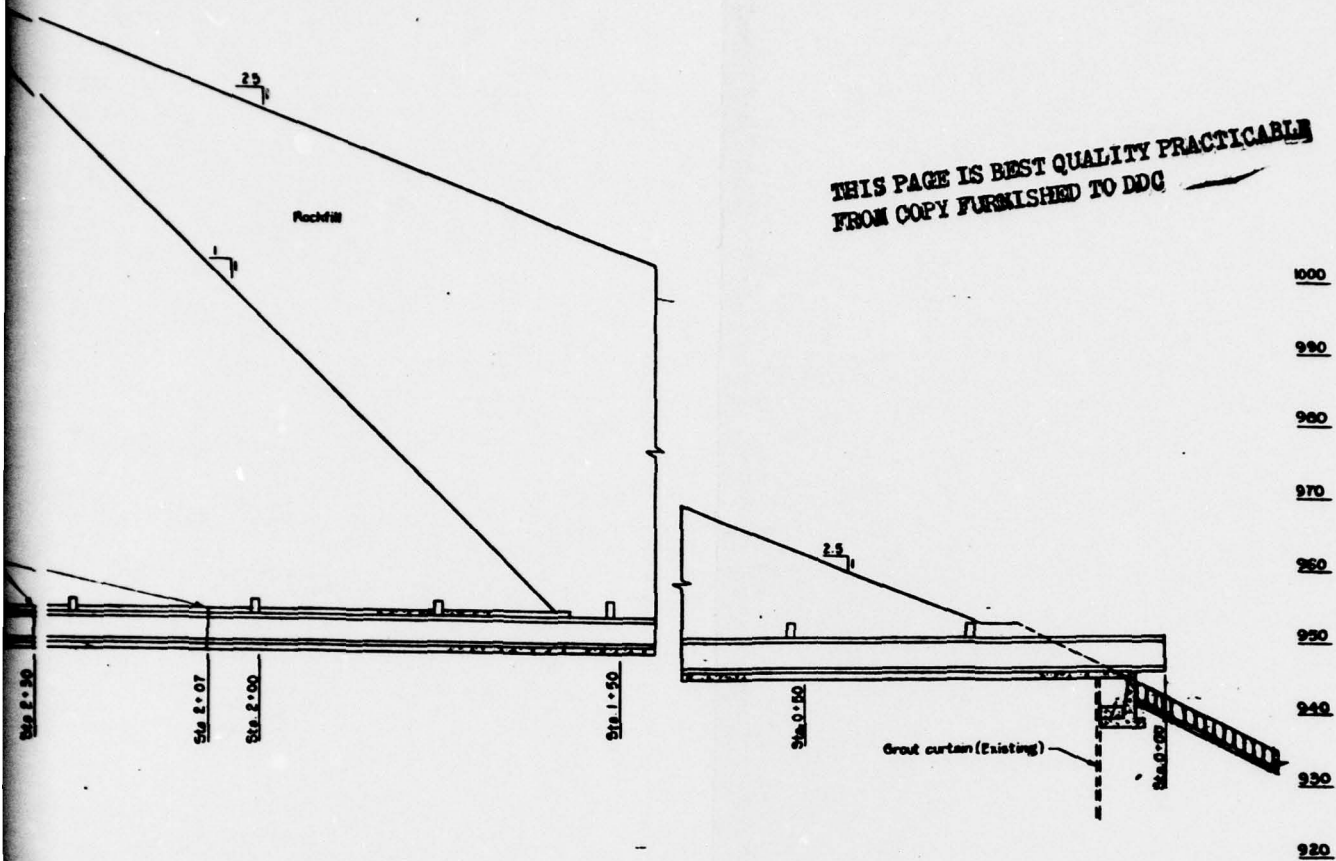
PLATE 8

Inspection of the dam following Tropical Storm Agnes, June 1972, revealed cracks in the 42-inch principal spillway conduit. In the summer of 1973, the Corps of Engineers prepared specifications to grout the conduit cracks. This work was performed by the Royal International, Inc. of Bridgeport, Pennsylvania. Details of the grouting program are presented on Plate 9 of Appendix E.

MODIFICATIONS The Department of Environmental Resources issued Drawing No. R54:3-2.1, entitled "Grouting Outlet Conduit", dated 12/21/73, presented as Plate 9 of Appendix E. Repair work was performed to the conduit.
