National Dam Inspection Program.

Lower Kittanning Dam (NDI-529),  
Susquehanna River Basin, Burgoon  
Run, Blair County, Pennsylvania.  
Phase I Inspection Report.

PHASE I REPORT  
NATIONAL DAM INSPECTION PROGRAM

LOWER KITTANNING DAM  
NDI I.D. NO. 529  
AUGUST 9, 1978

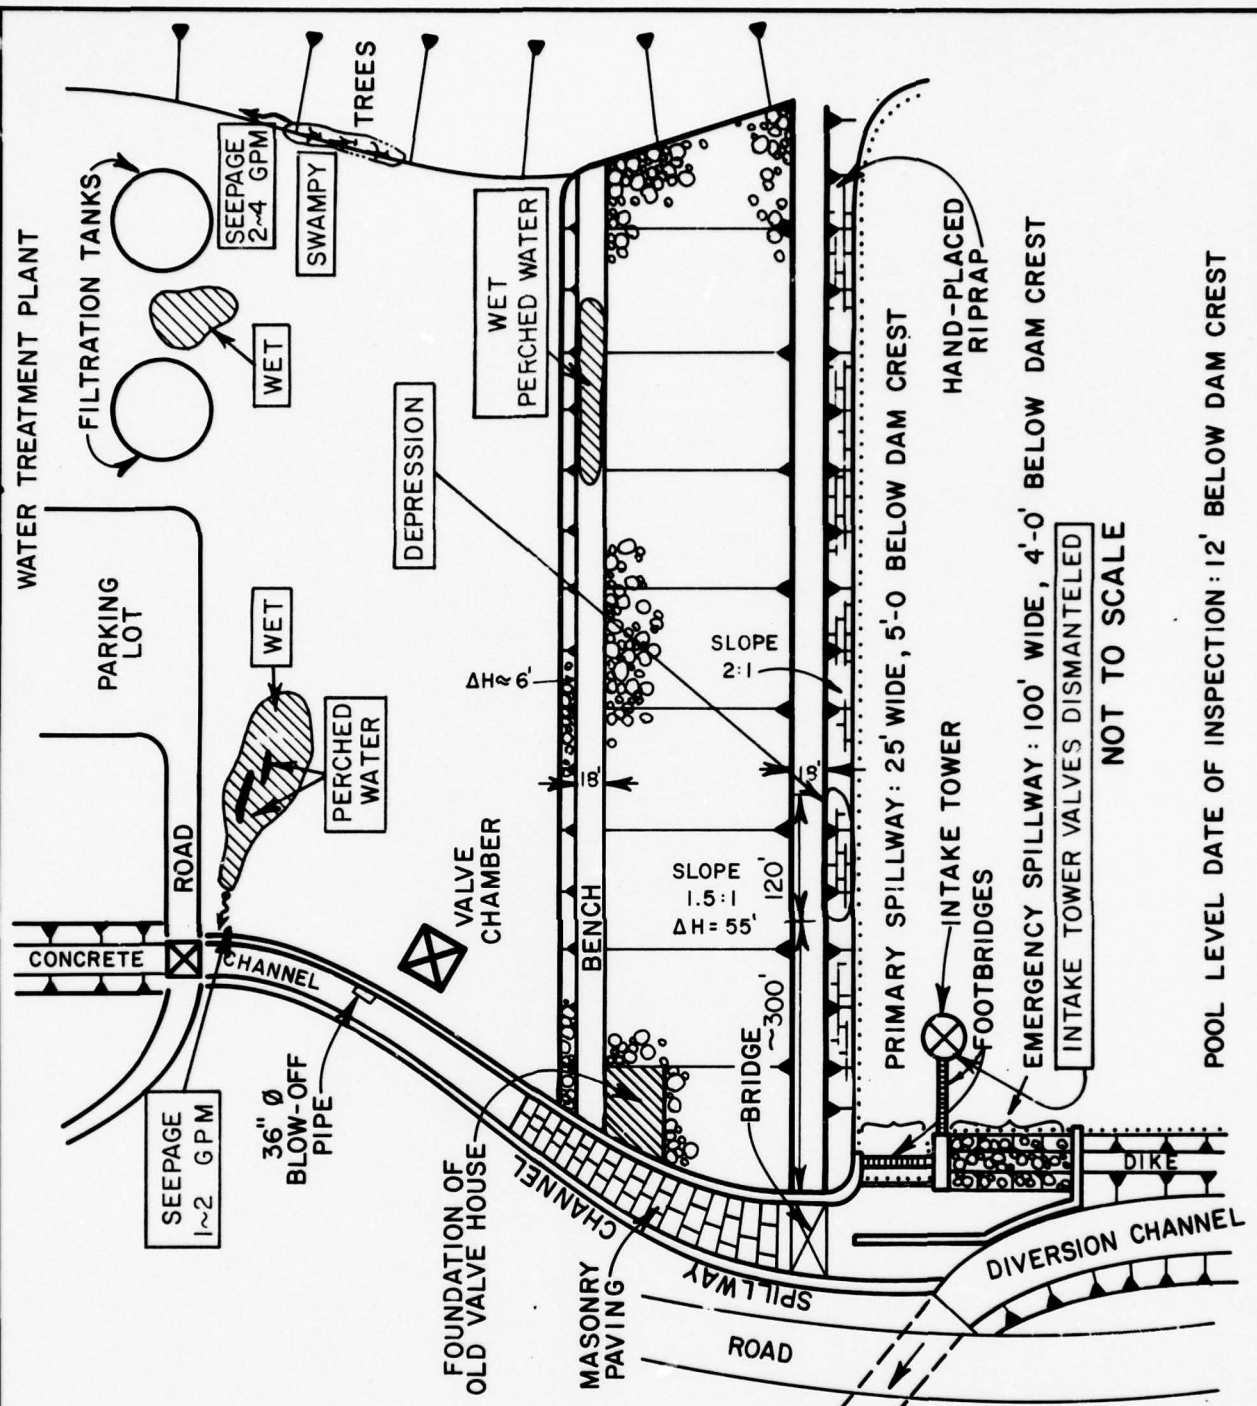
PLATE 7  
 LOWER DAM NDI ID:529  
 GENERAL PLAN  
 FIELD INSPECTION NOTES  
 FIELD INSPECTION DATE: AUGUST 9, 1978

1. A depression was observed on the upstream slope of the dam about 300 feet from the left abutment of the dam (Photographs 9 and 10). Measured vertically, the depression was about 18 inches deep at its left extreme and gradually diminished over a distance of 120 feet toward the right abutment.
2. Four wet areas were found on the downstream side of the dam. The first wet area was located on the bench at the toe of the dam near the right abutment. Water was perched on the bench. No measurable seepage was observed. The other three wet areas were located about 100 feet downstream of the toe of the dam. Plate 7 illustrates the location of these wet areas.

VISUAL EXAMINATION OF	OBSERVATIONS:	REMARKS OR RECOMMENDATIONS
JUNCTION OF EMBANKMENT AND ABUTMENT, SPILLWAY AND DAM	NO VISUAL SIGNS OF DISTRESS NO SEEPAGE.	
ANY NOTICEABLE SEEPAGE	SOME MINOR SEEPS BELOW TOE SEE PLATE 7 FOR LOCATION AND SEEPAGE QUANTITY ESTIMATES.	
STAFF GAGE AND RECORDER	NONE	
DRAINS	NONE.

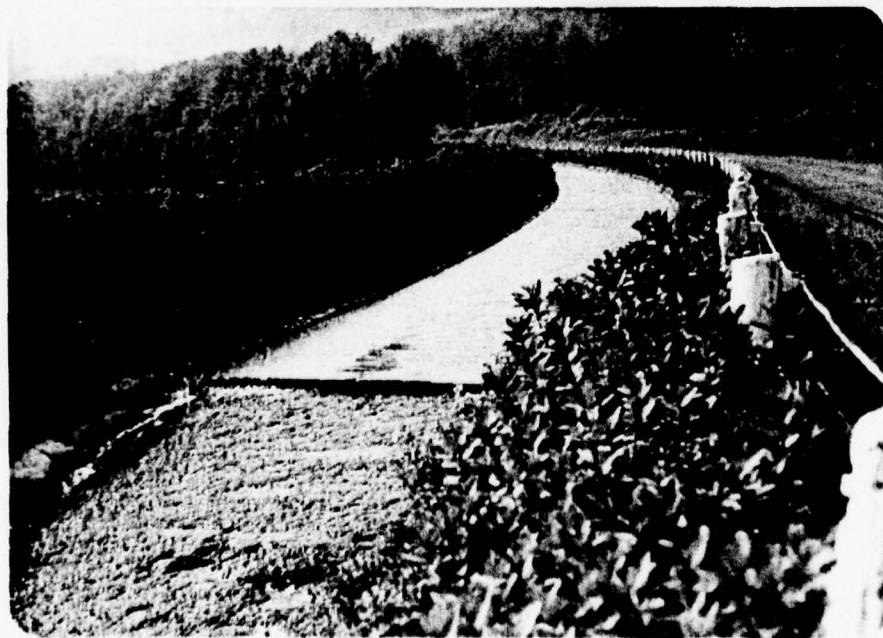
Photograph No. 4

The concrete in the diversion channel was found to be deteriorated due to action of acid mine drainage. However, the condition is not considered to be to an extent that would affect the structural performance of the concrete.

Diversion channel (note acid mine drainage).

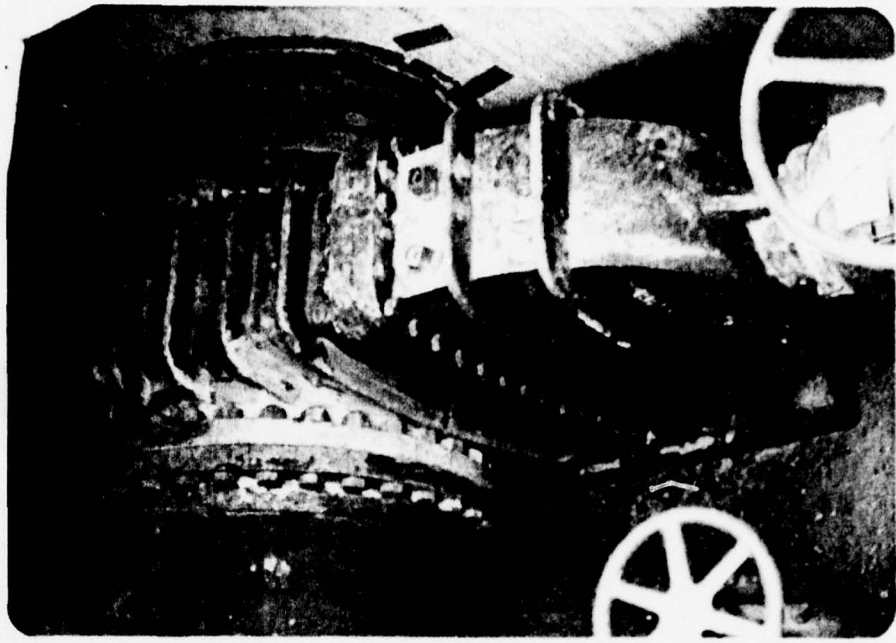
The downstream blow-off valve was operated by the city personnel and found to be functional.

Photograph No. 7  
Blow-off pipe valve.

4.5 Evaluation. The operational condition of the dam is considered to be good. However, it is considered advisable to develop a means of blocking the upstream end of the blow-off pipe in the event it is required to repair the pipe.

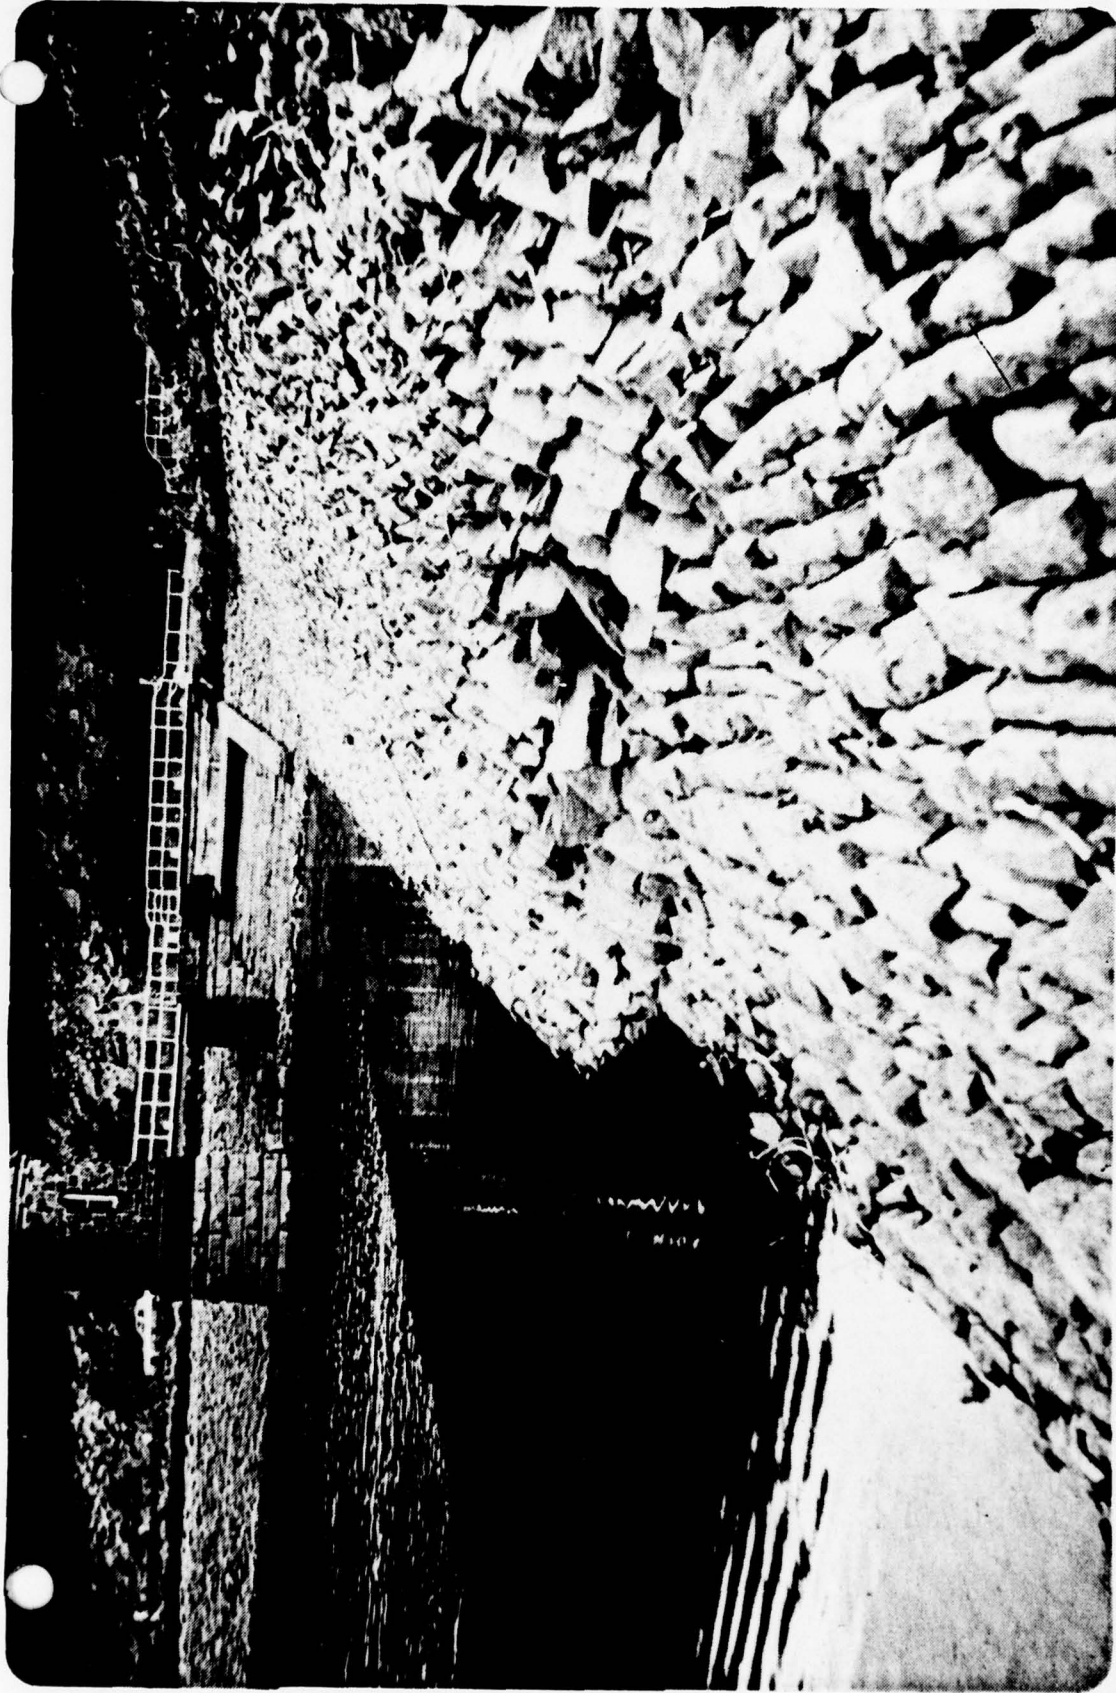
Photograph No. 9

3.2 Evaluation. In view of the depression observed on the upstream slope which is considered to be a threat to the integrity of the dam, the condition of the dam is considered to be poor.

a. Assessment. In view of the depression observed on the upstream slope of the dam which is considered to be a potential threat to the integrity of the embankment, the condition of Lower Kittanning Dam is assessed to be poor.

Depression on upstream face.

1. It is recommended that the effect of the depression on stability and seepage through the embankment should be investigated by a professional geotechnical engineer.

The lake level should be maintained at a level not higher than 15 feet below the crest of the dam until further investigation is undertaken and appropriate repairs completed.

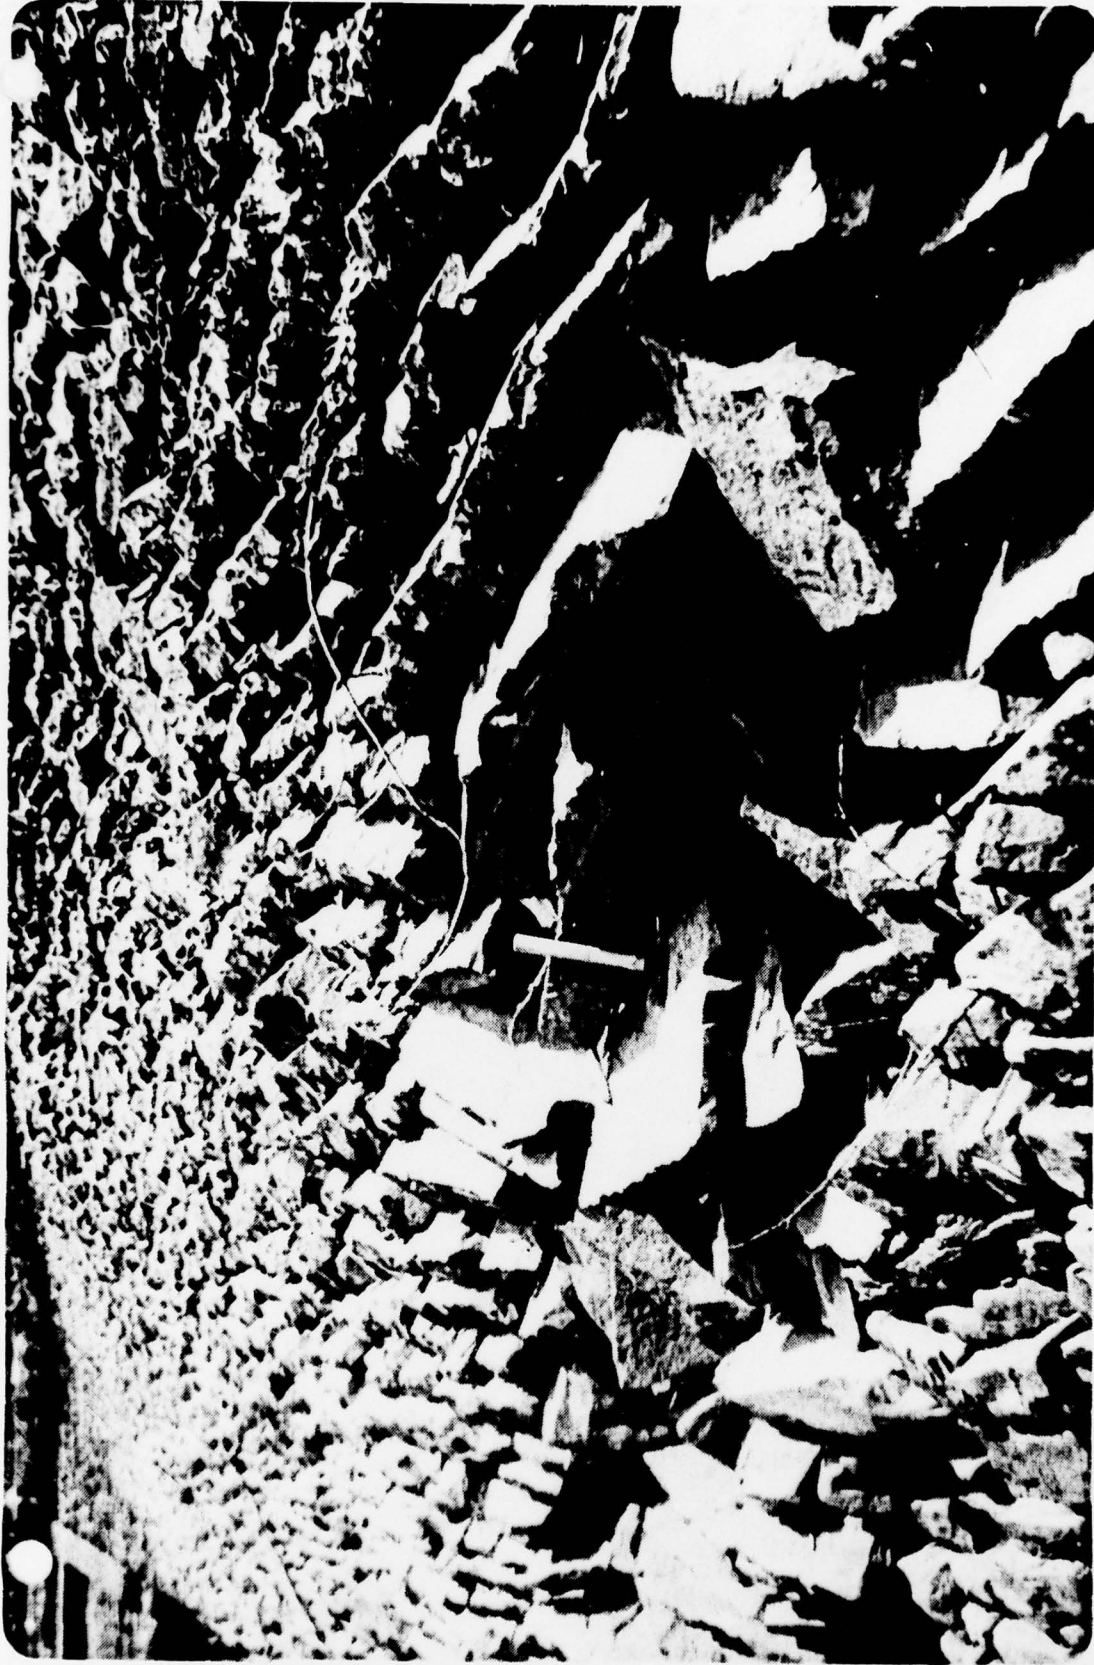
Photograph No. 10

Depression on upstream face (closeup).
