MILL CREEK NO. 2 DAM
NDI I.D. NO: 735

PHASE I INSPECTION REPORT
NATIONAL DAM INSPECTION PROGRAM

Mill Creek Number 2 Dam (NDI-735),
Ohio River Basin, Mill Creek,
Cambria County, Pennsylvania.
Phase I Inspection Report.

11 SEP 1978

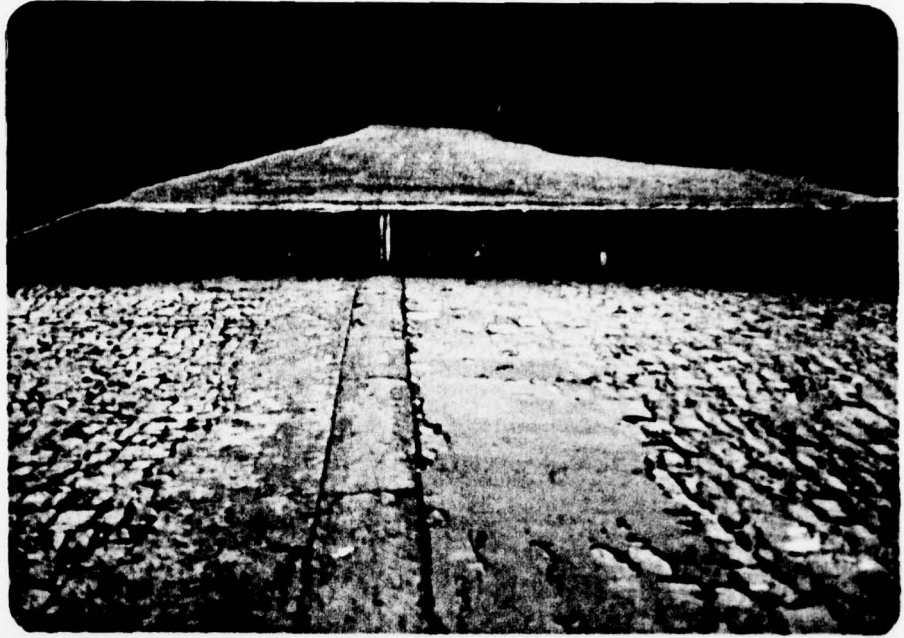
Photograph No. 1

Crest (looking east) (spillway crest
in foreground).

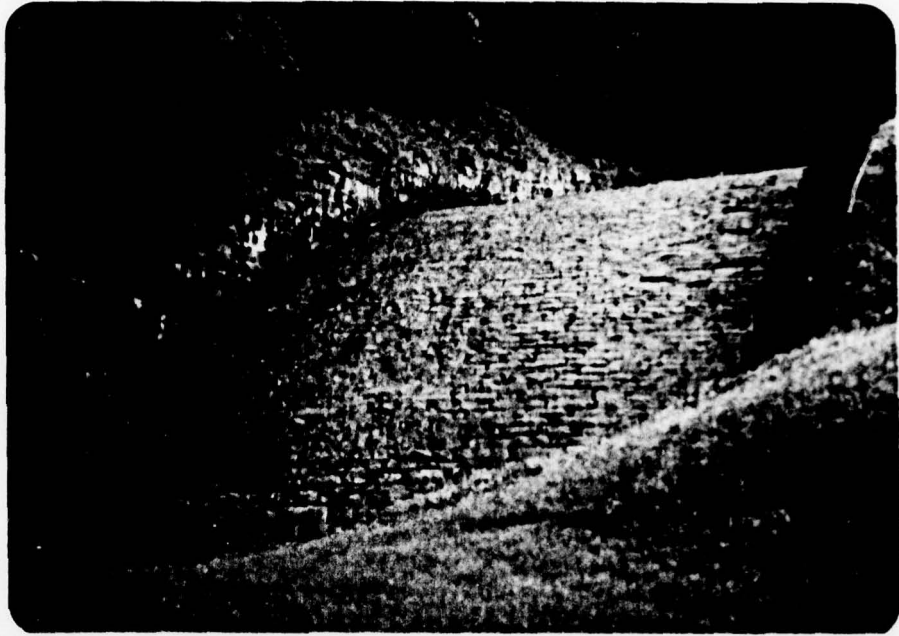
Photograph No. 3
Spillway discharge channel.

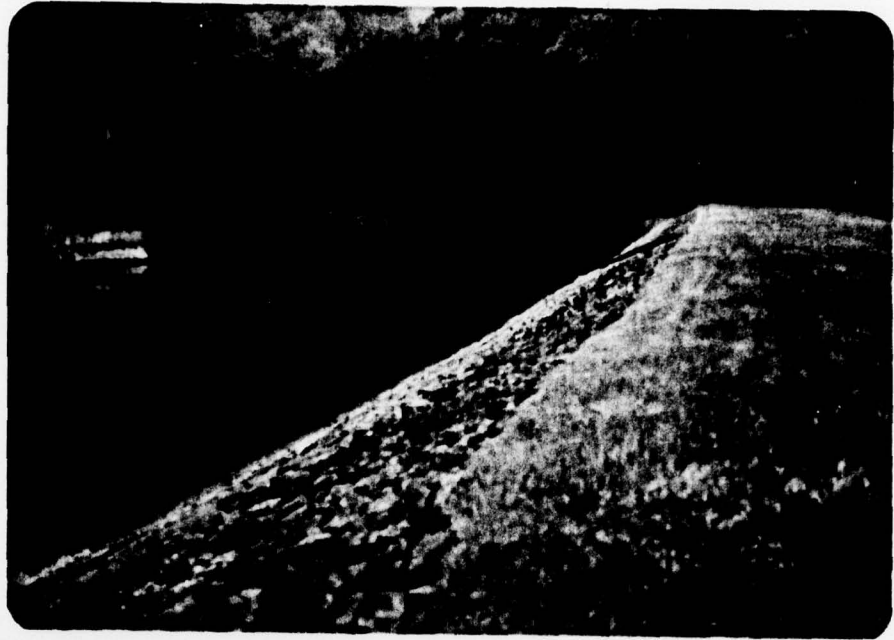
Photograph No. 5
Intake tower (accessible by boat only).

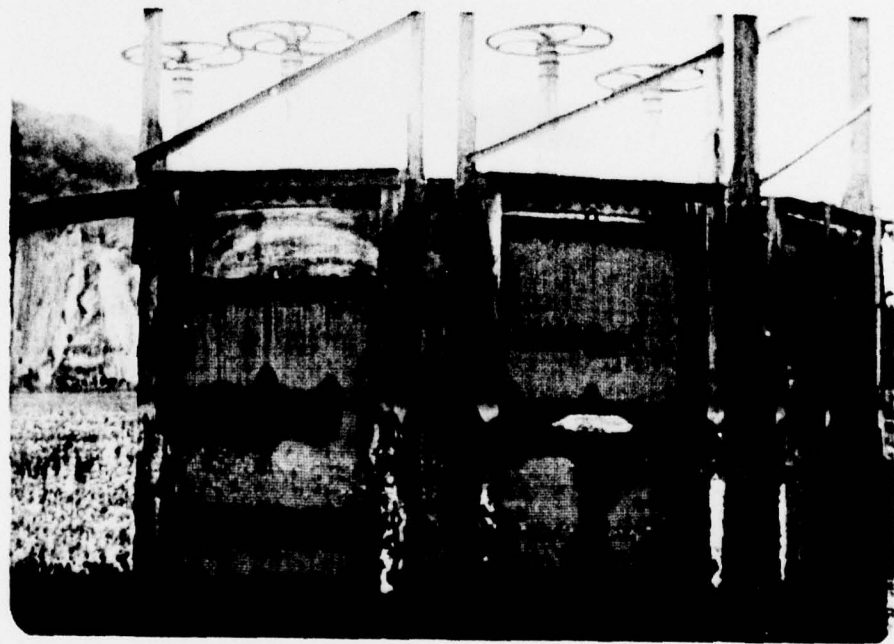
Photograph No. 6
Gate controls at intake tower.

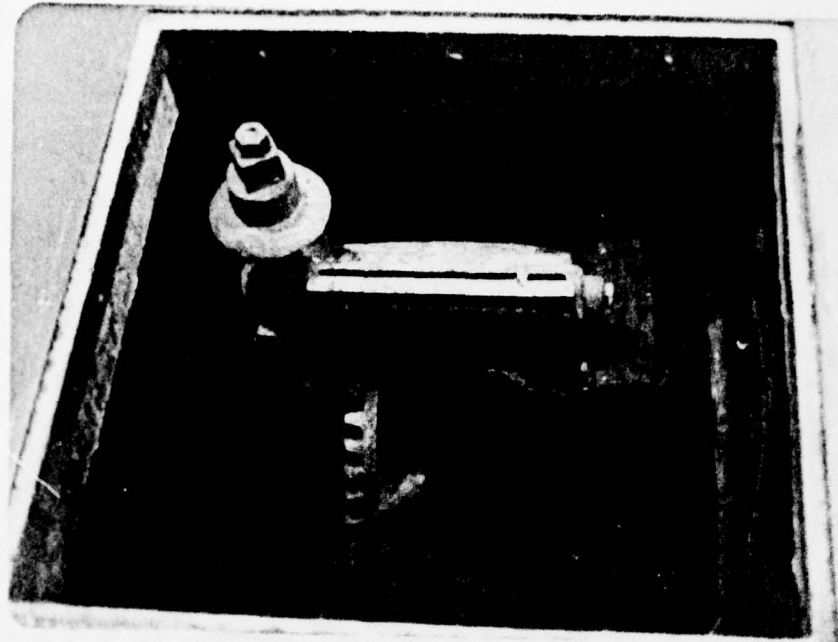
4.3 Maintenance of Operating Facilities. The maintenance condition of the operating facilities is considered to be poor. The dam tender reported that the downstream blow-off valve for the dam has not been operated in the past 25 years and only two intermediate level intake valves in the intake tower are functional. The upper and lower intake valves are closed and their operational condition is reported to be unknown. The operation of the blow-off valve was not observed.

4.5 Evaluation. While the maintenance condition of the embankment is considered to be good, the condition of the operating facilities is assessed to be poor. The dam tender reported that the downstream blow-off valve has not been operated in the past 25 years. The operational condition of the blow-off valves was not observed. It is therefore recommended that the owner immediately evaluate the operational condition of the outlet works system and perform necessary maintenance to adequately maintain the equipment. It is also recommended that better access be provided from the dam tender's house to the dam site.

Photograph No. 7
Blow-off valve at valve house.

1. The owner immediately initiate studies to more accurately ascertain the spillway capacity and the nature and extent of improvements required to provide sufficient spillway capacity.
2. The owner immediately evaluate the operational condition of the outlet works system and perform any necessary maintenance and/or repairs to make it functional.

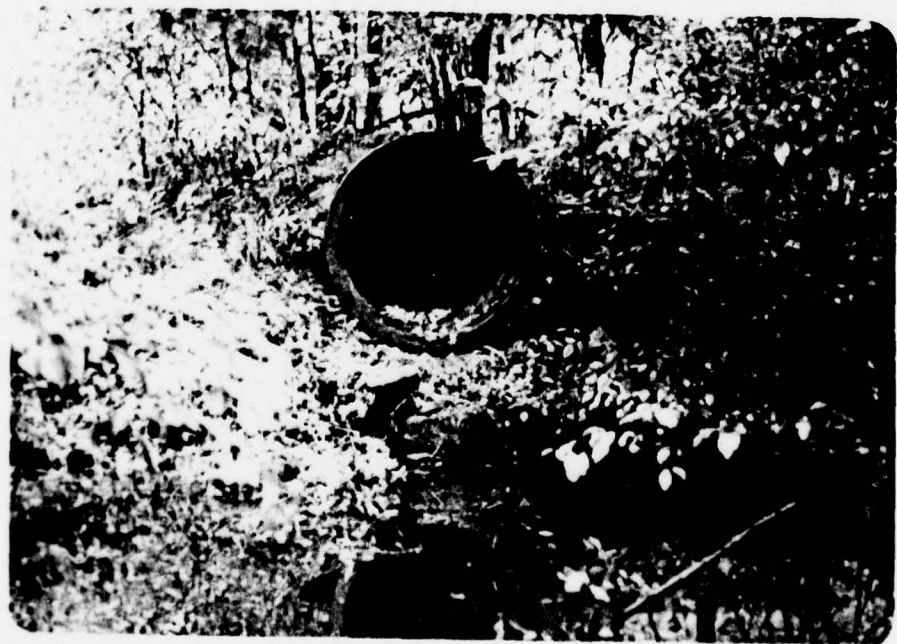
VISUAL EXAMINATION OF	OBSERVATIONS	REMARKS OR RECOMMENDATIONS
CRACKING AND SPALLING OF CONCRETE SURFACES IN OUTLET CONDUIT	36-inch cast-iron pipe. Only downstream end is visible.	
INTAKE STRUCTURE	Intake tower at the upstream toe of the dam. (Tower is accessible by boat only.)	
OUTLET STRUCTURE	Riprapped plunge pool	
OUTLET CHANNEL	Earth channel.	
EMERGENCY GATE	Dam tender reported that blow-off pipe valve is not functional.

Photograph No. 8
Blow-off pipe.

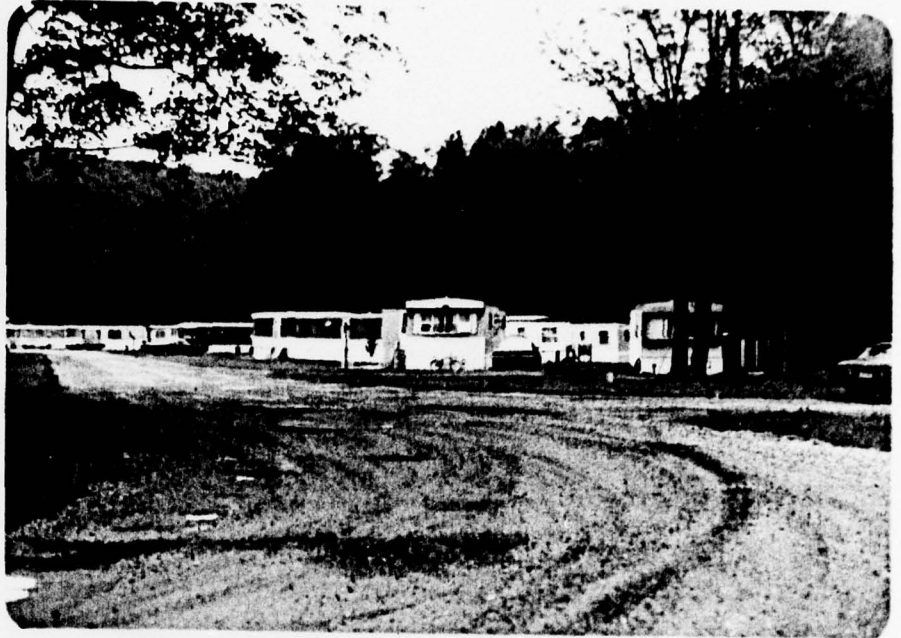
50 mobile homes and 30 homes in the lower one-mile reach of Mill Creek. It is estimated that in the event of failure there would be large loss of life and property damage, both in Mill Creek Valley and Bens Creek Valley and further downstream.

Photograph No. 9
Mobile home park (1-1/2 miles downstream).

3. The owner provide around-the clock surveillance during unusually heavy runoff and develop a formal warning system to alert the downstream residents in the event of an emergency. It is recommended that better access be provided from the dam tender's residence to the site.
4. The owner be advised that the dam and appurtenant structures should be inspected regularly and necessary maintenance should be performed.

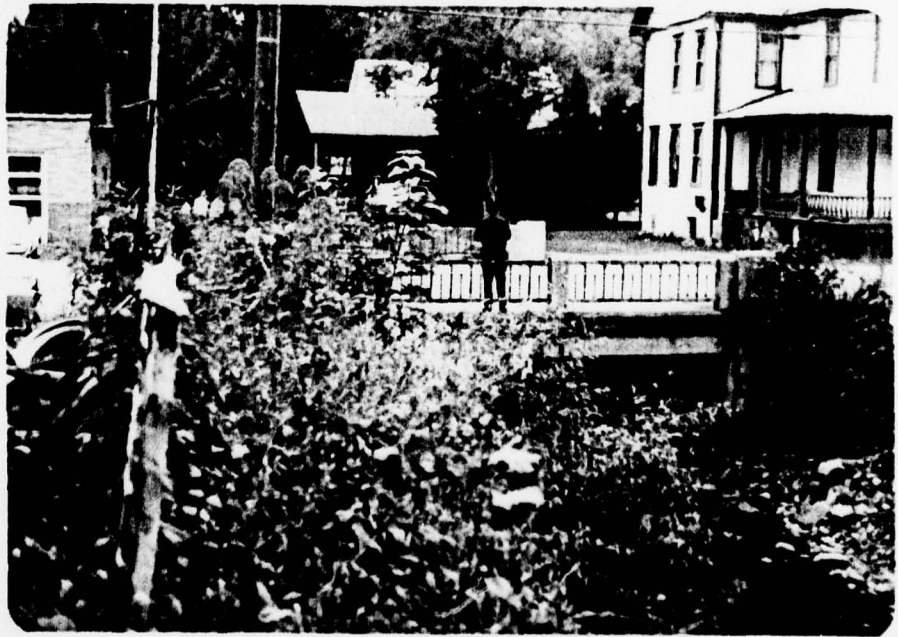
Photograph No. 10
Bridge over Mill Creek (two miles downstream).
