WILLIAMS RUN DAM

NDI I.D. NO: 432

National Dam Inspection Program, Williams Run Dam (NDI ID 432), Ohio River Basin, Williams Run, Cambria, Pennsylvania.

PHASE I INSPECTION REPORT.

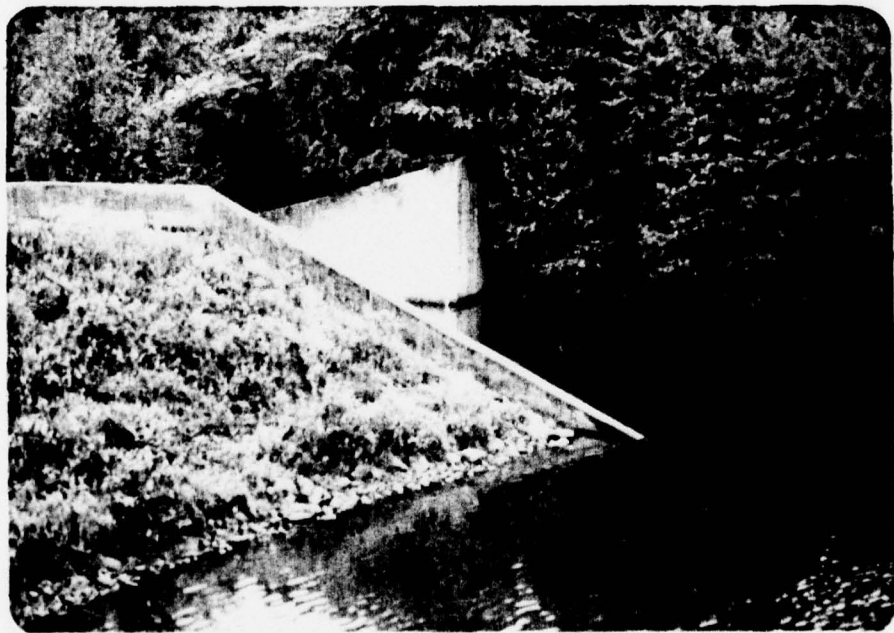
Photograph No. 2
Spillway approach channel.

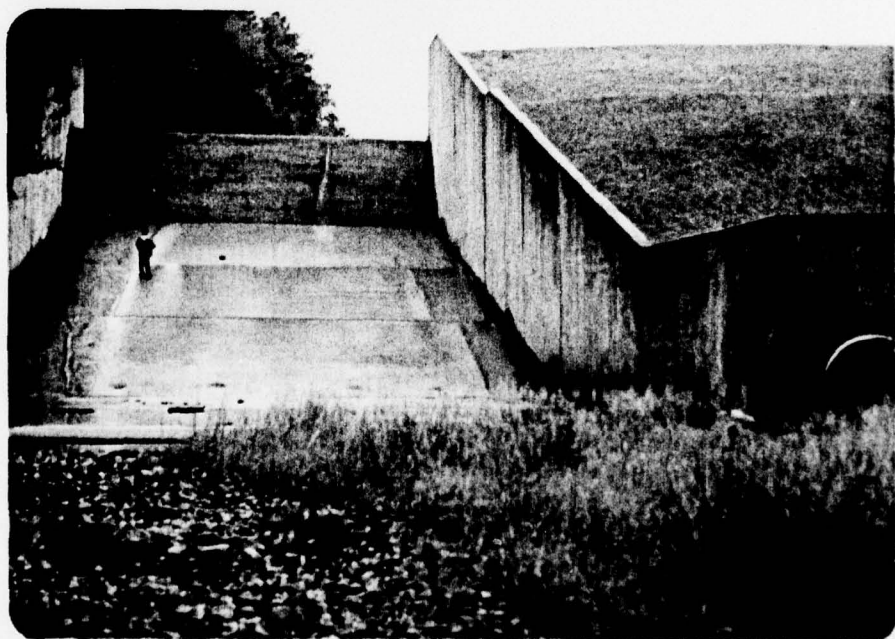
(3) Appurtenant Structures. Nanty Glo Water Authority personnel reported that during Tropical Storm Agnes a portion of the spillway discharge channel slab had failed. The extent of the repairs performed was observed in the field. The review of the structural configuration of the spillway discharge channel in view of this past failure raised some concern as to the stability of the retaining walls if a similar failure of the spillway were to occur in the future. This concern was based on the fact that the retaining walls are supported on the concrete slab forming the bottom of the spillway channel, and a failure in this slab may result in failure of the retaining walls. Although various causes, such as hydrostatic uplift or suction pressures, may have led to the failure, it appears from visual observations that the failure of the spillway bottom resulted from high suction pressures generated by high flow velocities over the spillway bottom. To the extent it can be determined, the repair measures did not incorporate any provisions for controlling suction pressures. Therefore, it is possible that a similar failure may happen in the future in the event of large flows over the spillway, thereby endangering the integrity of the dam.

(2) Appurtenant Structures. In view of the failure of the spillway slab during Tropical Storm Agnes in 1972, some concern exists as to the stability of the spillway discharge channel. It appears that spillway repairs have essentially followed the original design with the exception of installation of several relief wells at the toe of the spillway chute to drain the sand blanket underneath the slab. No provisions were made to eliminate the suction pressures generated by large flows which are suspected to have caused the failure of the dam during Tropical Storm Agnes.

Photograph No. 4
Spillway chute (note drainpipe outlet
on righthand side).

1. It is recommended that further studies be undertaken to determine the underlying causes of the failure of the spillway discharge channel, the adequacy of the repairs performed, and to take necessary measures to eliminate the potential of a similar failure in the future. Measures, such as aerating the nappe to eliminate suction pressures, may be considered.
2. In view of the presence of old coal mine workings beneath the dam, it is recommended that the dam and its vicinity and the reservoir area should

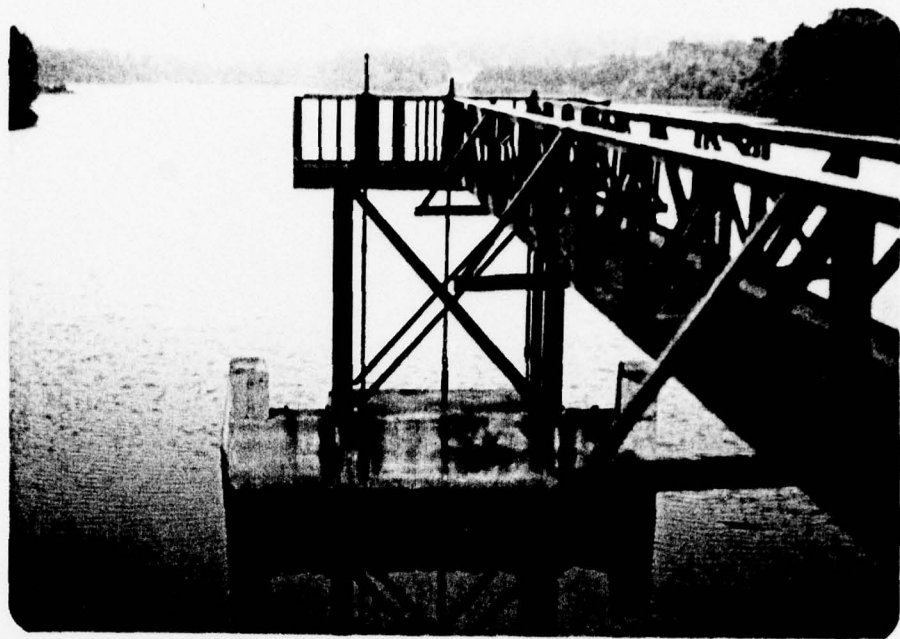
The outlet pipe valve was operated by borough personnel and observed to be functional.

Photograph No. 5
Upstream valve controls.

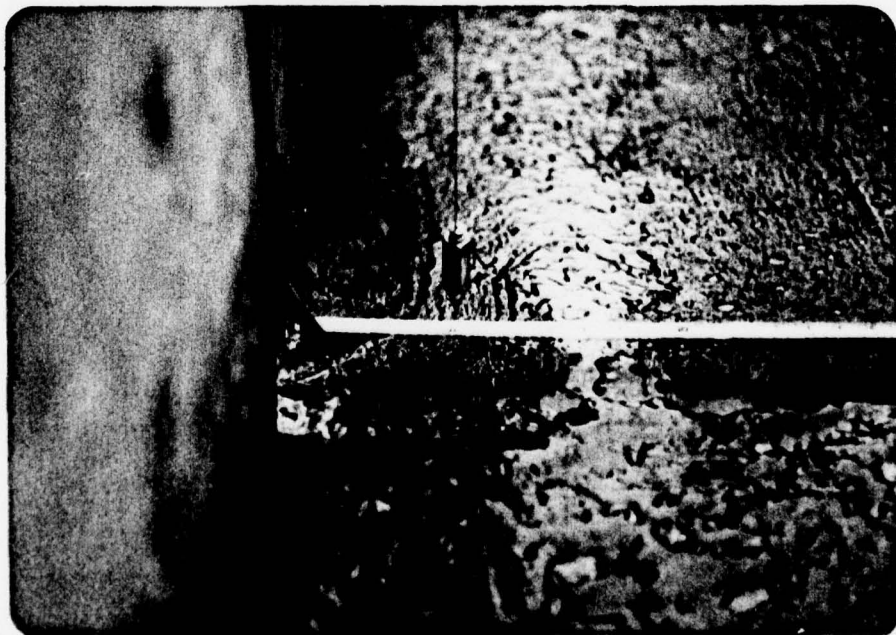
Photograph No. 6
Right spillway wall (looking downstream)
five inches out of plumb.

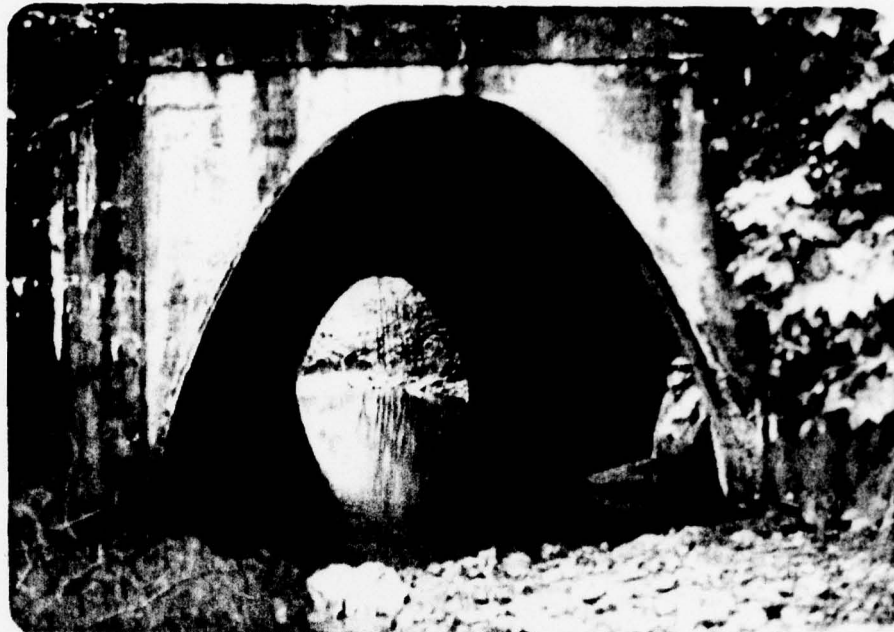
Photograph No. 7
Culvert under Route 422 (looking downstream).

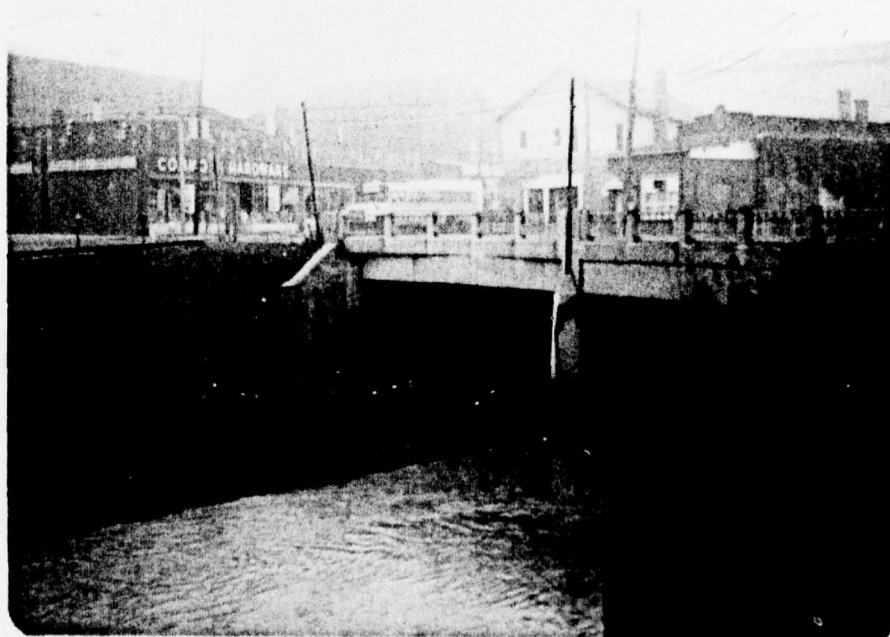
Photograph No. 8
South Branch of Black Lick Creek at
Nanty Glo (six miles downstream).
