**TYRONE RESERVOIR 1**

**NDI I.D. NO: 536**

**PHASE I INSPECTION REPORT.**

D'APPOLONIA CONSULTING ENGINEERS  
10 DUFF ROAD  
PITTSBURGH, PA. 15235  
SEPTEMBER 1978

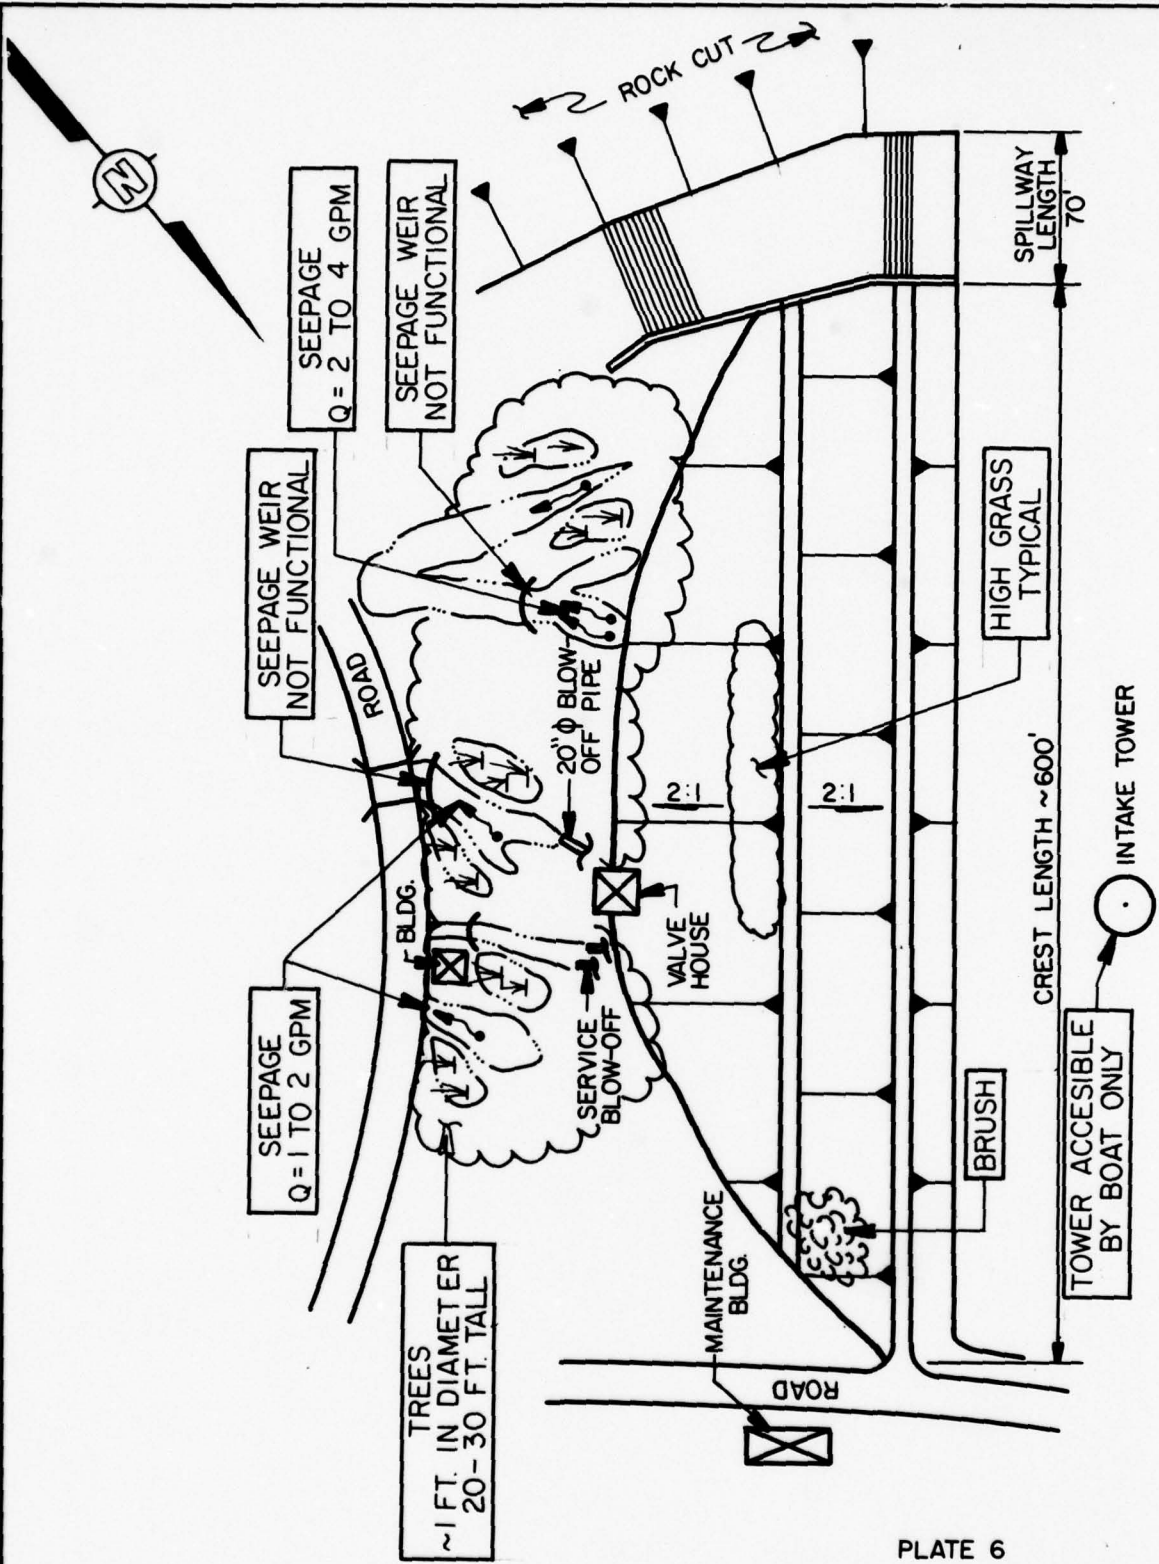
PLATE 6  
 TYRONE RESORVOIR #1  
 GENERAL PLAN  
 FIELD INSPECTION NOTES  
 FIELD INSPECTION DATE : JULY 11 , 1978

1. Numerous wet areas and three seepage areas were observed below the toe of the dam. The seepage flows were estimated to be in the range of one to four gallons per minute as shown in Plate 6.
2. The downstream face of the dam was found to be covered with high grass which should be mowed annually.

VISUAL EXAMINATION OF	OBSERVATIONS	REMARKS OR RECOMMENDATIONS
JUNCTION OF EMBANKMENT AND ABUTMENT, SPILLWAY AND DAM	NO VISUAL SIGNS OF DISTRESS, NO SEEPAGE	
ANY NOTICEABLE SEEPAGE	SOME WET & SWAMPY AREAS BELOW TOE. SEEPAGE MINOR Q & I TO 4 GPM	SEE PLATE 6 FOR LOCATION OF SEEPS.
STAFF GAGE AND RECORDER	NONE	
DRAINS	NONE

VISUAL EXAMINATION OF	OBSERVATIONS	REMARKS OR RECOMMENDATIONS
MONUMENTATION/SURVEYS	NONE	
OBSERVATION WELLS	NONE	
WEIRS	THREE ABANDONED SEEPAGE WEIRS. SEE PLATE 6 FOR LOCATION.	THIS PAGE IS BEST QUALITY PRACTICABLE FROM COPY FURNISHED TO DDG
PIEZOMETERS	NONE	
OTHER	NONE

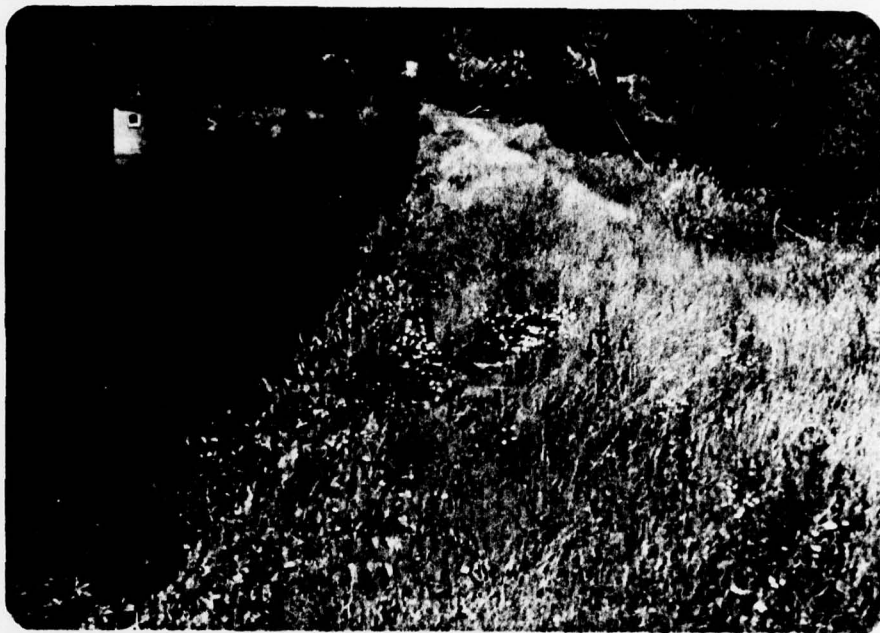
Photograph No. 1  
Crest (note intake tower is inaccessible).

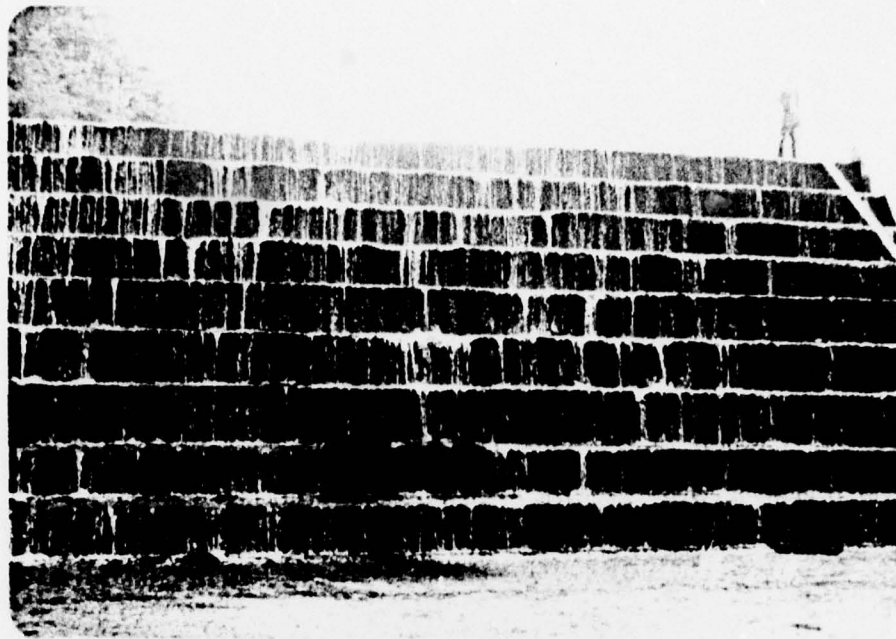
Photograph No. 3  
Spillway discharge channel.

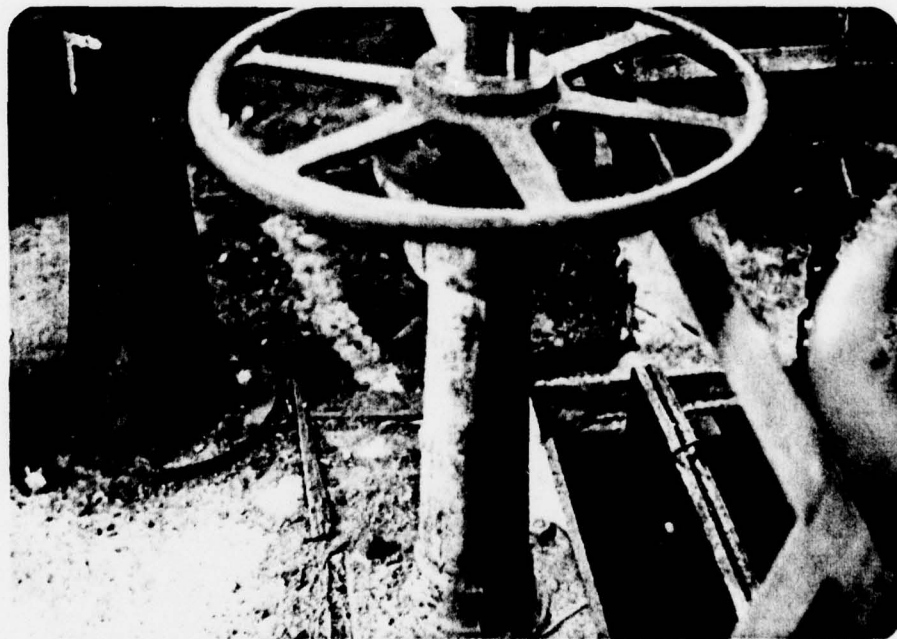
4.3 Maintenance of Operating Facilities. Borough personnel reported that the blow-off valve for the dam is not functional. Visual observations indicate that the operating equipment is in poor condition. The intake tower where the upstream valves for the blow-off pipe are located has no bridge; it is only accessible by boat.

Photograph No. 4  
Gate control at intake tower.

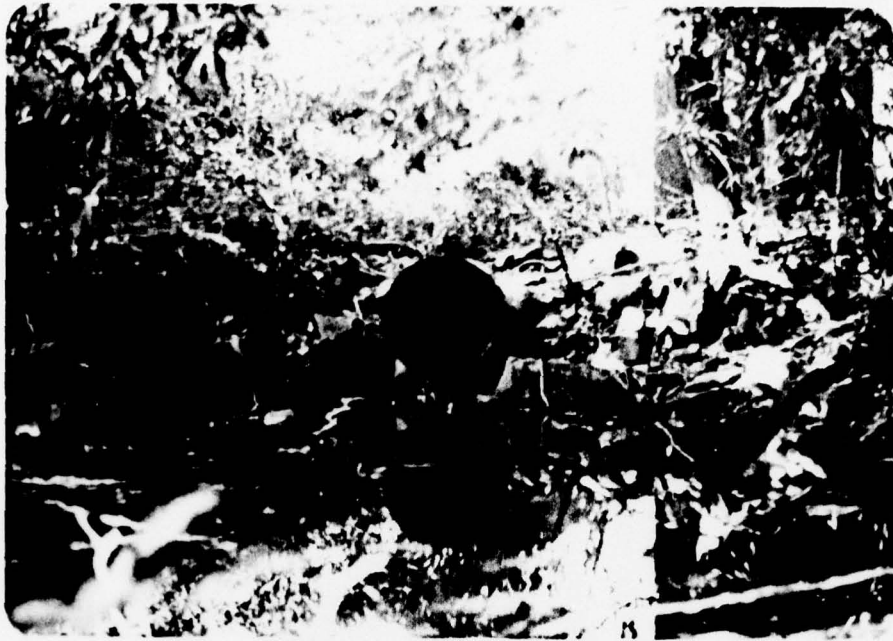
Tyrone Borough personnel reported that the drawdown facility for the reservoir is not functional. It is therefore recommended that the owner assess the functional condition of the operating facilities.

Photograph No. 5  
Blow-off pipe plunge pool.

1. The owner should initiate additional studies to more accurately ascertain the spillway capacity and the nature and extent of improvements required to provide sufficient spillway capacity.
2. The owner should evaluate the stability of the dam considering the wet conditions existing below the toe of the dam. In addition, the owner should monitor and record seepage quantities regularly and observe the turbidity of the seeps.
3. The owner should immediately evaluate the operational condition of the lake blow-off valve and perform any necessary maintenance and/or repairs to make it functional.

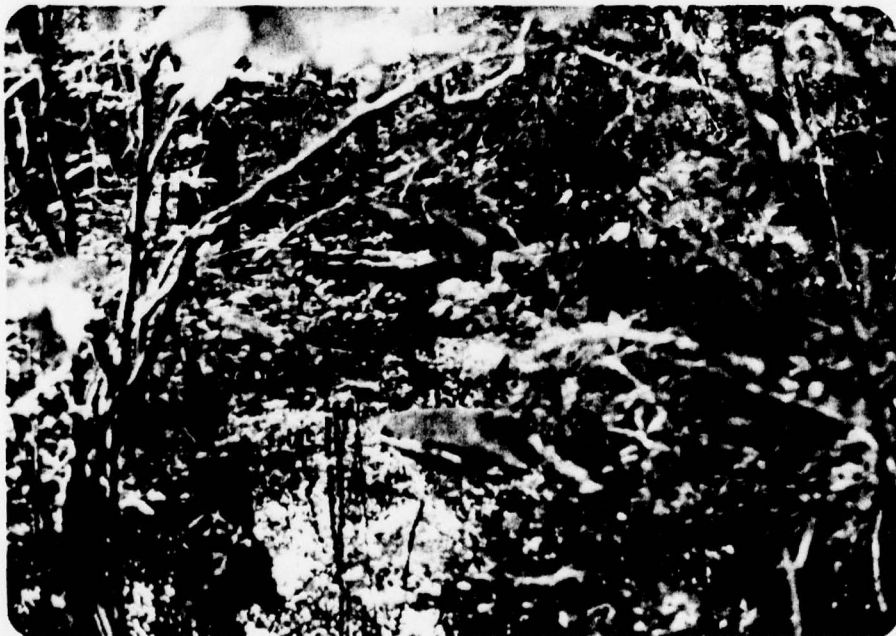
3.2 Evaluation. General condition of the dam is considered to be fair. The extent of the wet areas below the dam raises some concern as to the effect of the seepage through the dam on the stability of the embankment. The owner should monitor and record seepage quantities and observe the turbidity of the seeps.

Photograph No. 6  
Seepage at toe (note abandoned seepage weir).
