National Dam Inspection Program. Mill Run Dam (NDI ID 533), Susquehanna River Basin, Mill Run, Blair County, Pennsylvania. Phase I Inspection Report.

MILL RUN DAM

NDI I.D. NO: 533

PHASE I INSPECTION REPORT  
NATIONAL DAM INSPECTION PROGRAM

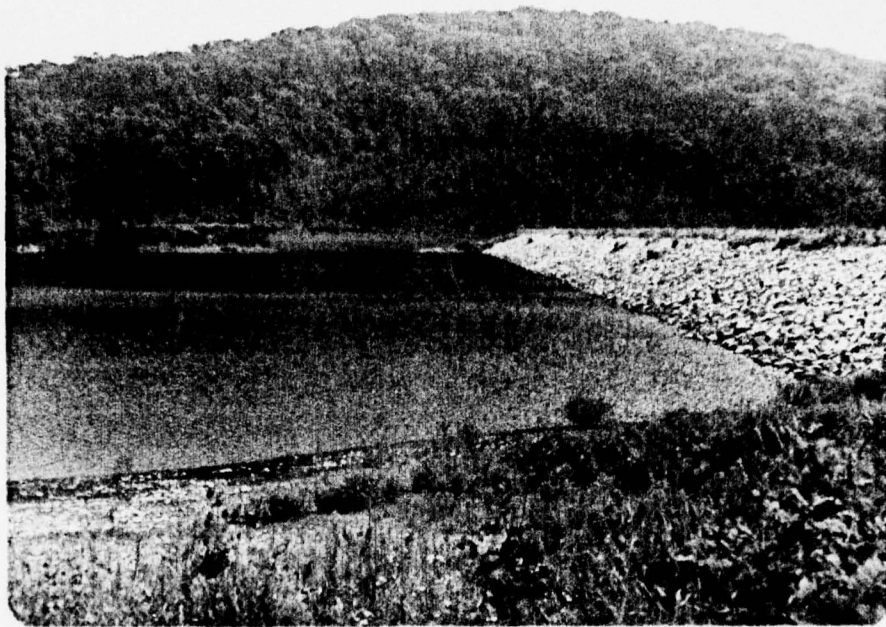
Upstream Face

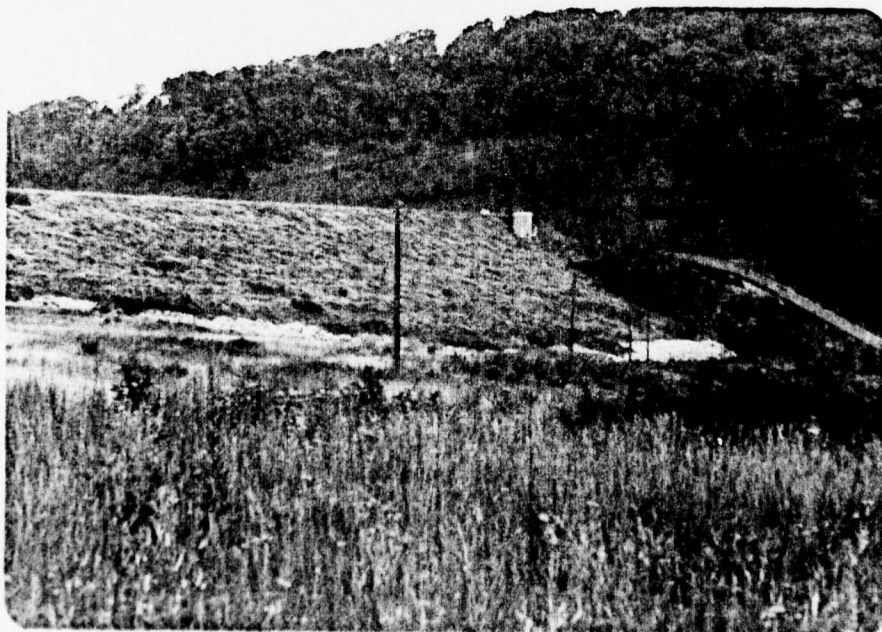
Downstream Face

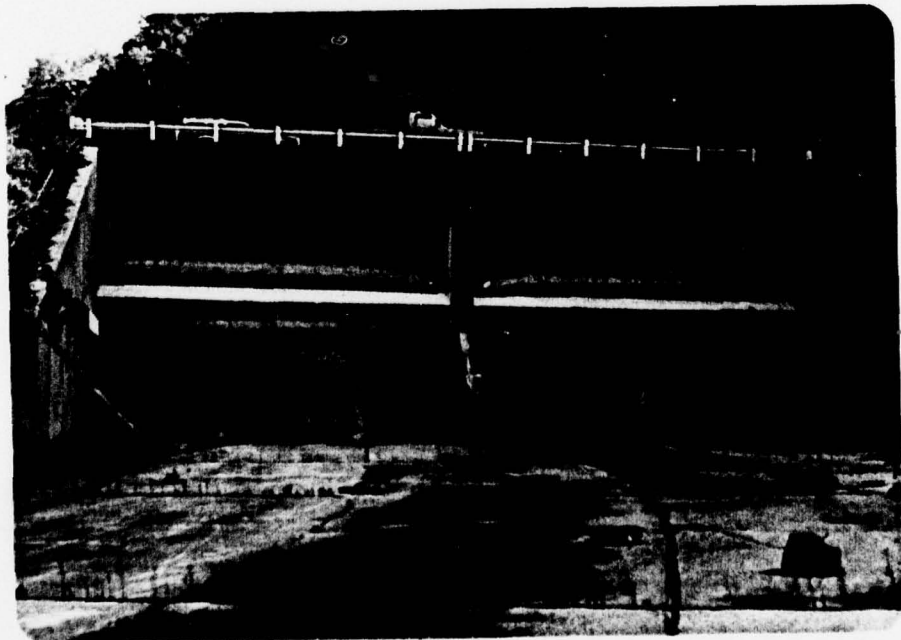
The inflatable gates were inflated by the authority personnel and were found to be functional. The maintenance condition of the control equipment for the gates is considered to be satisfactory. However, because a sudden release of water in the event of a failure of the spillway gates may cause property damage downstream by overflowing the channel on a residential area of Altoona and considering the unique nature of the Fabridam spillway gates, it is considered advisable that these facilities be periodically inspected by engineers experienced in design and installation of such equipment.

Photograph No. 2  
Spillway crest (note inflatable spillway gates).

Because sudden release of water in the event of a failure of the Fabridam spillway gates may cause property damage downstream and because of the unique nature of these gates, this appurtenance should be frequently inspected by personnel experienced in design, construction, maintenance, and operation of such equipment.

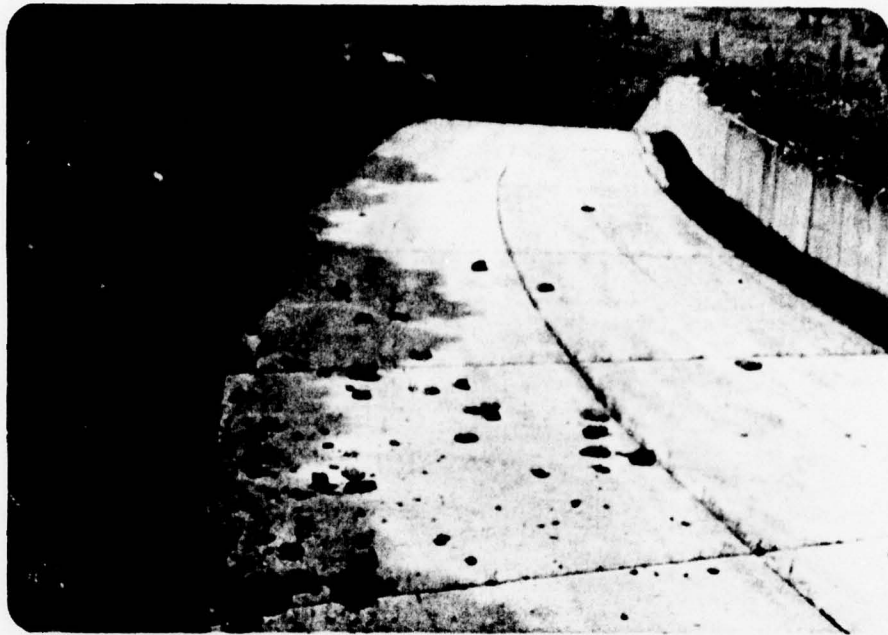
Photograph No. 3

In general, the structures were found to be in good condition. However, a steep rock cut along the spillway approach channel and discharge chute is considered to pose a potential for partial blockage of these channels in the event of a significant rock slide. Boulders in the approach channel and spillway chute demonstrate this potential.

Spillway discharge channel (note fallen rocks from rock cut).

It is recommended that seepage from the sand drains be monitored and recorded. The steep rock cut along the spillway should be frequently observed and necessary remedial measures taken to prevent rock slides that may partially block the spillway channel.

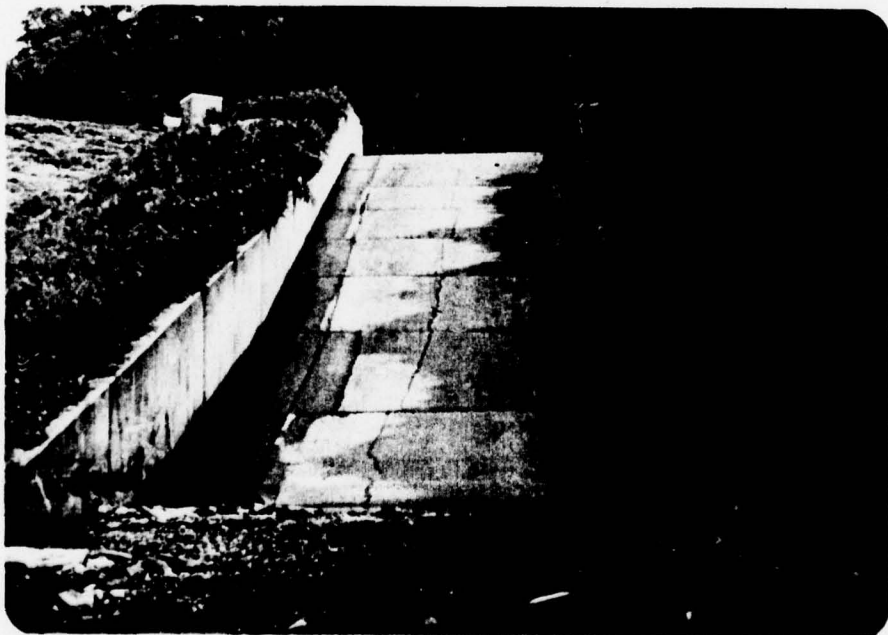
Photograph No. 4

Flow into the spillway discharge channel was estimated to be 10 to 15 gallons per minute. All the observed seepages were found to be clear.

Spillway discharge channel and plunge pool.

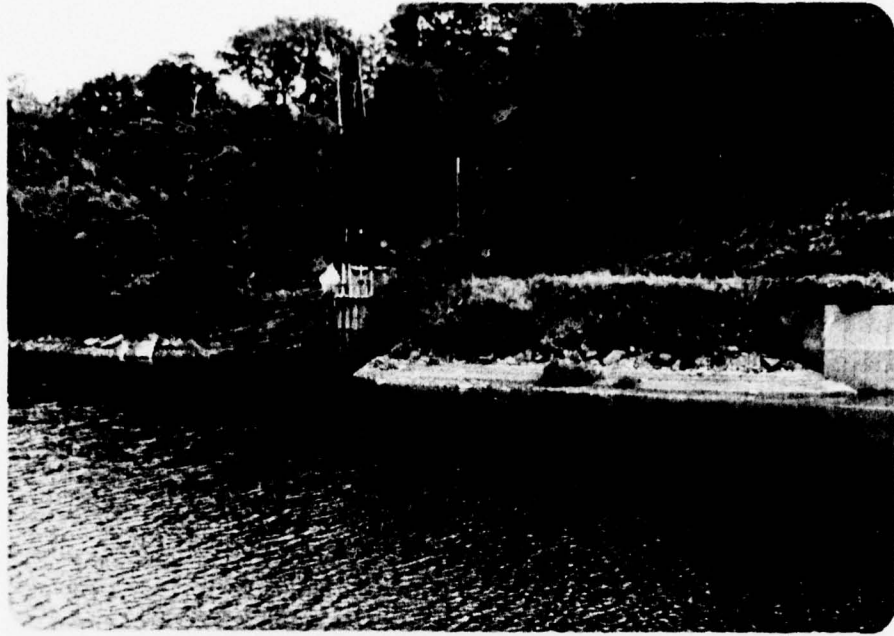
Photograph No. 5  
Intake tower.

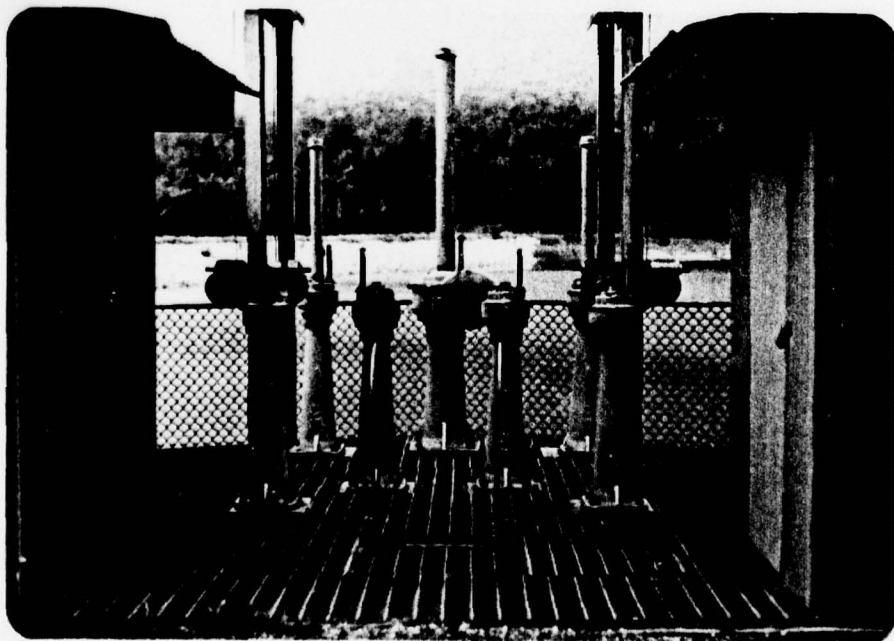
Photograph No. 6  
Intake tower gate controls.

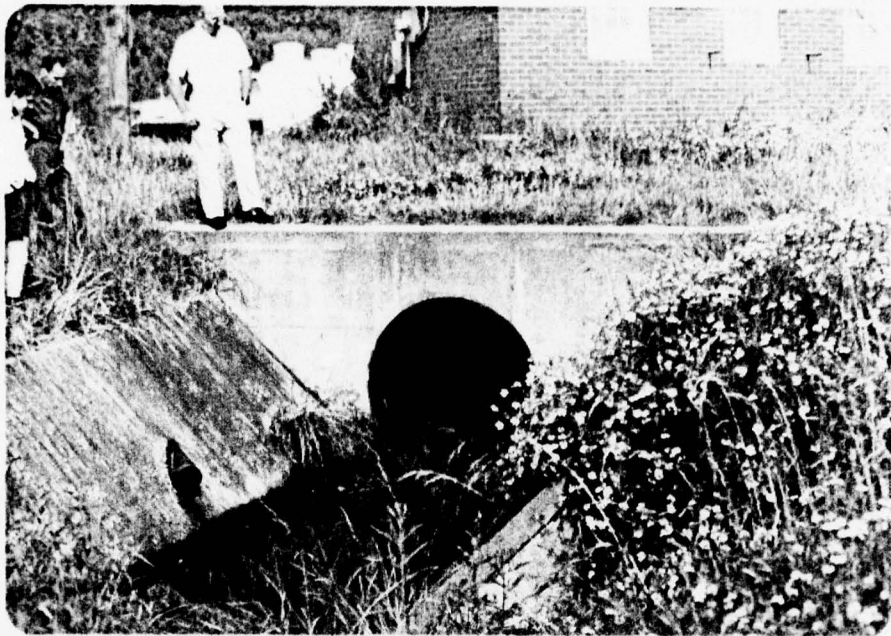
Photograph No. 7  
Lake blow-off pipe.

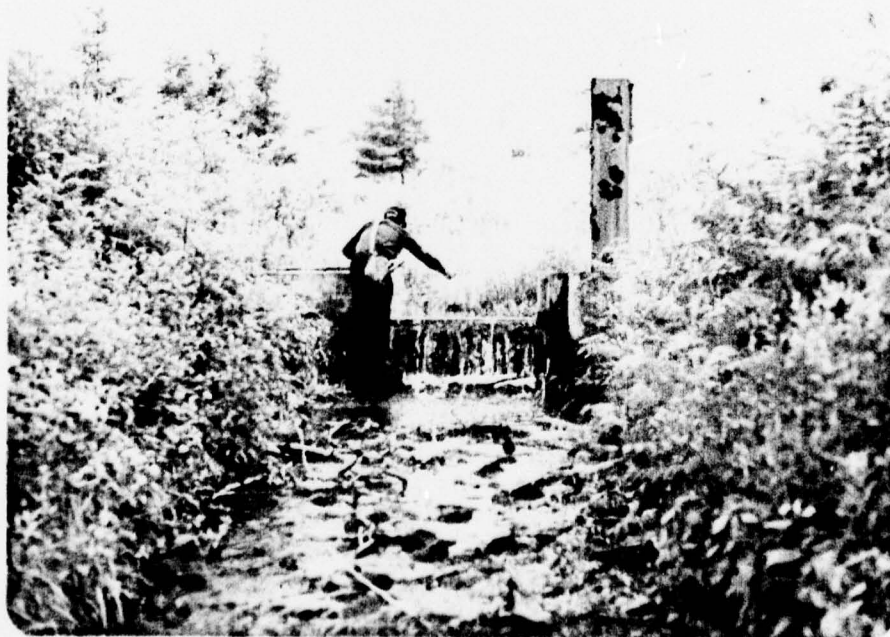
3.2 Evaluation. In general, the condition of the dam is considered to be good. The quantity of seepage from the dam (165 gpm) on the date of inspection was found to be within the limits of reported past seepage flow. Seepage was clear and no signs of internal erosion were found. A remote seepage monitoring device installed on the access to the discharge channel was found to be nonfunctional. The water authority personnel reported that seepage flows are not being recorded.

Photograph No. 8  
Seepage weir.

4.2 Maintenance of the Dam. The general condition of the dam is considered to be satisfactory. However, it is considered necessary to resume monitoring seepage flows from the sand drains to determine that the rate of flow is not increasing with time.

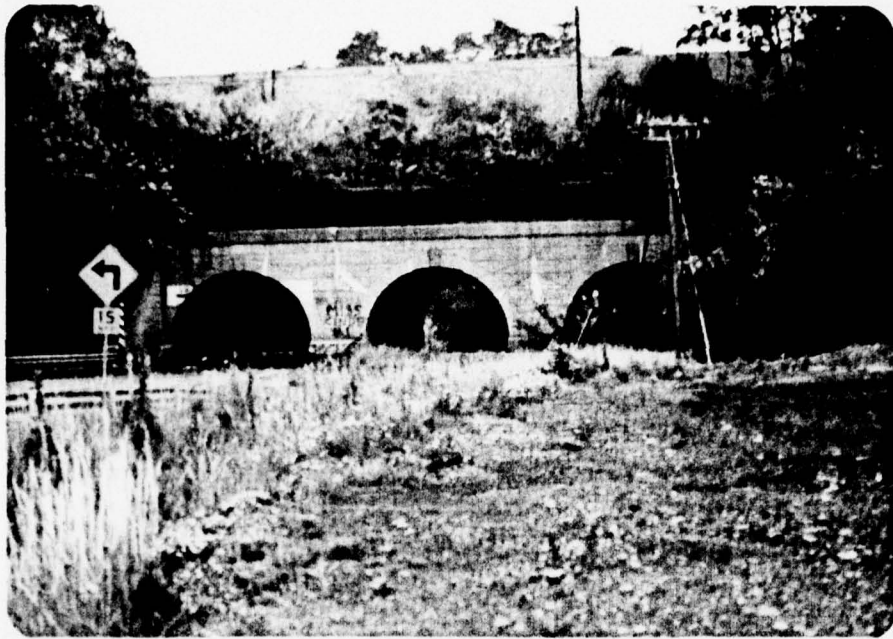
Photograph No. 9

Penn-Central Railroad embankment (2 miles downstream;  
stream flows through middle arch).

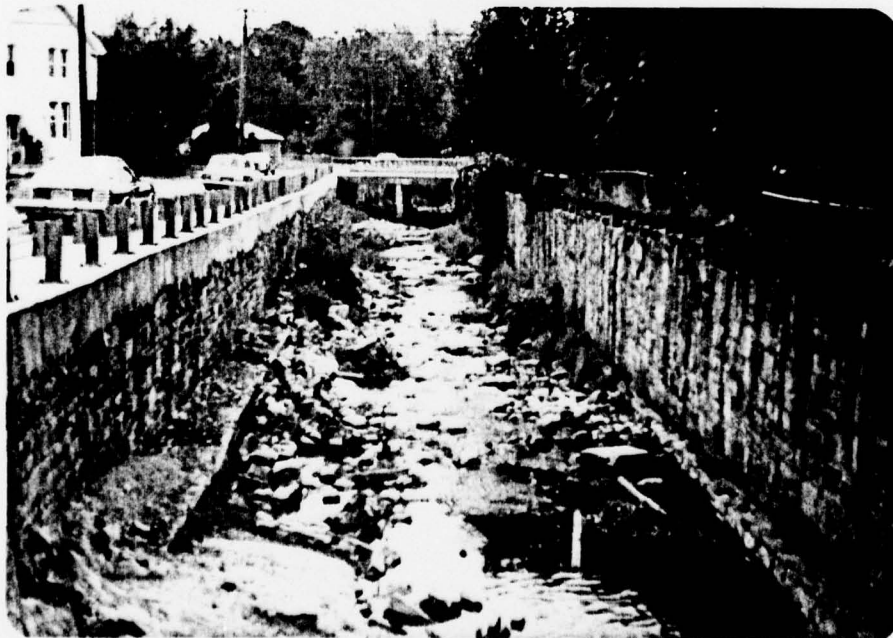
Photograph No. 10

Typical stream channel through Altoona.
