JOHN C. SMITH DAM

NDI ID NO: 238

PHASE I INSPECTION REPORT.

NATIONAL DAM INSPECTION PROGRAM

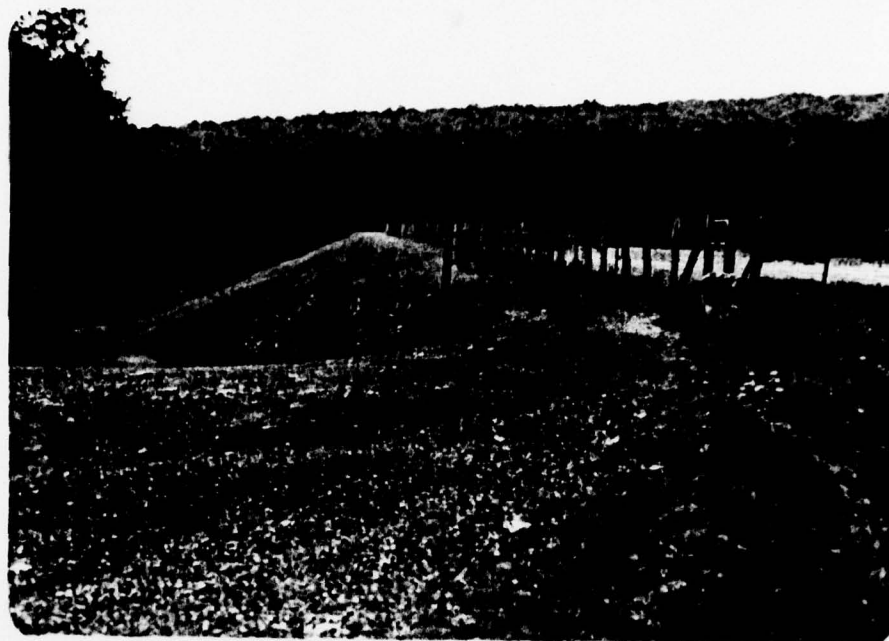
Photograph No. 1
Crest (looking east).

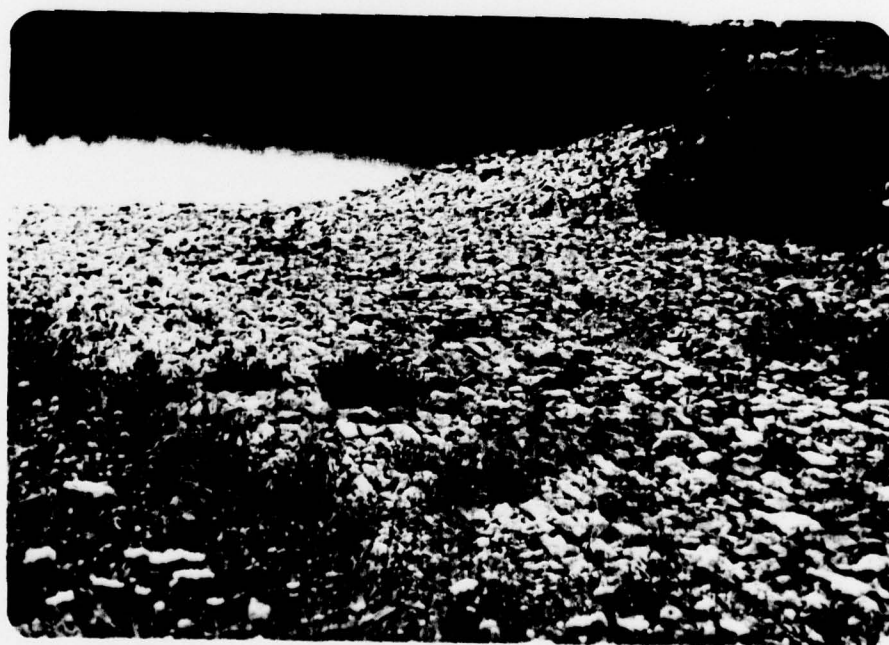
Photograph No. 2
Spillway approach channel.

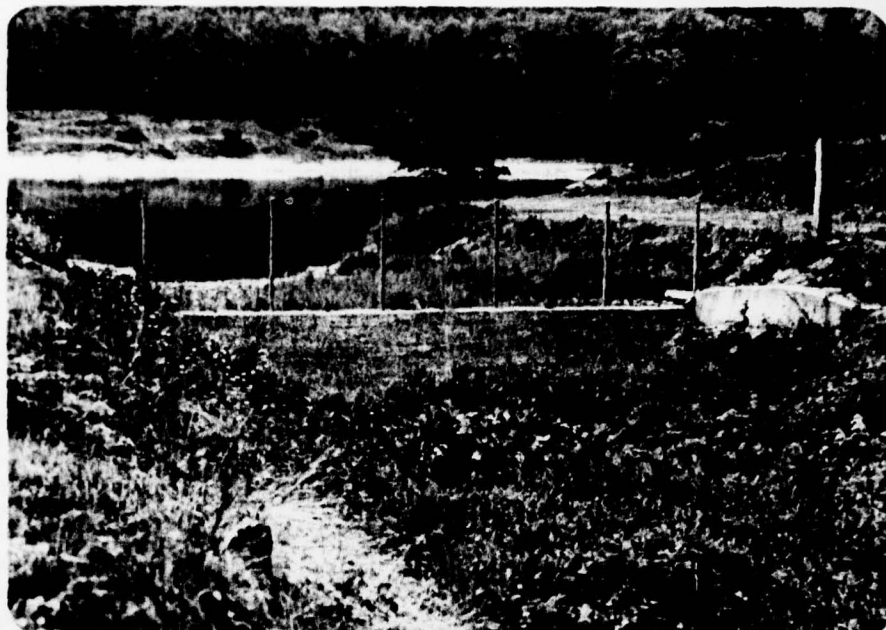
Photograph No. 3
Spillway crest.

VISUAL EXAMINATION OF	OBSERVATIONS	REMARKS OR RECOMMENDATIONS
CONCRETE WEIR	Concrete overflow section. There is a barbed wire fence across the spillway crest.	
APPROACH CHANNEL	Trapezoidal ripped channel	
DISCHARGE CHANNEL	Natural ravine	
BRIDGE AND PIERS	There is a bridge across the discharge channel of the spillway approximately 50 feet downstream from the crest of the spillway.	This bridge constitutes a potential for blockage of the spillway.

The barbed wire fence across the crest of the spillway and the bridge across the discharge channel are considered to pose a potential for blockage of the spillway with debris in the event of a flood. It is therefore recommended that the barbed wire fence be immediately removed and the need for enlarging the bridge span should be investigated.

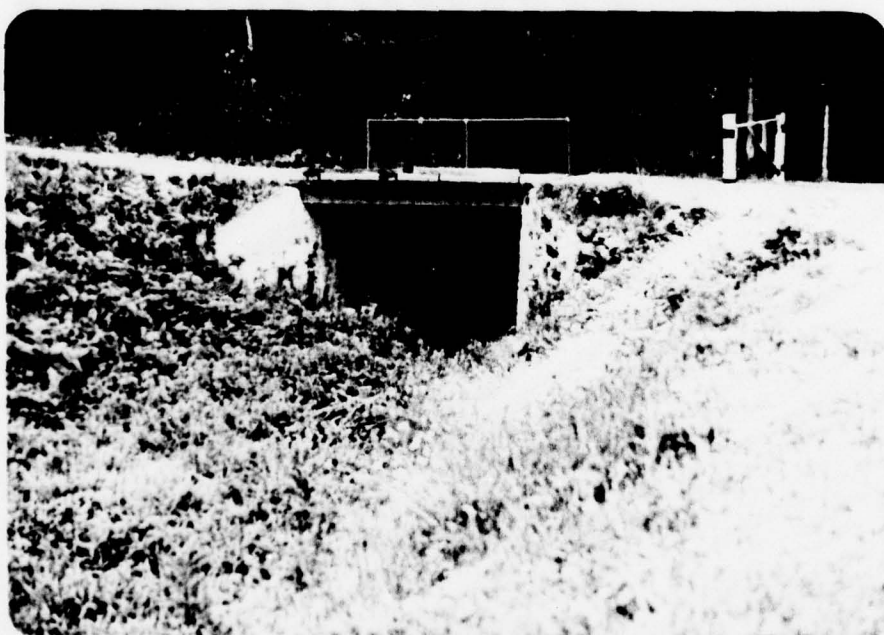
Photograph No. 4
Bridge over spillway discharge channel
(about 50 feet downstream from the
spillway crest).

The most significant condition at the dam is found to be potential blockage of the spillway with debris due to the presence of a barbed wire fence across the spillway crest and a small bridge spanning the spillway discharge channel.

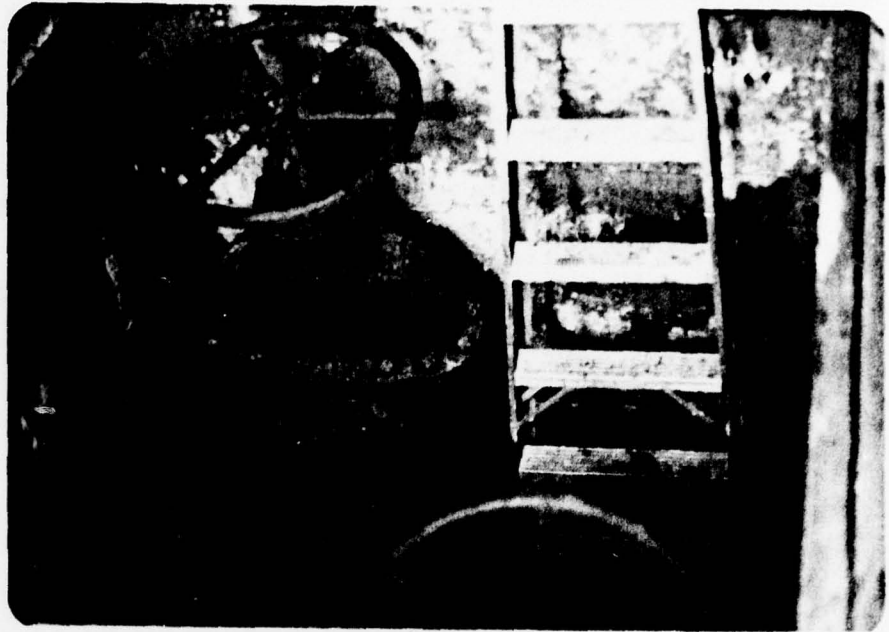
Photograph No. 5
Outlet pipe valve at valve house.

4.3 Maintenance of Operating Facilities. The maintenance condition of the operating facilities is considered to be fair. The operation of the blow-off valve was not observed. However, subsequent to the field inspection, borough personnel reported that the blow-off valve was operated and observed to be functional. Borough personnel reported that one of the three abandoned steel pipes located on the upstream face of the dam contains the stem of the upstream control valve for the outlet pipe. However, no hoist mechanism exists for this gate and it is reported that it has not been operated in the recent past.

3. The owner should take necessary steps to repair the valve located on the upstream end of the drainpipe.
4. In view of the reported seepage condition through the left abutment, it is recommended that further studies be undertaken to assess the effect of this seepage condition on the performance of the embankment, in the event it is required to raise pool level above the normal pool elevation (approximately Elevation 1330) that has existed in the recent past.

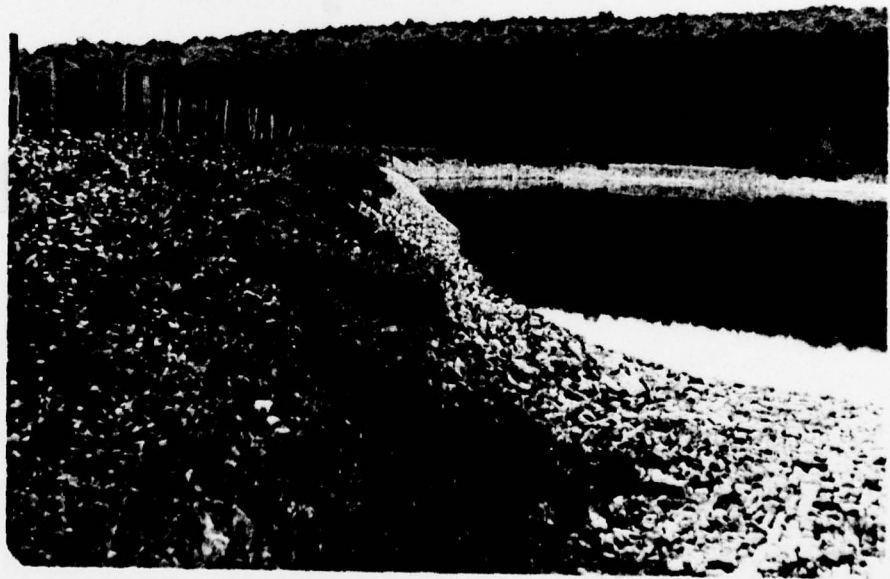
VISUAL EXAMINATION OF	OBSERVATIONS	REMARKS OR RECOMMENDATIONS
SURFACE CRACKS	None found	
UNUSUAL MOVEMENT OR CRACKING AT OR BEYOND THE TOE	A general depression exists on the upstream face near the spillway approach channel. However, no signs of distress were observed.	
SLOUGHING OR EROSION OF EMBANKMENT AND ABUTMENT SLOPES	None found	
VERTICAL AND HORIZONTAL ALIGNMENT OF THE CREST	No perceivable misalignment	
RIPRAP FAILURES	None

Photograph No. 6
Minor depression on upstream face.
