YELLOW CREEK STATE PARK DAM

NDI I.D. NO: 282

PHASE I INSPECTION REPORT NATIONAL DAM INSPECTION PROGRAM

D'APPOLONIA CONSULTING ENGINEERS
10 DUFF ROAD
PITTSBURGH, PA. 15235
SEPTEMBER 1978

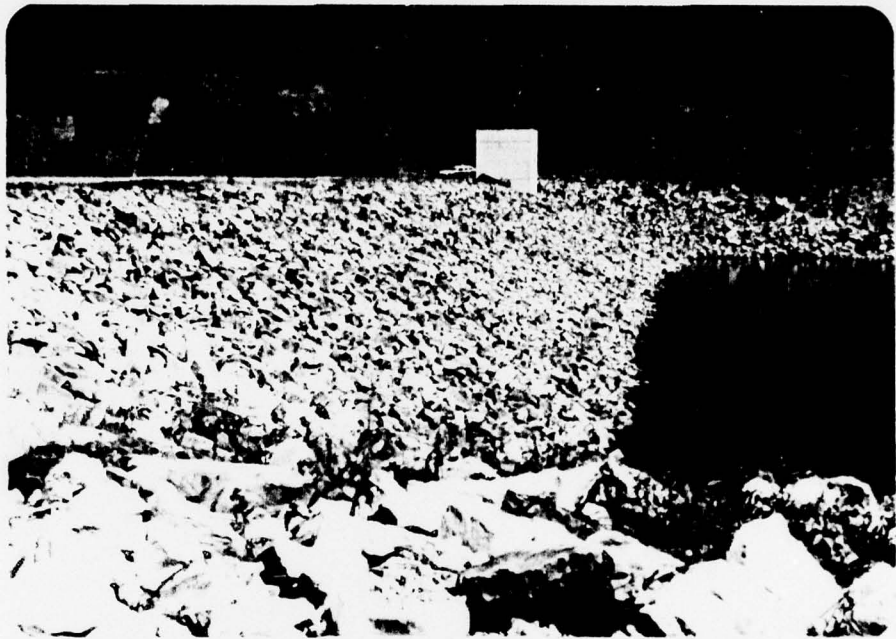
Upstream Face

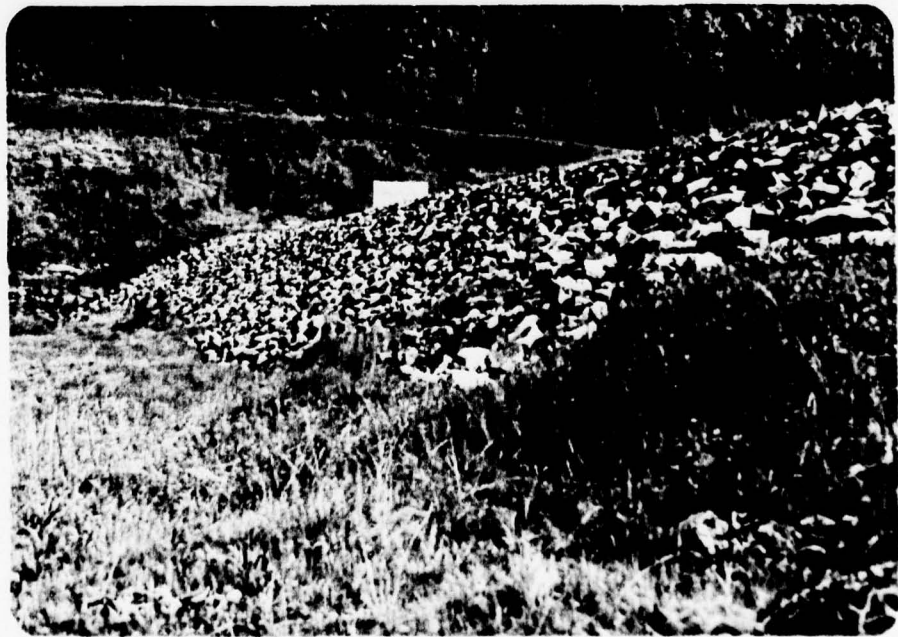
Downstream Face

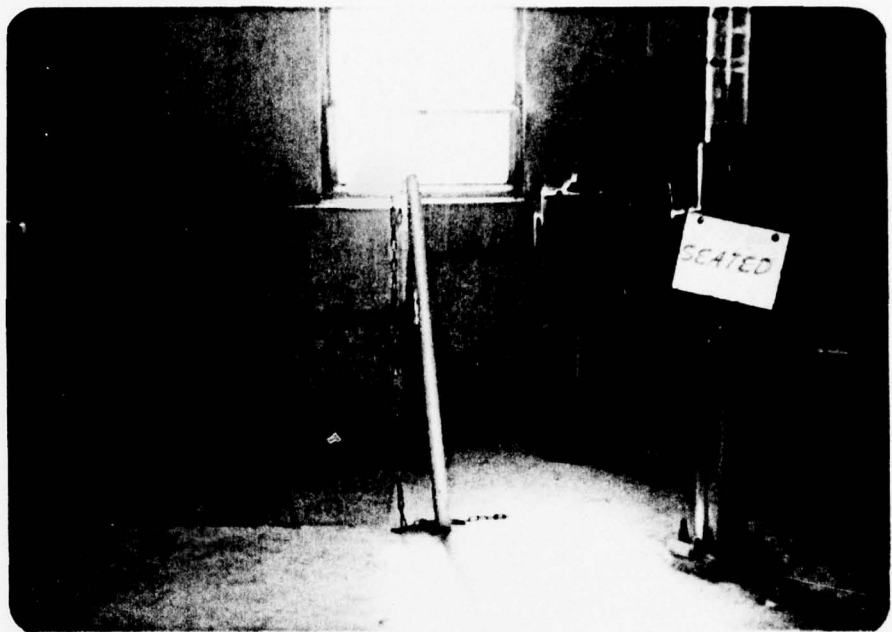
Photograph No. 3
Outlet pipe gate controls.

4.3 Maintenance of Operating Facilities. The maintenance of the operating facilities is considered to be fair. State park personnel reported that the bottom sill of the outlet conduit sluice gate has been displaced. Therefore, the sluice gate could not be completely closed. The inside of the control structure was observed and found to be in good condition. The outlet conduit sluice gate was operated and observed to be functional.

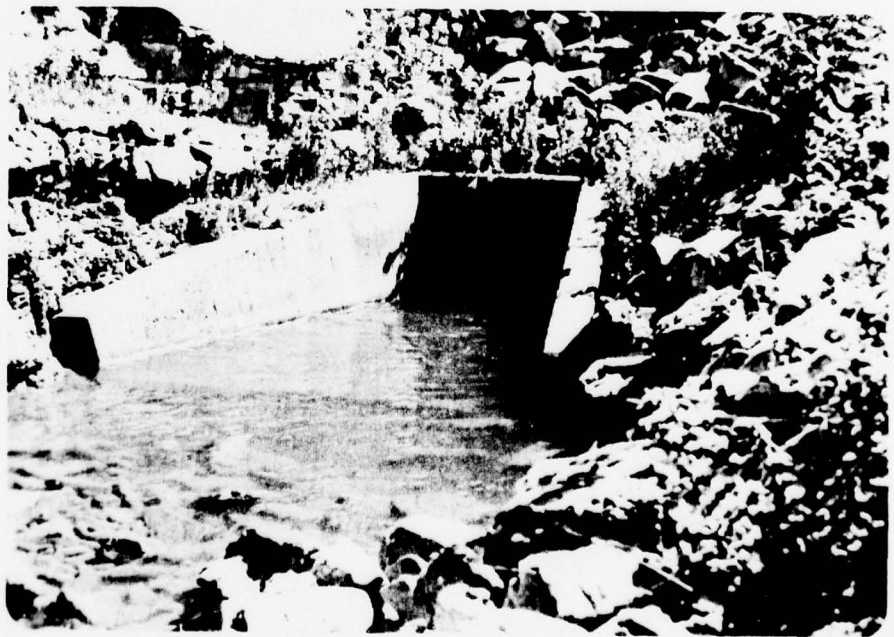
Photograph No. 4
Outlet pipe.

3.2 Evaluation. The condition of the dam is considered to be good. However, the rock erosion along the spillway walls should be repaired to avoid structural damage to the retaining walls. The outlet pipe was half-full due to the flow from the sluice gate; therefore, it was not inspected.

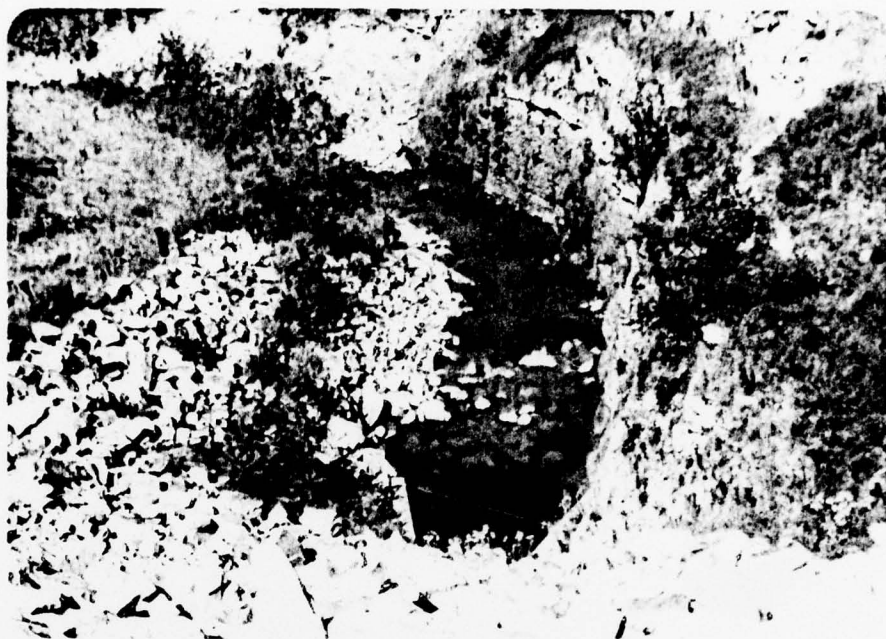
Photograph No. 5

c. Appurtenant Structures. The appurtenant structures were examined for deterioration or other signs of distress and obstructions that would limit flow. In general, the structures were found to be in good condition. Severe erosion of rock was observed along the concrete walls on the right side of the spillway discharge channel. Some sections of the wall foundations were exposed by three to four feet. This erosion reportedly occurred in July 1977. Minor rock slides were observed in the outlet works discharge channel. The appearance of the cut along the right side of the outlet works discharge channel suggested the potential for rock slides that could result in the blockage of the outlet works discharge channel.

Outlet pipe discharge channel (note
rock slide into channel).

3. The rock cut along the right side of the outlet works discharge channel should be periodically observed and necessary maintenance performed to avoid rock slides into the channel that may block the flow.
4. It is recommended that the outlet conduit sluice gate be repaired to permit adequate seating of the gate.
5. It is recommended that the owner develop a formal warning system to alert the downstream residents in the event of an emergency.
6. The owner should be advised that the dam and appurtenant structures should be inspected regularly and necessary maintenance should be performed.

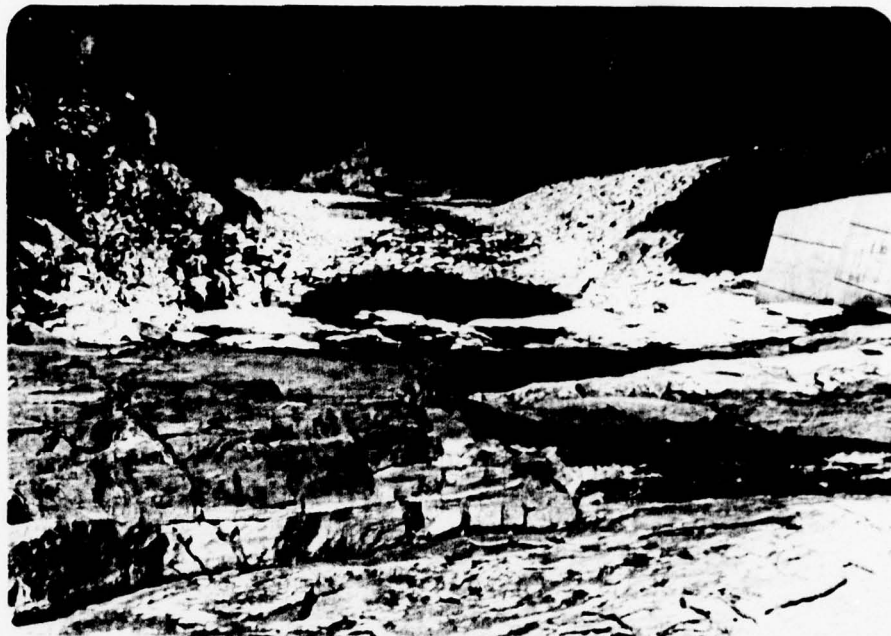
Photograph No. 7

Spillway channel (looking downstream).

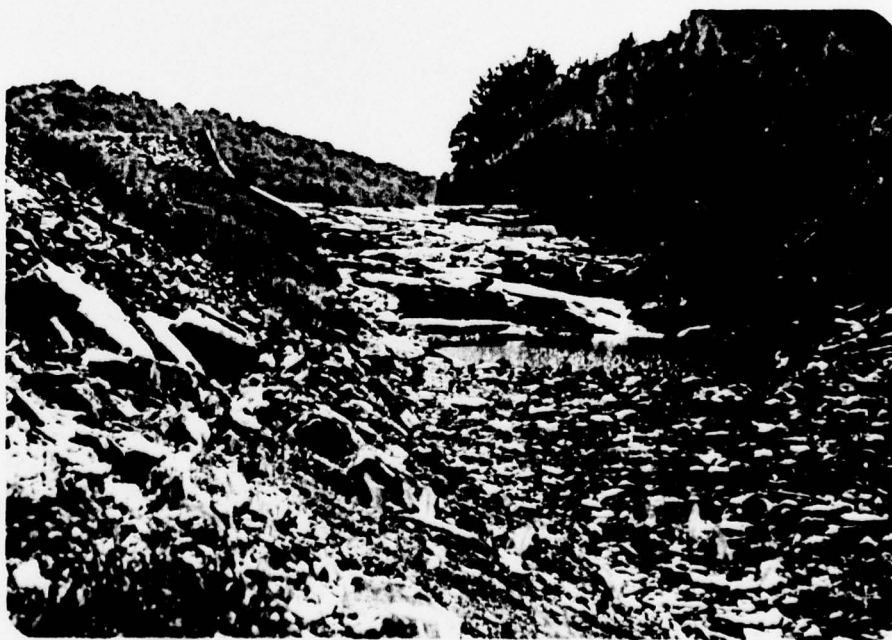
Photograph No. 8

Spillway channel (looking upstream).

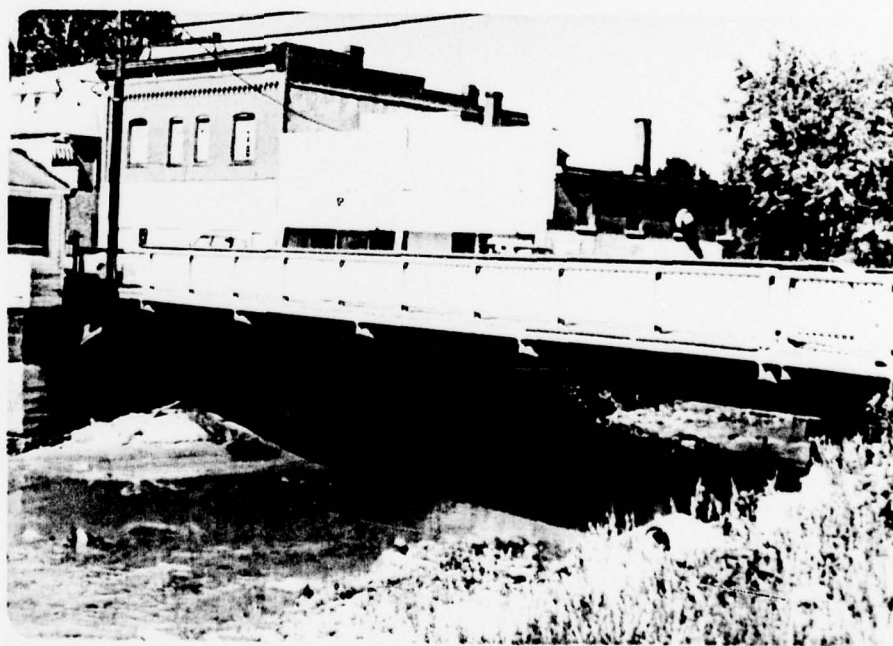
Photograph No. 10

Yellow Creek at Homer City.
