D'APPOLONIA CONSULTING ENGINEERS PITTSBURGH PA
NATIONAL DAM INSPECTION PROGRAM. SHAWNEE DAM (NDI-832). SUSQUEH--ETC(U)
SEP 78

SHAWNEE DAM

NDI I.D. NO: 832

**PHASE I INSPECTION REPORT
NATIONAL DAM INSPECTION PROGRAM**

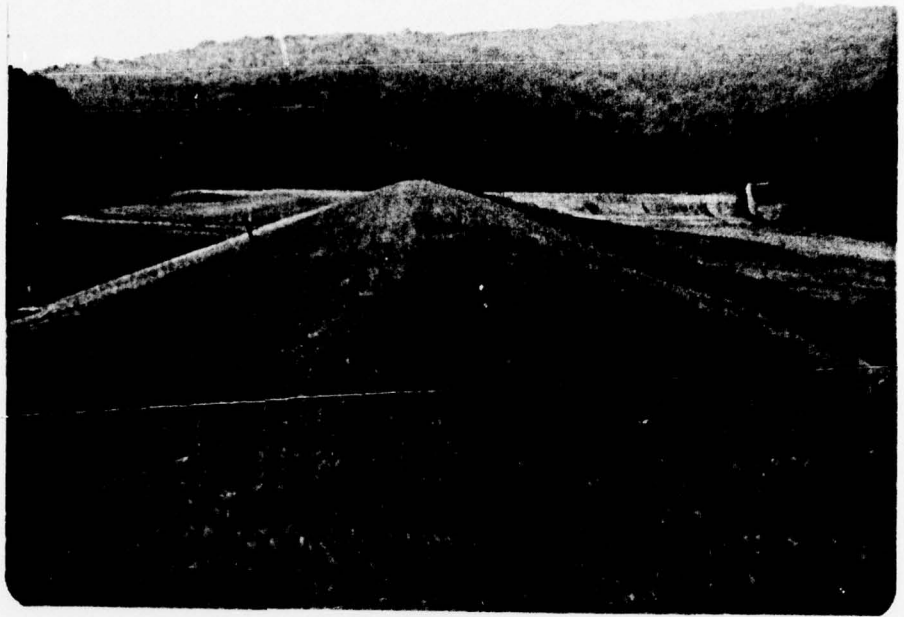
Photograph No. 1
Crest (looking northeast).

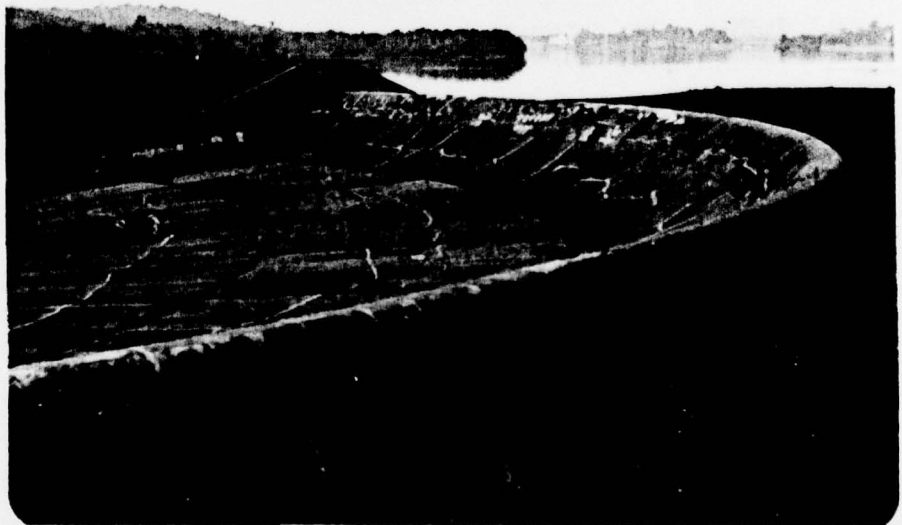
Photograph No. 2
Spillway crest.

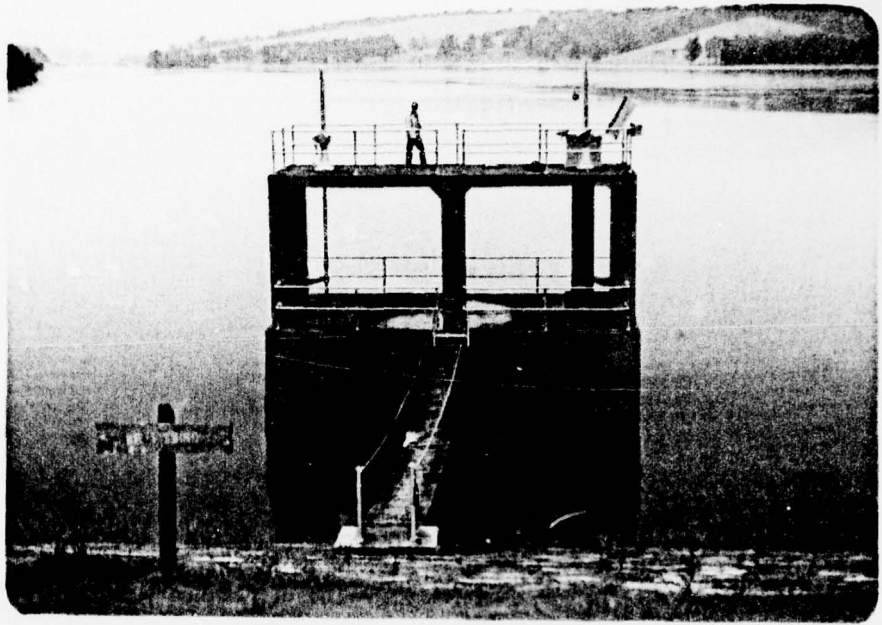
Photograph No. 3
Siphon spillway intake tower.

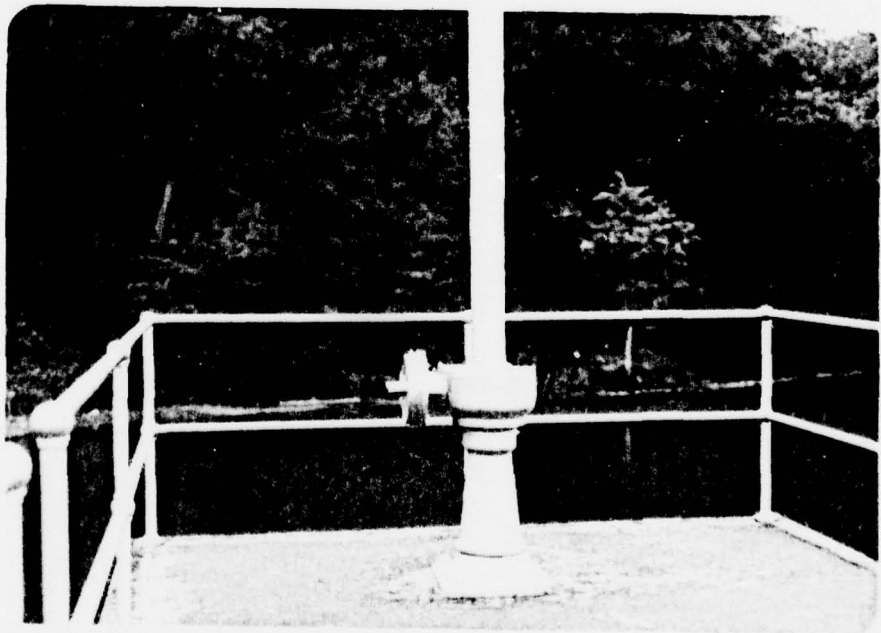
4.3 Maintenance of Operating Facilities. The field observations indicated that the operating facilities are adequately maintained. The low flow outlet sluice gates were operated and observed to be functional.

Photograph No. 4
Outlet gate hoist.

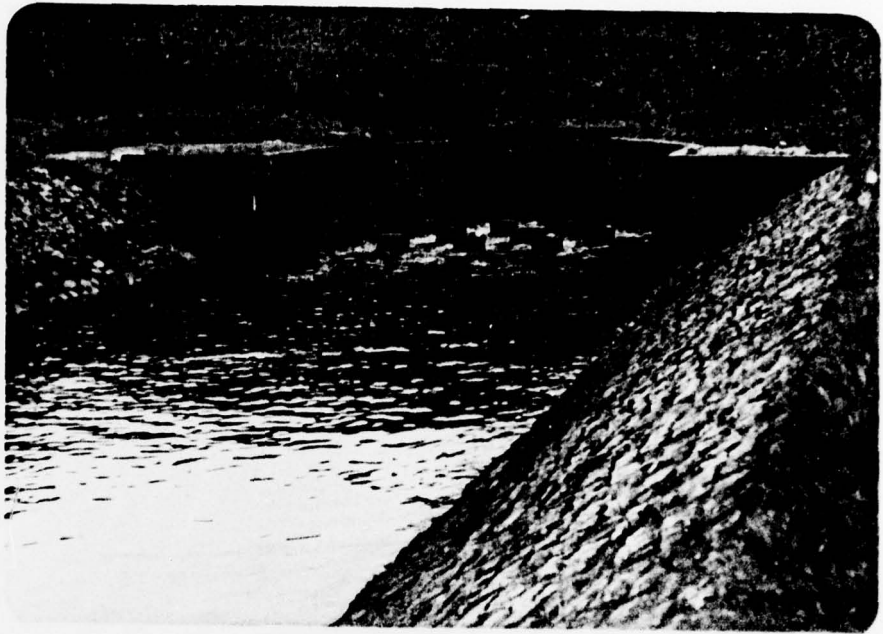
VISUAL EXAMINATION OF	OBSERVATIONS	REMARKS OR RECOMMENDATIONS
CRACKING AND SPALLING OF CONCRETE SURFACES IN OUTLET CONDUIT	6-foot by 10-foot reinforced concrete culvert. In good condition. The construction joints are wet but there is no measureable seepage.	
INTAKE STRUCTURE	Most of the structure is submerged. The visible portions are in good condition.	
OUTLET STRUCTURE	Stilling basin; good condition.	
OUTLET CHANNEL	Trapezoidal masonry channel; free of debris; no apparent obstructions.	
EMERGENCY GATE	The sluice gates were operated by the state personnel and observed to be functional.

Photograph No. 5
Outlet conduit.

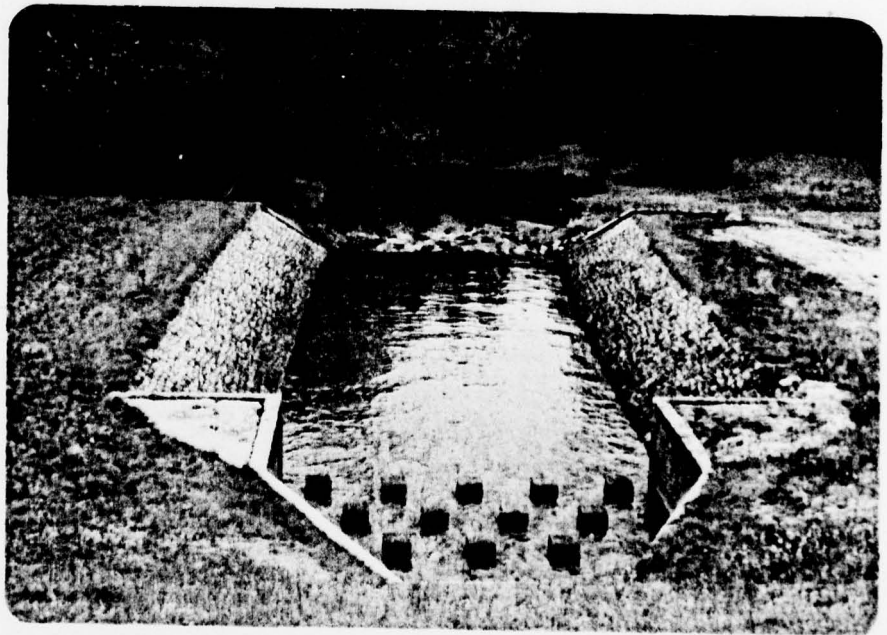
Photograph No. 6
Outlet conduit discharge channel.

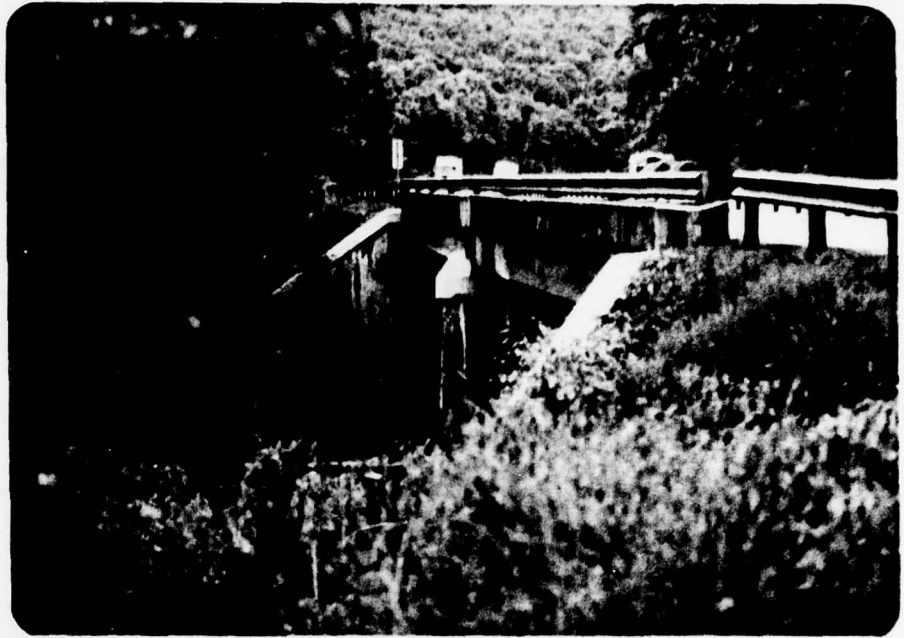
Photograph No. 7

Bridge on Pennsylvania Turnpike over
Shawnee Branch (one mile downstream).

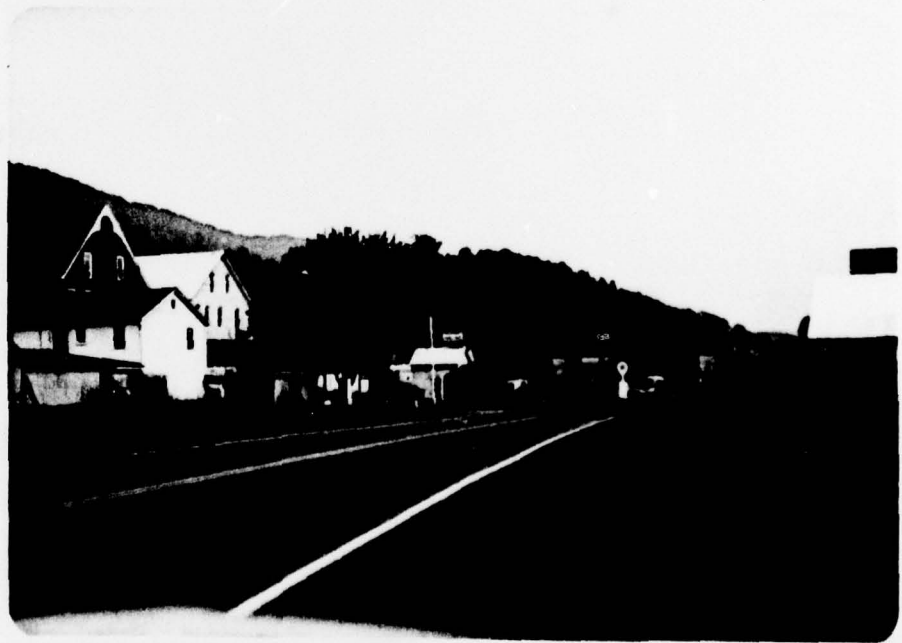
Photograph No. 8

Town of Manns Choice (two miles downstream
along Raystown Branch of the Juniata River).
