TITICUS DAM

**WESTCHESTER COUNTY, NEW YORK
INVENTORY NO. 50**

**PHASE I INSPECTION REPORT
NATIONAL DAM SAFETY PROGRAM**

Name of Dam: TITICUS DAM (I.D. No. 50)
State Located: NEW YORK STATE
County Located: WESTCHESTER COUNTY
Stream: TITICUS RIVER
Date of Inspection: 24 APRIL 1978

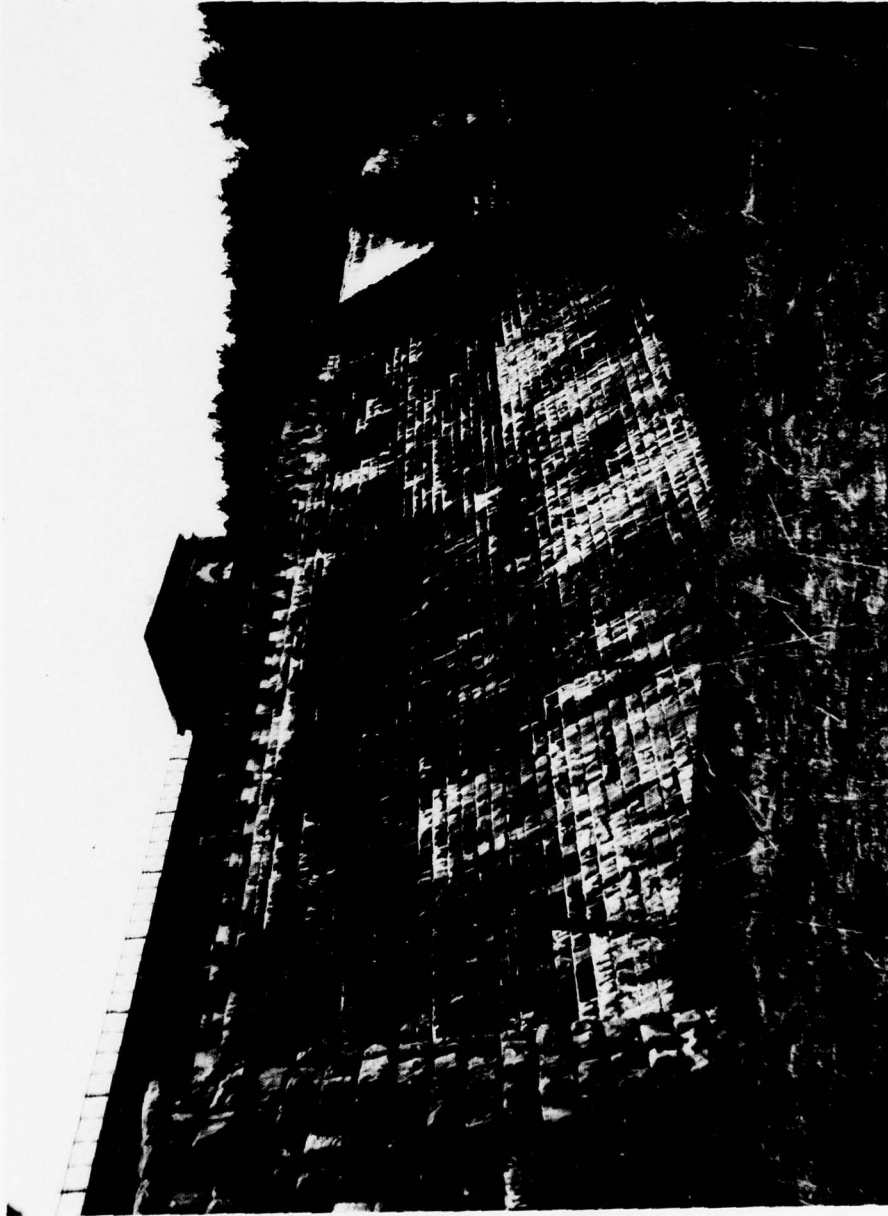
OVERVIEW OF MASONRY DAM AND SPILLWAY

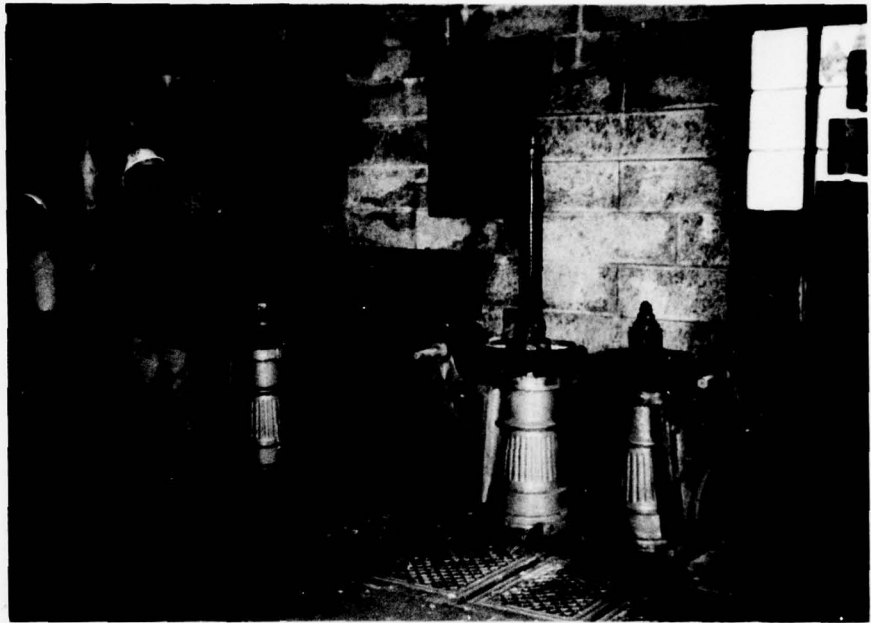
GATE OPERATING STANDS, SOUTH DIVISION OF GATEHOUSE

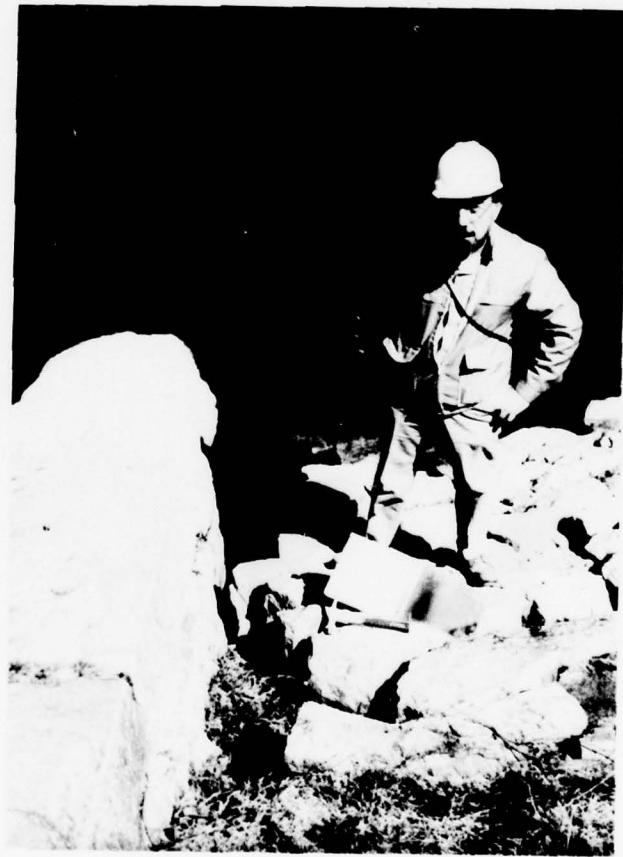
There was no sign of sloughing, erosion, cracking or other distress on the upstream slope and visible portion of the riprap of the north embankment. There are indications of minor downslope movement of the riprap, below the top course of stone, on the south embankment near the spillway approach wall. The affected area is limited to a section from the wall to a distance 25 ft south of the wall, with the maximum downslope movement of 1.0 to 1.5 ft occurring at a location approximately 15 ft south of the wall. There appears to be a 4 to 9 inch separation between the north edge of the riprap paving stones and the south face of the south spillway approach wall.

SEPARATION OF RIPRAP FROM S. SPILLWAY APPROACH WALL, SOUTH EMBANKMENT

(a) Condition of Riprap Generally good, except for 25 ft
section on south embank. abutting spillway
approach wall, 9 inch u/s movement

4. Junctions with Abutments or Embankments Generally good except at spillway left approach wall, where there is 3-9" gap between riprap and wall
5. Drains - Foundation, Joint, Face None under Masonry dam. Some seepage from D/S retaining walls; from cracks & weep holes on north side, from joints on south side
6. Water Passages, Conduits, Sluices Water passages could not be inspected.

- a. Monitoring of riprap and cracking of the masonry retaining walls, as called for in Section 3.2, should be initiated and continued on a periodic basis.
- b. Heavy brush, shrubs and saplings should be removed from all locations on the embankment dams.

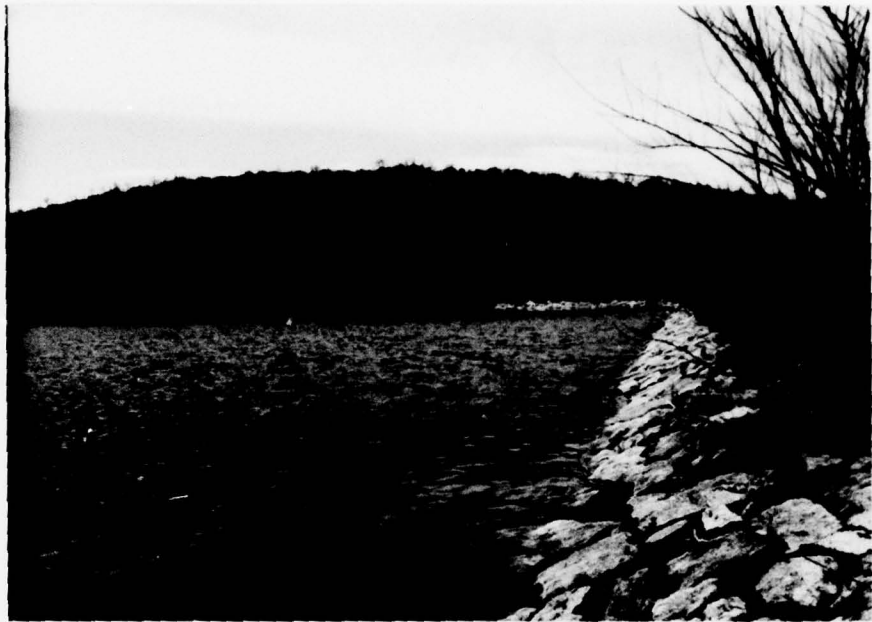
UPSTREAM SLOPE OF NORTH EMBANKMENT

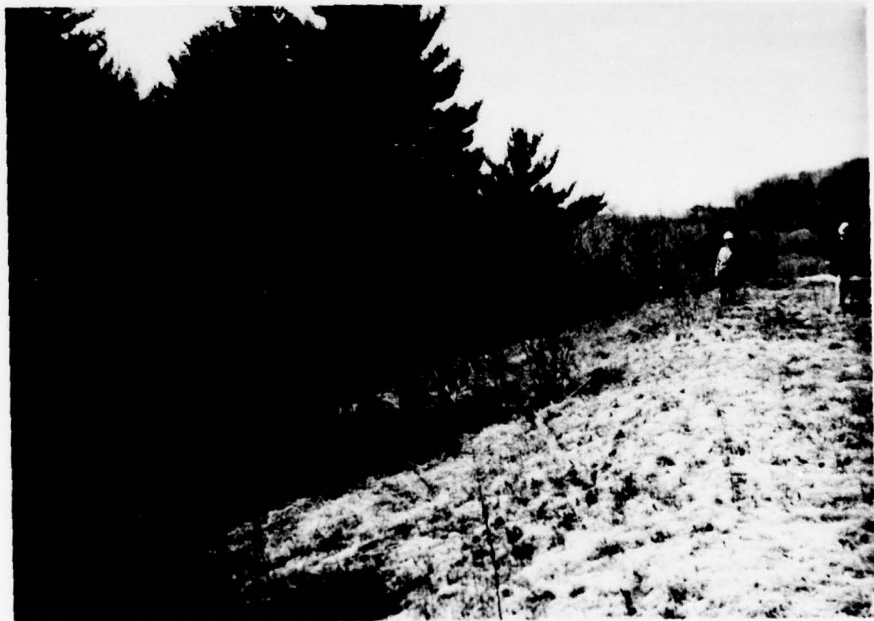
DOWNSTREAM SLOPE OF SOUTH EMBANKMENT
