CARMEL DAM  
(WEST BRANCH RESERVOIR)

PUTNAM COUNTY, NEW YORK  
INVENTORY NO. 29

PHASE I INSPECTION REPORT  
NATIONAL DAM SAFETY PROGRAM

MAY 24, 1978

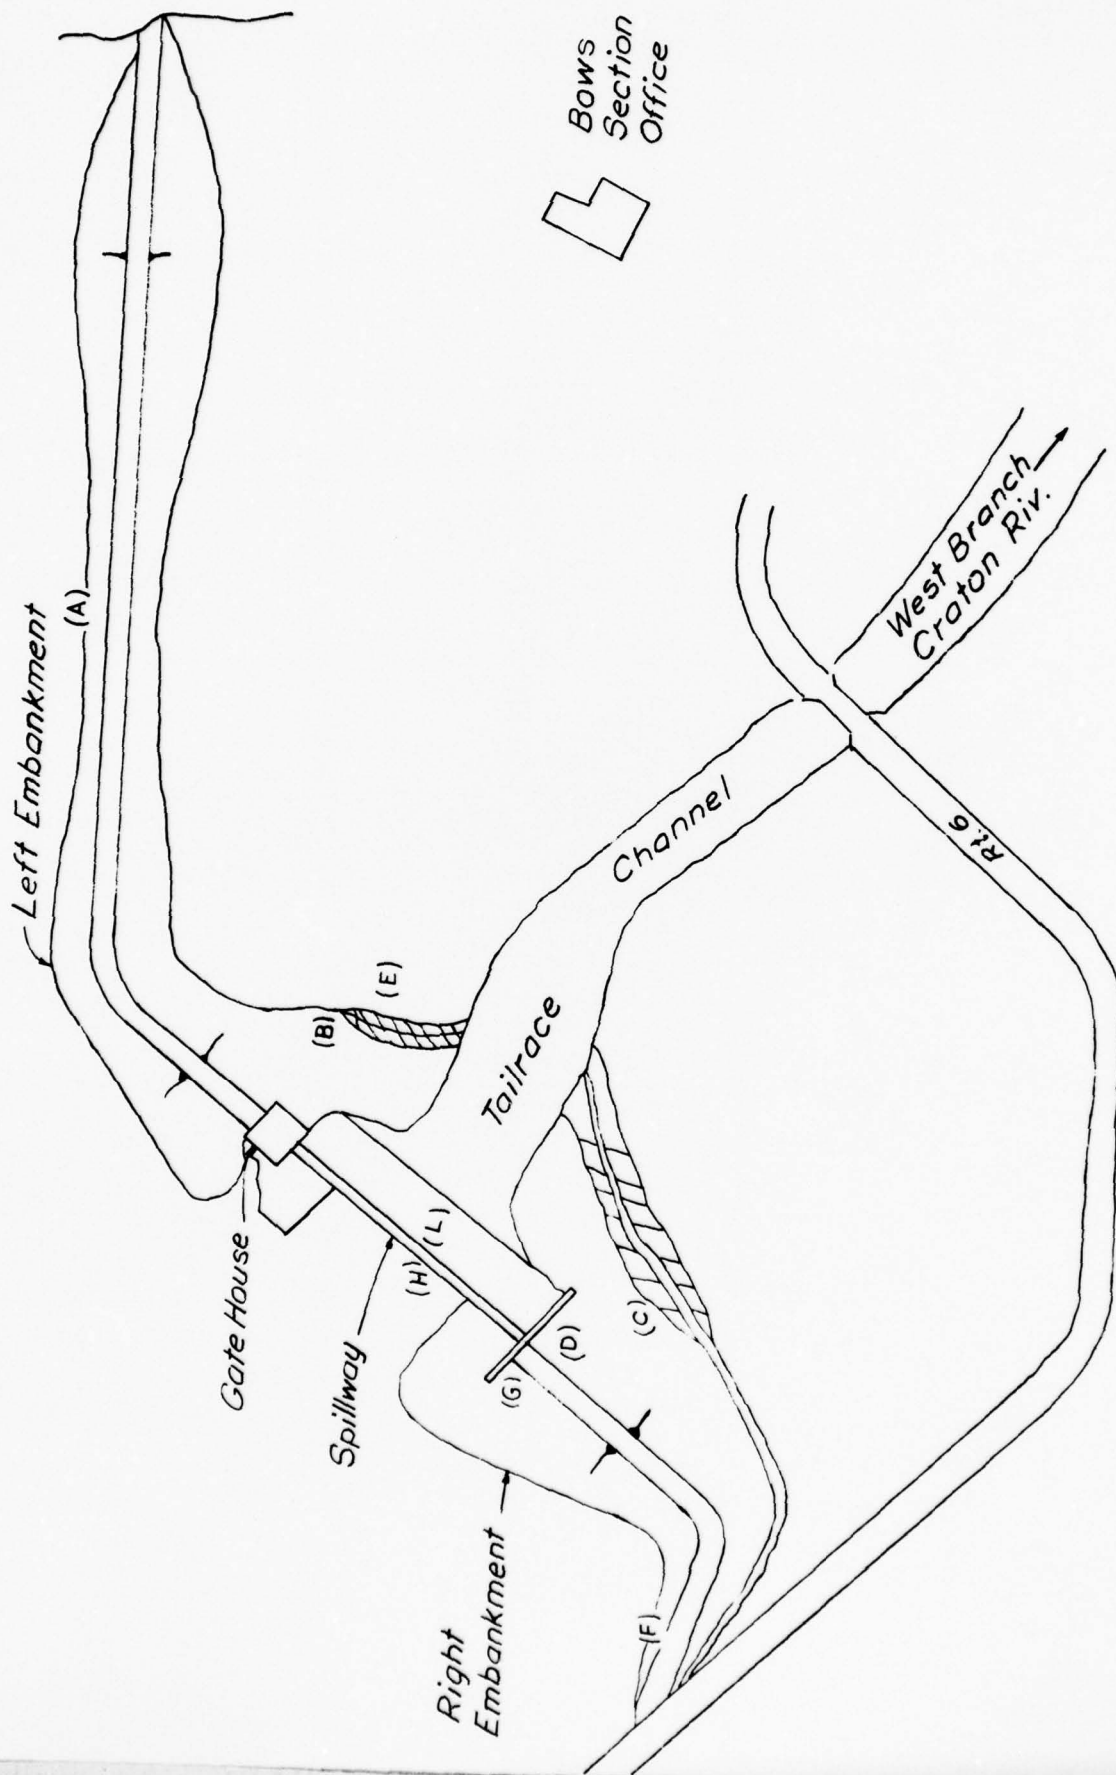
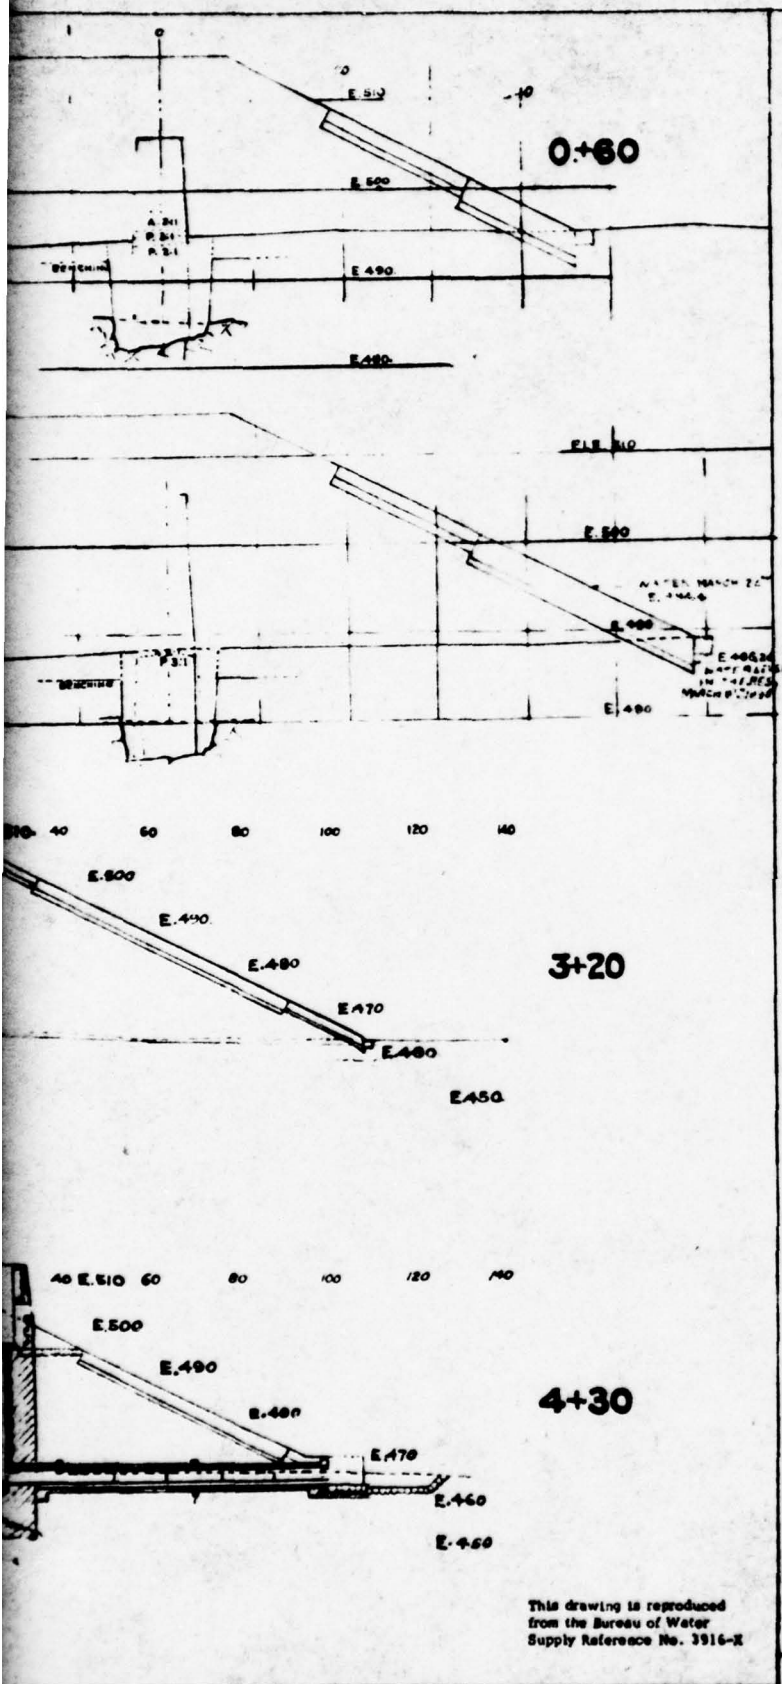
LOCATIONS OF OBSERVATIONS  
WEST BRANCH RESERVOIR  
MAIN CARMEL DAM  
NOT TO SCALE

The letters in parenthesis indicate the locations of observations listed in Chapter 3.1.

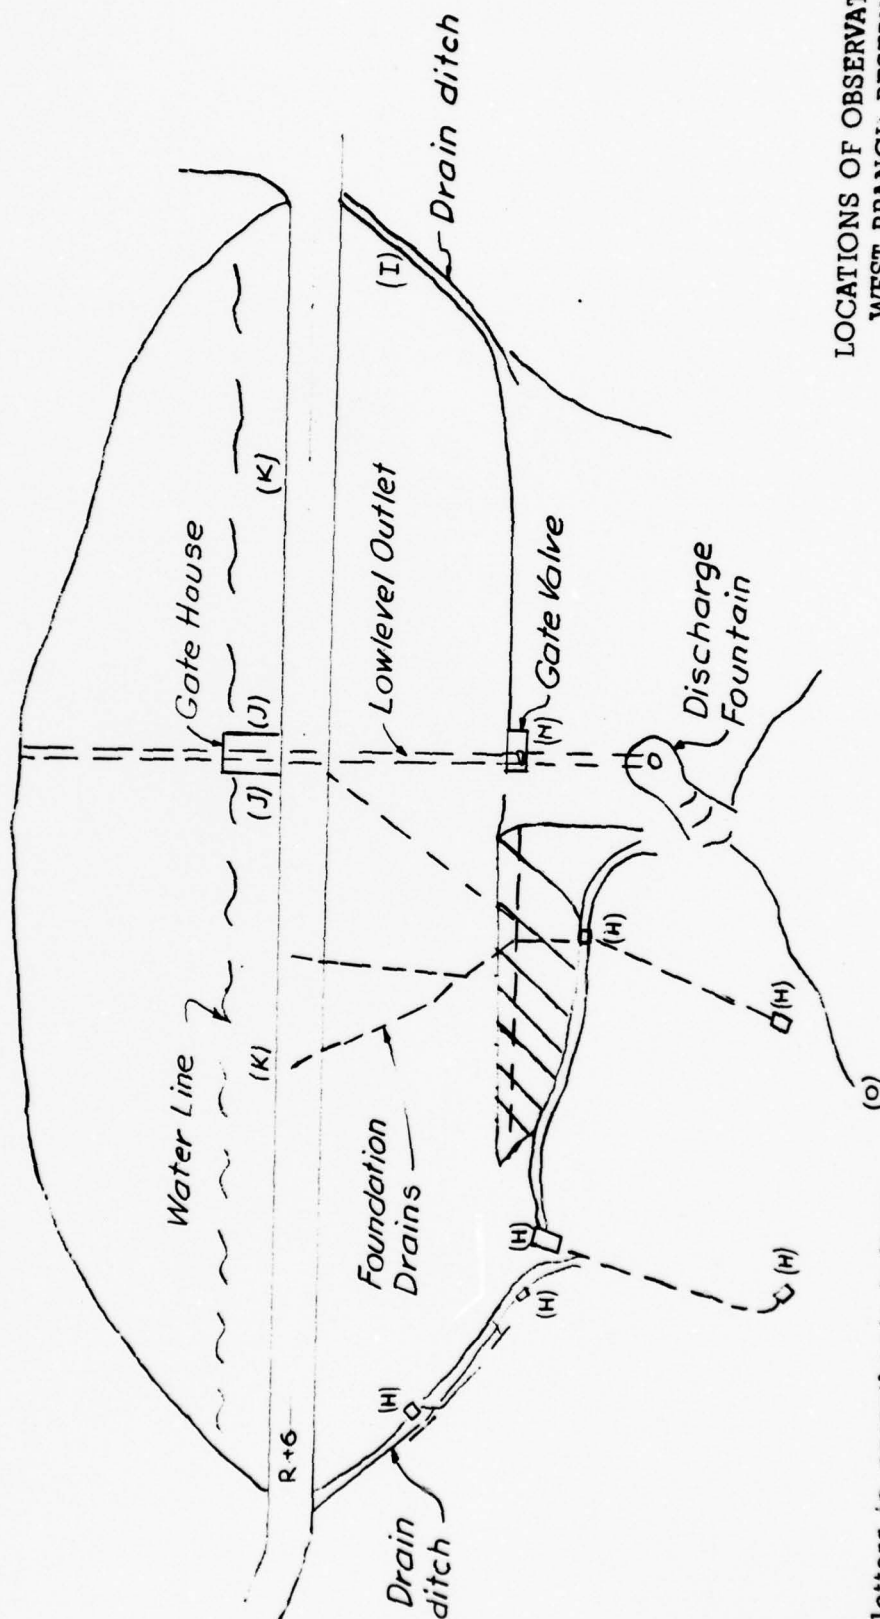
LOCATIONS OF OBSERVATIONS  
WEST BRANCH RESERVOIR  
AUXILIARY DAM  
NOT TO SCALE

The letters in parenthesis indicate the locations of observations listed in Chapter 3.1.

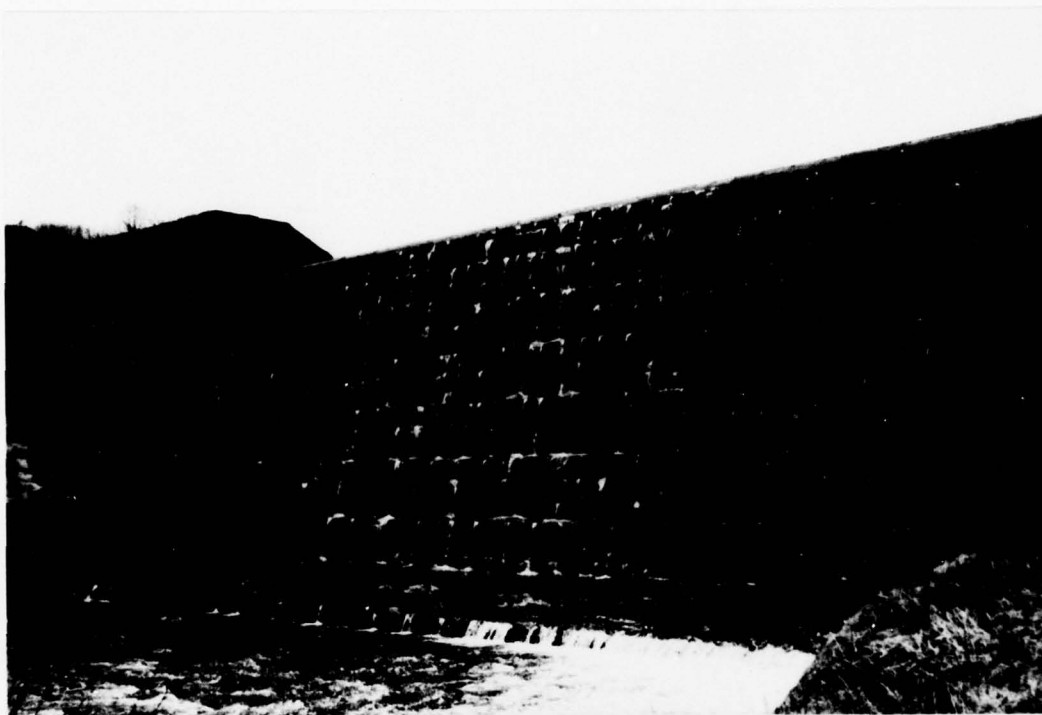
The seepage through the spillway structure appears to enter the structure through the joints of the two top rows of dislocated surface stones. The water either surfaces downstream of these two rows of stones or continues downward behind the facing stones and exits through the joints at lower levels. While this condition does not appear to represent imminent danger, if left unattended, may lead to further damage to the structure, particularly when subjected to freezing and thawing cycles.

DOWNSTREAM SLOPE OF SPILLWAY SHOWING  
SEEPAGE FLOW [OBSERVATION (L)]  
(CARMEL MAIN DAM)

- a. The stonework, serving as spillway facing needs to be repaired in order to correct the seepage condition noted at locations (L) and (M).
- b. The seepage and wet conditions noted at locations (B) and (C) should be systematically observed and possibly corrected by trench drains or protected by filter blankets.

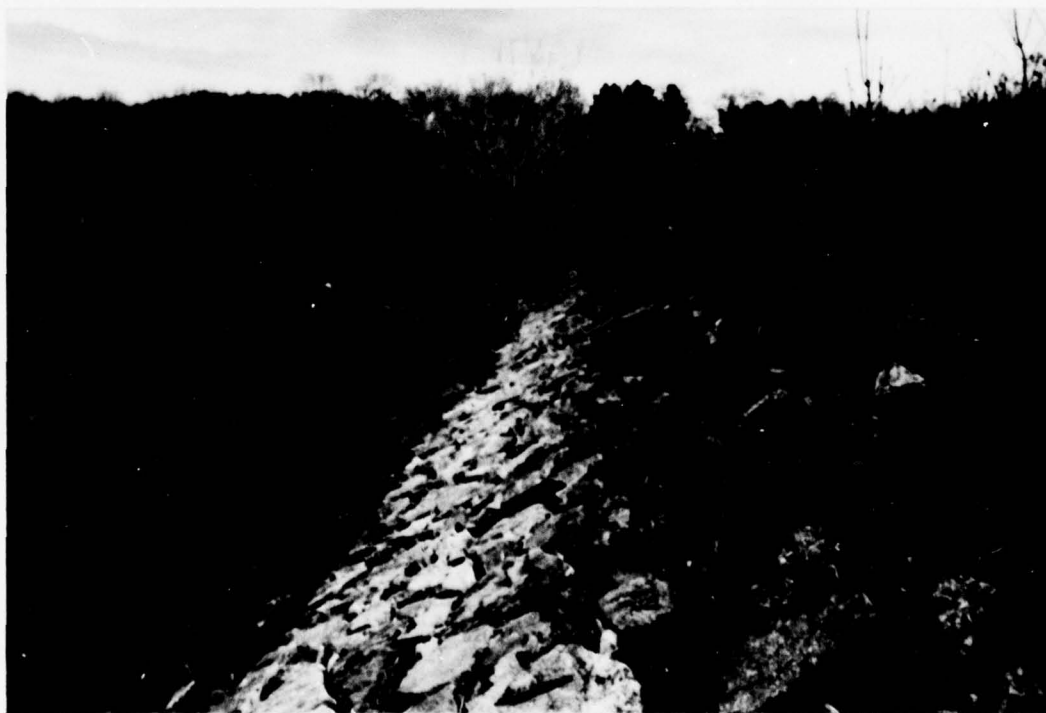
UPSTREAM SLOPE PROTECTION. SOME VEGETATION  
GROWTH IS SHOWN. [OBSERVATION (A)]  
(CARMEL MAIN DAM)

- e. The following measures can be carried out as part of the maintenance work: Removing trees and bushes, repairing minor damage and erosion of slope protection, clearing debris, and treating animal burrows. (Locations (A), (D), (E), (G), (I) and (K)).

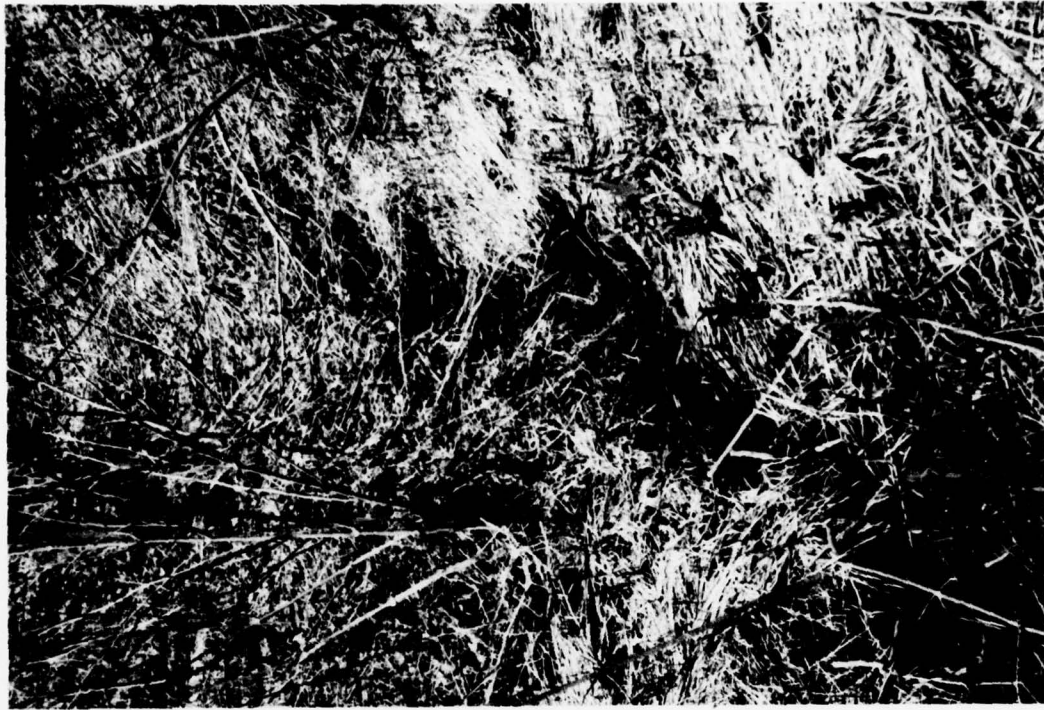
The seepage noted at left abutment contact of the main dam is not detrimental to project safety unless it increases in quantity or the water turns muddy.

SEEPAGE FLOW AT ABUTMENT CONTACT  
OF LEFT EMBANKMENT [OBSERVATION (B)]  
(CARMEL MAIN DAM)

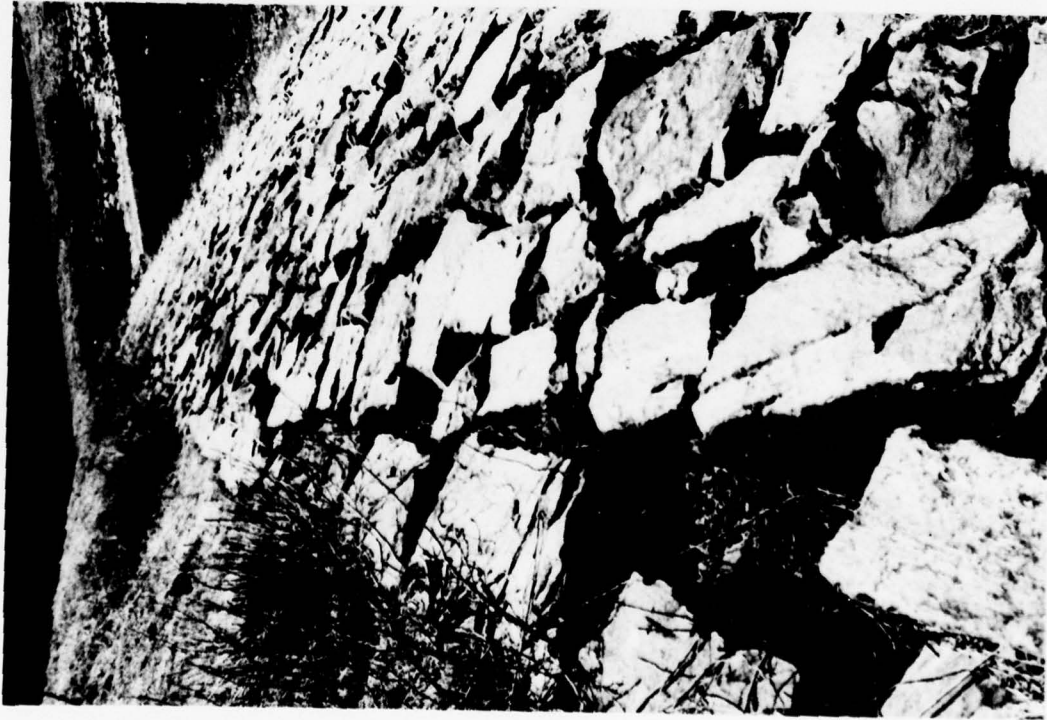
(G) The upstream stone slope protection has developed a depression and a bulge to the right of the spillway. In this area there is a crack in the slope protection which is associated with the slight downward movement of the stones.

The quality of the upstream slope protection is excellent and its condition is good. There are minor damages located on the slope near structures, such as gate houses, and spillway walls. The presence of these structures probably contributes to the disturbing effect of the waves.

DAMAGE TO UPSTREAM SLOPE PROTECTION  
LEFT OF SPILLWAY WALL [OBSERVATION (G)]  
(CARMEL MAIN DAM)

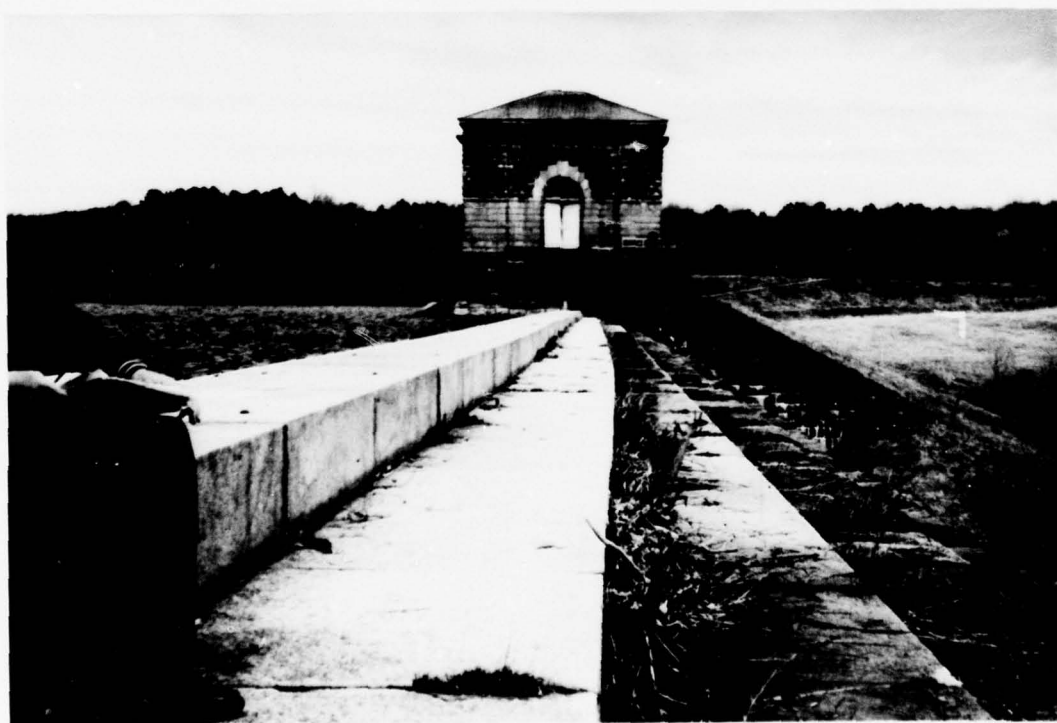
The pronounced curvature of the top masonry courses near the middle of the spillway is assumed to be caused by ice pressure. During the winter of 1977-78 there was as much as 26 inches of ice in the reservoir. The curvature might have been greater if steel rods had not been installed to anchor these top courses. The movement of the top masonry courses probably crushed any mortar in the joints resulting in some leakage through the joints. This is not considered a hazardous condition.

SPILLWAY CREST, DISLOCATED STONES OF THE UPPER TWO  
COURSES AND SEEPAGE FLOW ARE SHOWN [OBSERVATIONS (M) AND (L)]  
(CARMEL MAIN DAM)
