LEVEL IV  
LOWER HUDSON RIVER BASIN  
**POCANTICO LAKE DAM  
WESTCHESTER COUNTY  
NEW YORK  
INVENTORY NO 49**

**PHASE I INSPECTION REPORT  
NATIONAL DAM SAFETY PROGRAM**

Name of Dam Pocantico Dam NY49

State Located New York  
County Located Westchester  
Stream Pocantico River  
Date of Inspection July 26, 1978

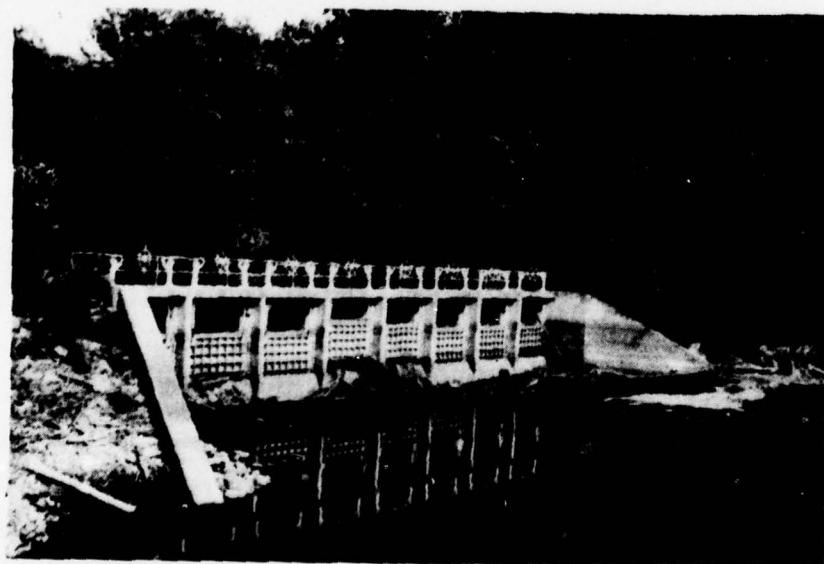
4. View of spillway structure with  
eight 8 X 4 sluice gates.

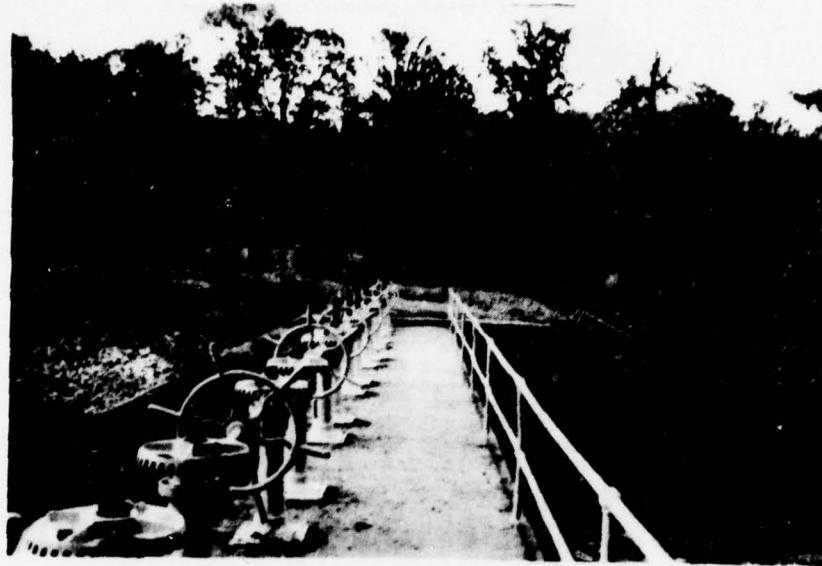
5. Manually operated gate equipment.

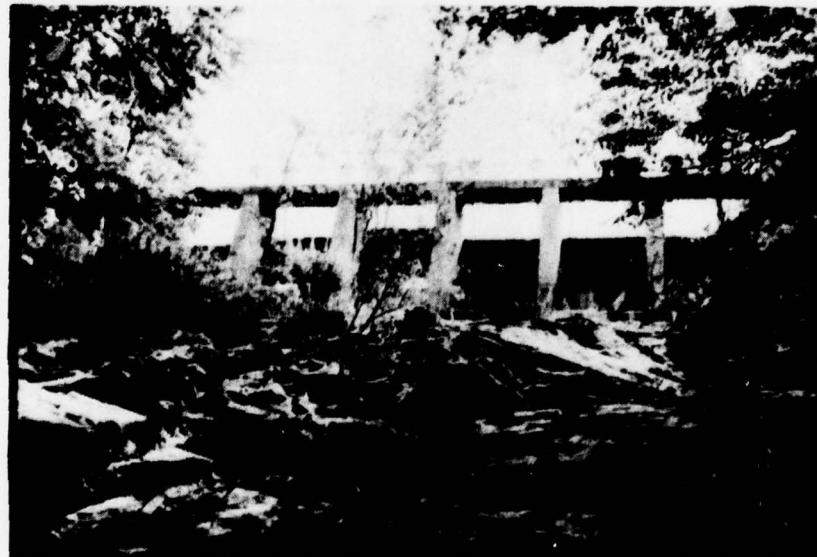
6. View of spillway from downstream channel.

The channel immediately below the spillway is shown in Photograph 6. It is largely exposed rock. Photograph 10 shows some embankment erosion further downstream. This is not considered serious.

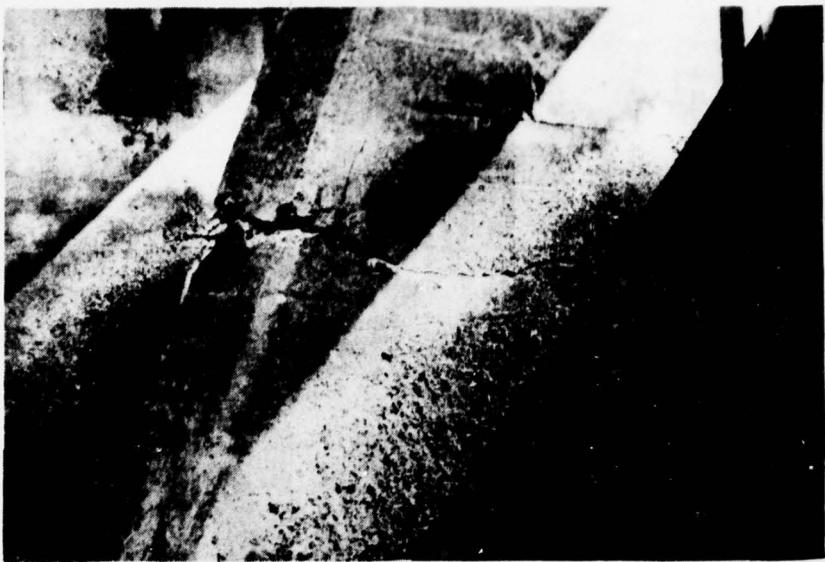
7. Detail of spillway gate dividing wall showing cracks.

The spillway concrete sill shown in Photograph 8 is in fair condition. Some wear of the surface material has taken place. One of the spillway's dividing wall and support frame for the sluice gates is cracked as shown in Photograph 7. The spillway gates, shown in Photograph 5, are reported to be operable but are not well maintained so as to be easily operated.

The spillway structure should be kept clear of debris which could interfere with proper operation of sluice gates and spillway flow. Repair of damaged/deteriorated concrete in the spillway structure should be undertaken to prevent progressive effects. The area downstream of the spillway should be kept clear of debris and plant growth which could interfere with rapid passage of waste water.

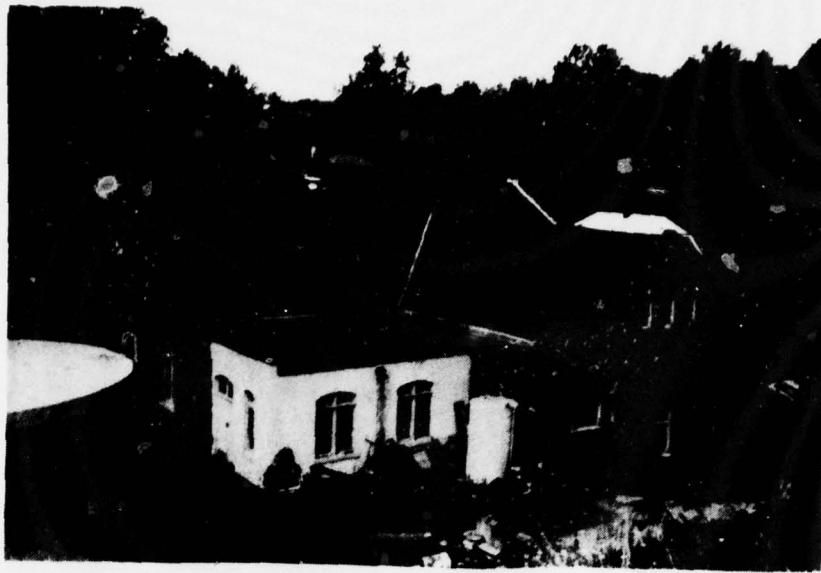
11. Abandoned filtration plant below  
dam.

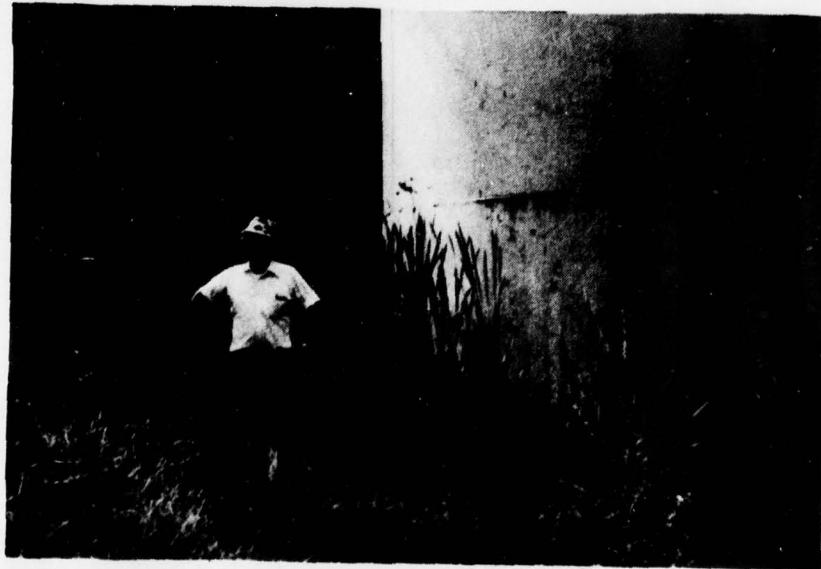
12. Cattails at toe of embankment near  
storage tank. Wetness from either  
seepage or poor surface drainage.

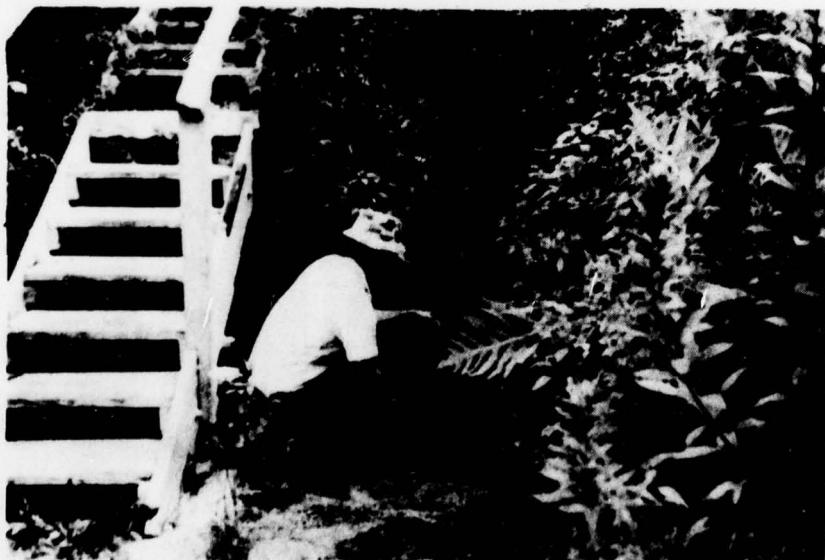
14. Cavity in east abutment embankment area  
below dam. Some water flowing.
