ELIZABETH RIVER BASIN
ELIZABETH RIVER, UNION COUNTY
NEW JERSEY

URSINO DAM

NJ 00387

**PHASE 1 INSPECTION REPORT
NATIONAL DAM SAFETY PROGRAM**

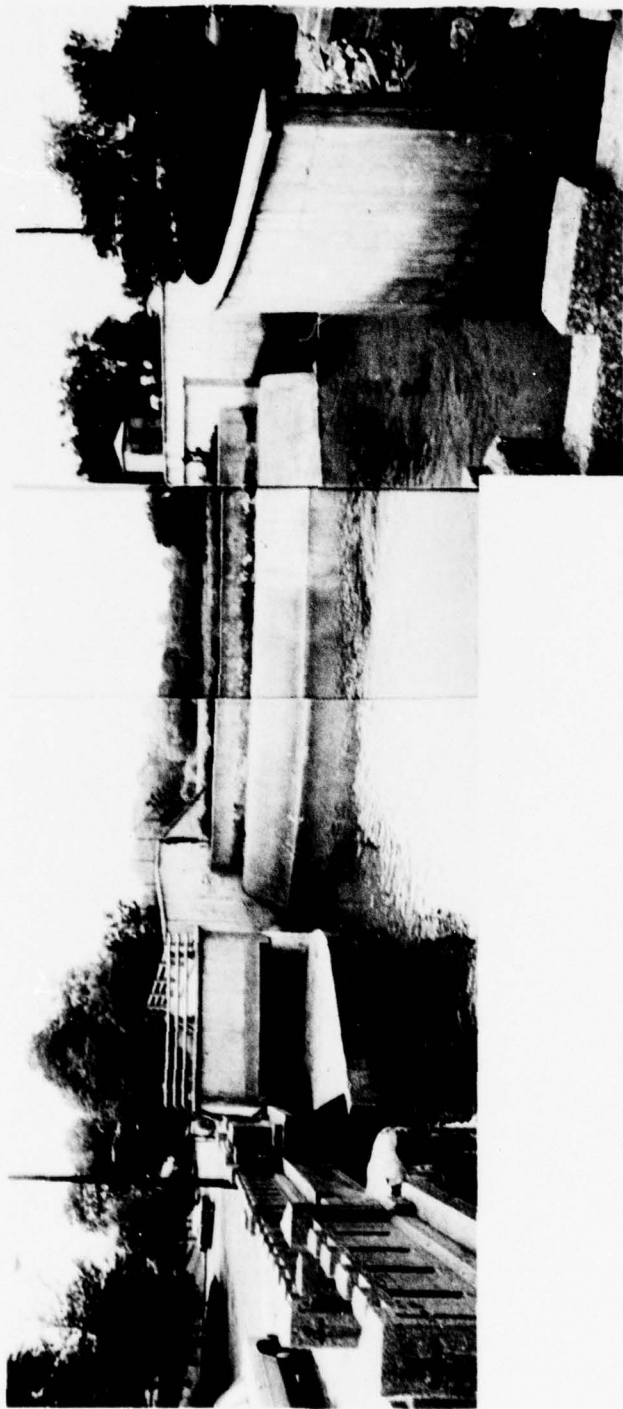
May 1978
URSINO FLOOD CONTROL PROJECT LOOKING UPSTREAM FROM TROTTERS LAND BRIDGE

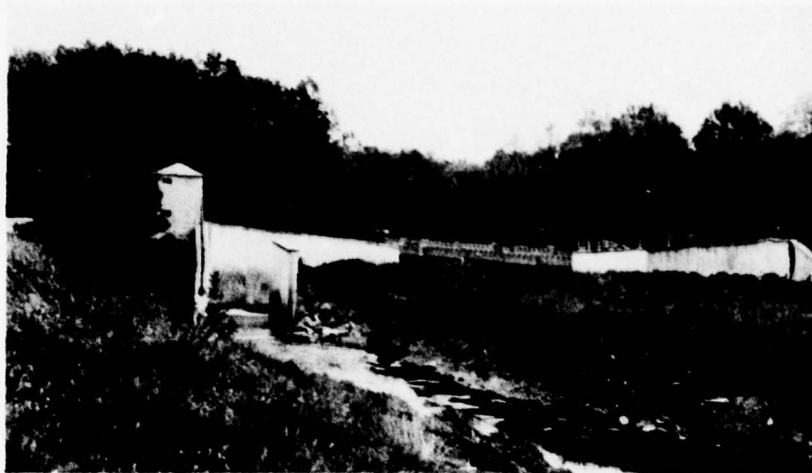
LOOKING DOWNSTREAM AT ELIZABETH RIVER AND URSINO DAM WITH
CONCRETE CHANNEL SECTION AND USGS GAGING STATION

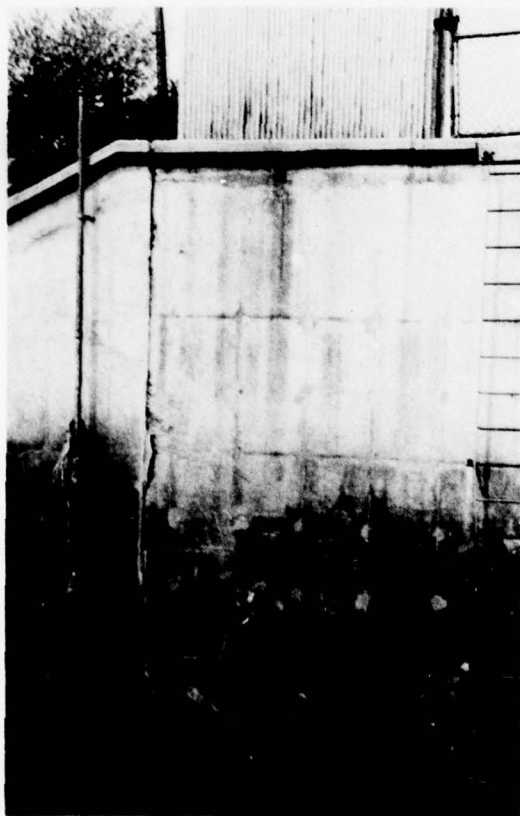
3.1.2 Concrete Gravity Control Structure and Emergency Spillway: The dam modification was completed in 1973. The reinforced concrete flume, walls, and the concrete gravity control structure generally appear to be in good condition. There are some minor surface cracks along construction joints of the concrete wing walls (See photographs in Appendix C).

LEFT CHANNEL WALL WITH
SPALLING AT JOINT

The maintenance procedures for this structure are inadequate in that the grass needed mowing, concrete cracks needed repairing, riprap protection was lacking (paragraph 3.1.5), and fencing which was destroyed has not been replaced. The welded access covers should be opened, and secured with heavy duty locks.

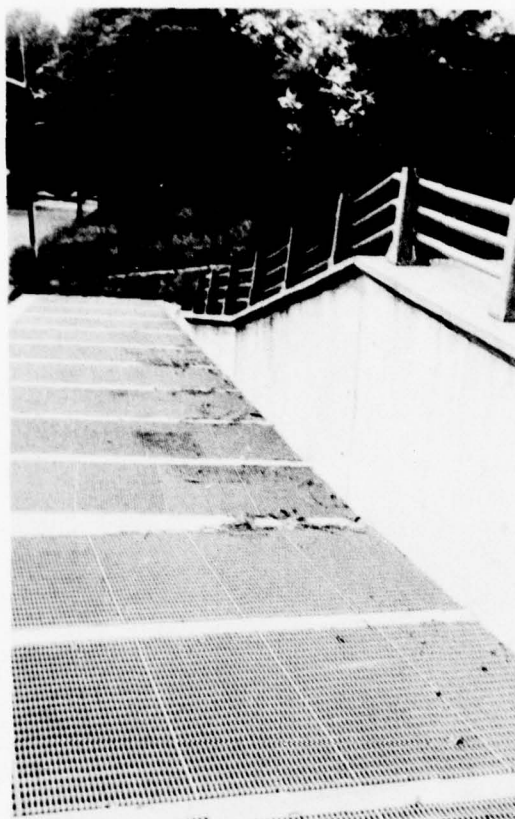
RETAINING WALL WITH STORM WATER
FLUME ALONG TROTTERS LANE

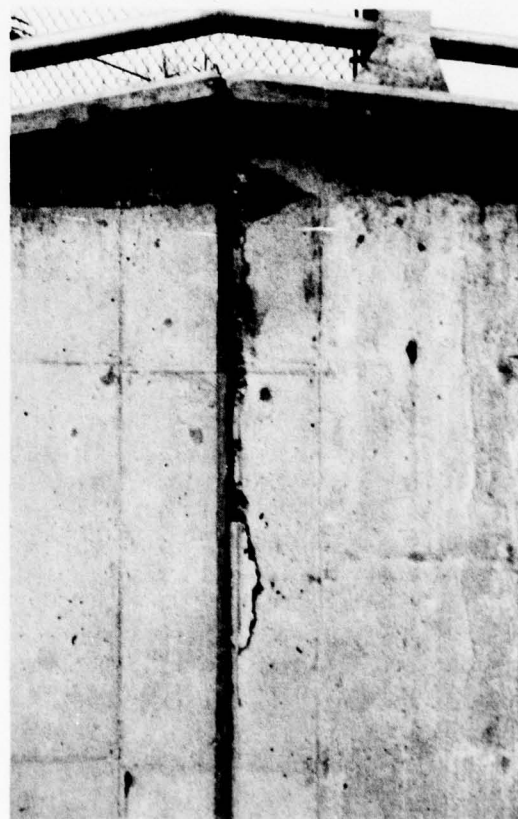
RETAINING WALL JOINT WITH SPALLING
ALONG STORM WATER FLUME

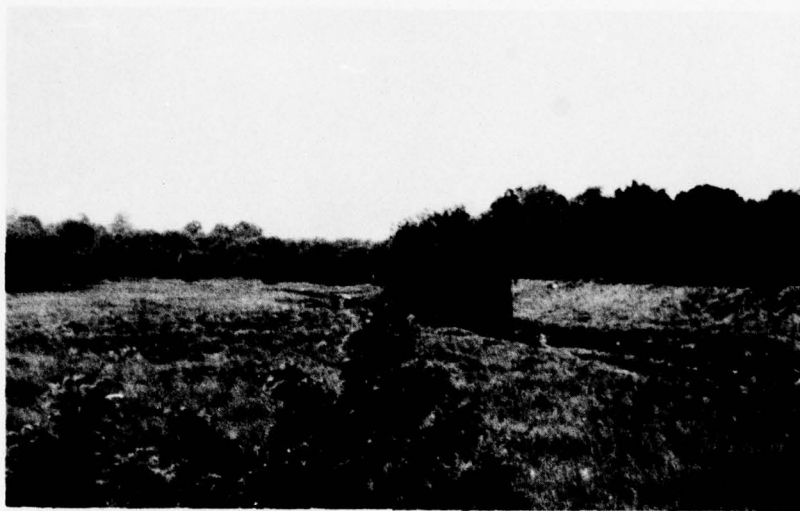
LOOKING UPSTREAM AT URSINO DETENTION BASIN WITH EAST LEVEE

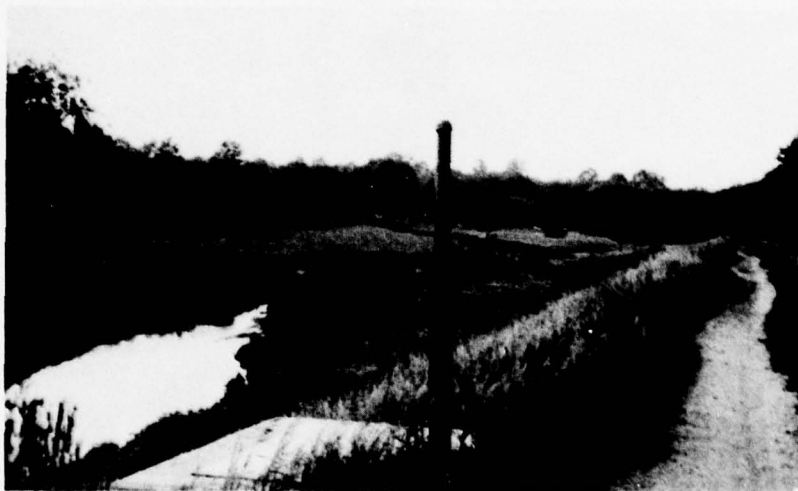
LOOKING UPSTREAM ALONG THE ELIZABETH RIVER
WITH DRAINAGE STRUCTURE NO. 76 AND EAST LEVEE
