# MORRISTOWN RESERVOIR DAM

## NJ 00352

### PHASE 1 INSPECTION REPORT NATIONAL DAM SAFETY PROGRAM

March, 1979

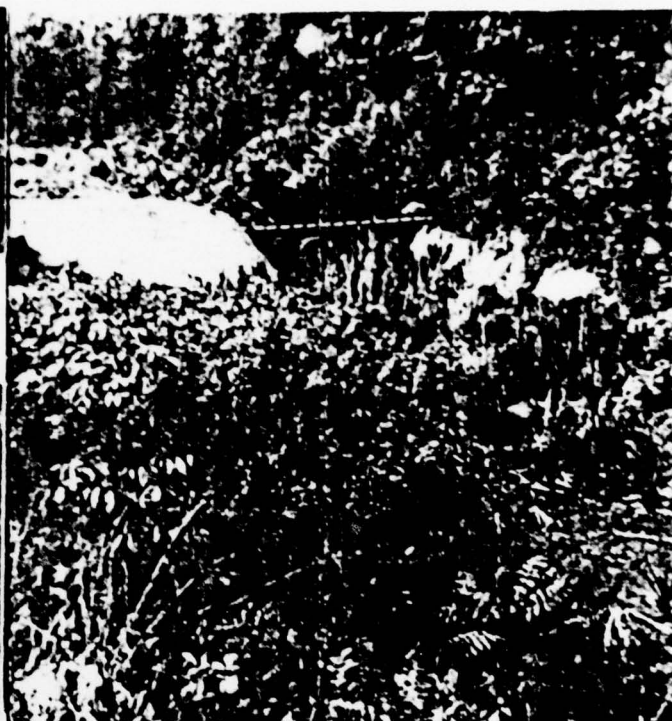
SWALE BEHIND SECONDARY DIKE

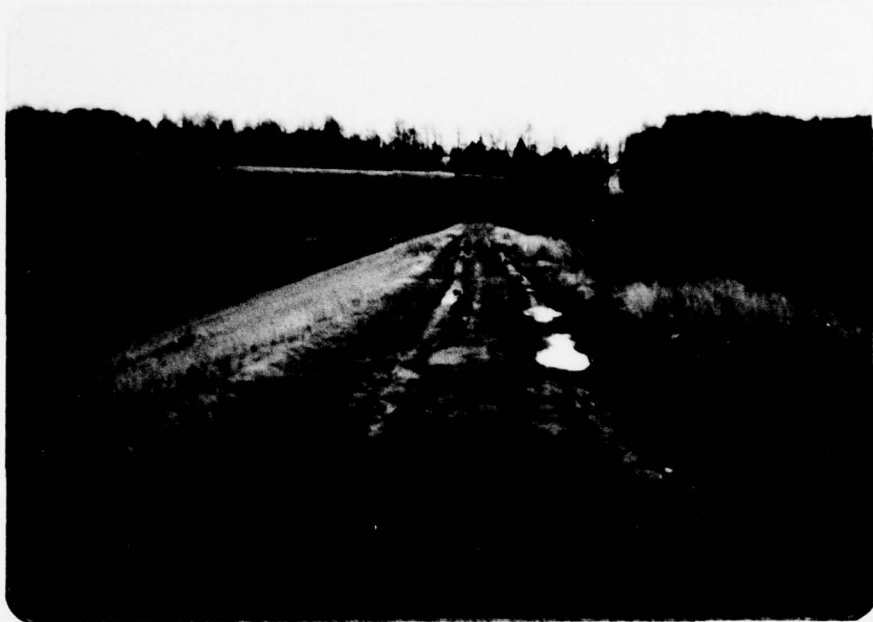
Crest of earthfill dam. Note sags  
in crest.

1. Depressions in the roadway along the crest of the dam should be suitably backfilled and adequate road surface material provided at the top of the dam.
2. Spalls and cracks in the concrete spillway apron, gatehouse structure and footbridge should be repaired.

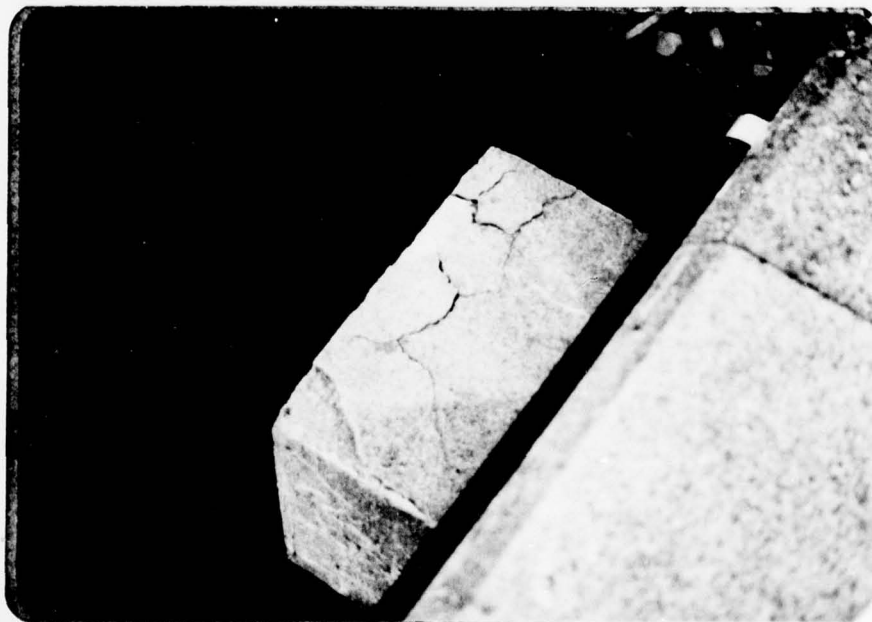
Pier supporting footbridge.  
Note: deteriorated concrete.
