DELaware RIVER BASIN
CROSSWICKS CREEK, OCEAN COUNTY
NEW JERSEY

LEVEL ^{II}
**OAKFORD LAKE DAM
NJ 00544**

PHASE 1 INSPECTION REPORT
NATIONAL DAM SAFETY PROGRAM

January, 1979

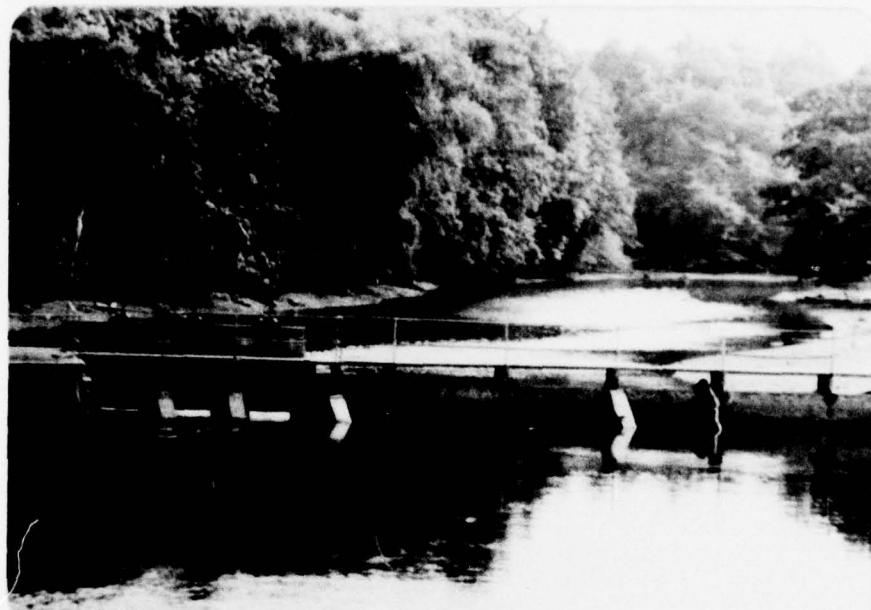
3. The stilling basin for the outlet gates section is undercut at the toe of the left buttress, causing the buttress to settle and crack.
4. The right slide outlet gate has been damaged in the flood of August 1978 making it impossible to close all the way.

Photo 1 - View of downstream face of dam from Main Street Bridge.
Note left gate that was damaged and could not be raised completely.(Photo taken September 7, 1978)

- d. Within two years the right low level outlet gate should be repaired.
- e. Within six months replace and repair the railing on the dike and walkway so that it serves its intended purpose.

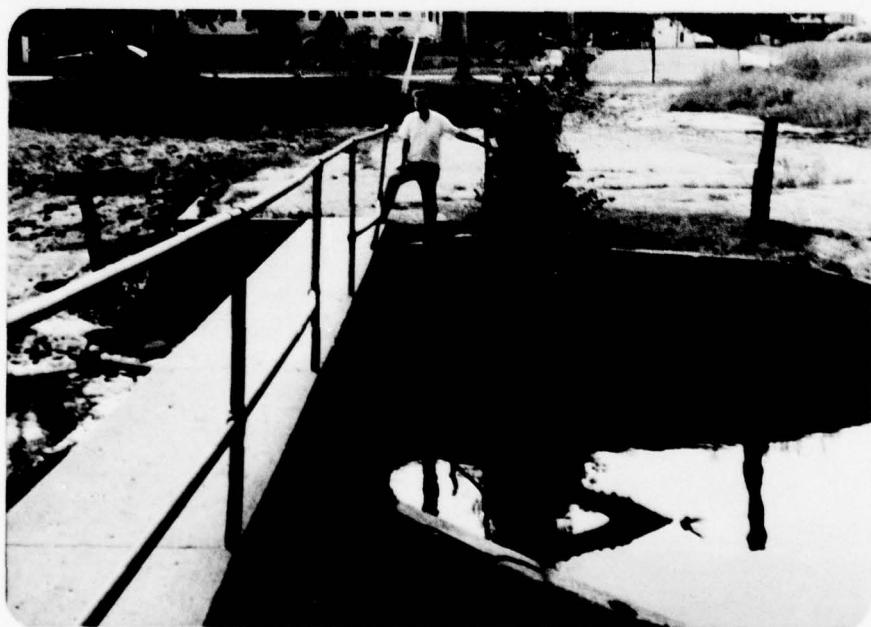
Photo 2 - View of concrete spillway and left abutment from low level outlet section. (Photo taken September 7, 1978)

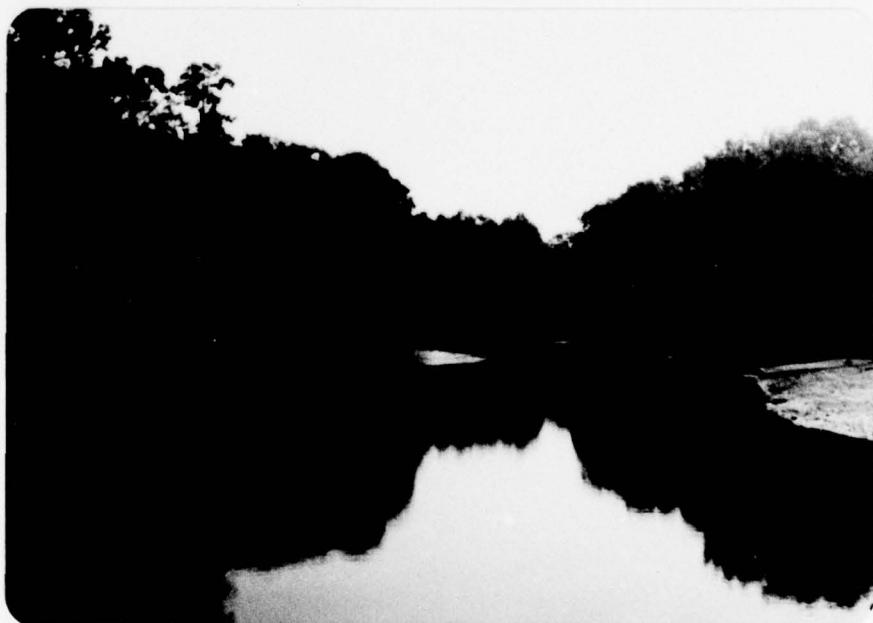
Photo 6 - View of reservoir from dam. Tree line is normal water level with gates closed. (Photo taken September 7, 1978)

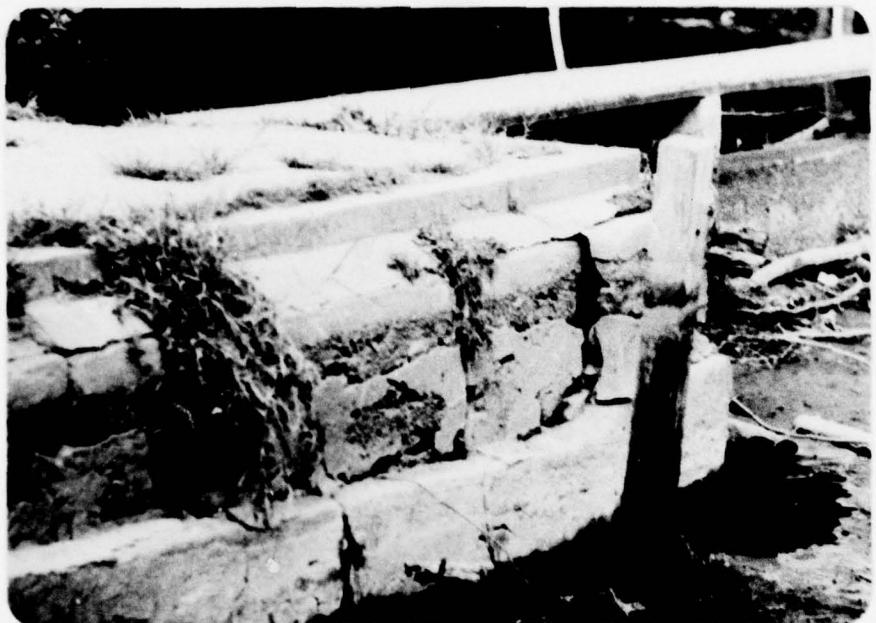
The stilling basin was under water and could not be observed. The concrete facing on the spillway left abutment and upstream wing-wall is severely deteriorated and missing. The facing on the upstream side of the abutment is completely missing, exposing the timber piling and fill material.

Photo 7 - Upstream face of left abutment showing missing and deteriorated concrete facing. (Photo taken September 7, 1978)

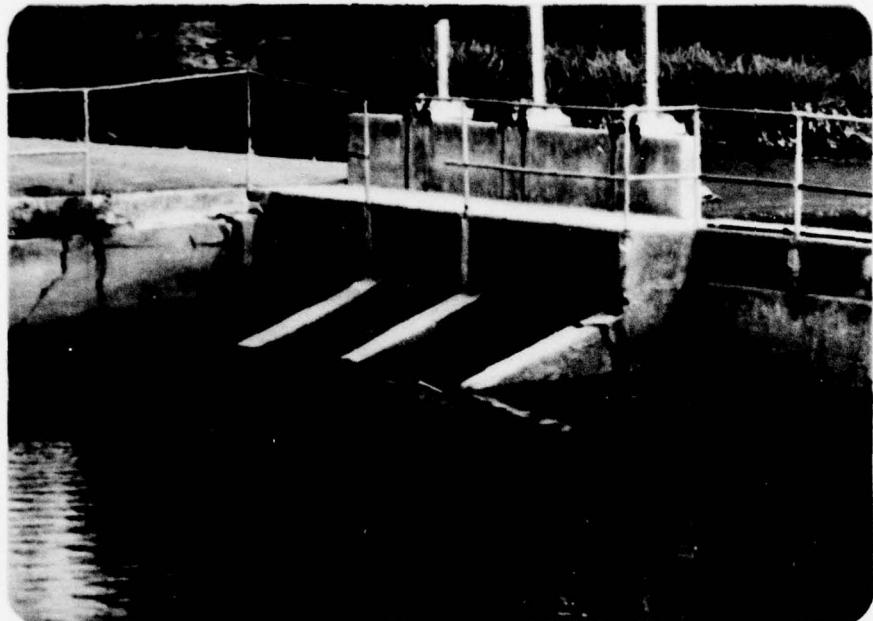
The concrete of the low level outlet section has spalling on both the upstream and downstream faces. The left buttress has a structural crack running down through the footing. At the time of inspection, the separation was approximately 3-inch wide, which according to local officials is wider than what it was before the flood of August 1978 hit the area. The crack appears to be caused by undercutting of the footing and the

resulting settlement of the buttress. Probing the streambed area left of buttress footing, revealed the bottom to be 3 to 4-foot deeper than that at the end of the stilling basin. The stilling basin was under water and could not be observed but probing the area seems to indicate the basin is cracked as shown on the reconnaissance sketches (Figure 2).

Photo 9 - View of downstream face of low level outlet section showing cracked left buttress. Also note cracked abutment wall to the left. (Photo taken September 7, 1978)

- b. Within eighteen months repair the cracked buttress and stilling basin at the low level outlet sections.
- c. Within eighteen months fill in the area downstream of the concrete weir with heavy riprap stone to prevent scouring.

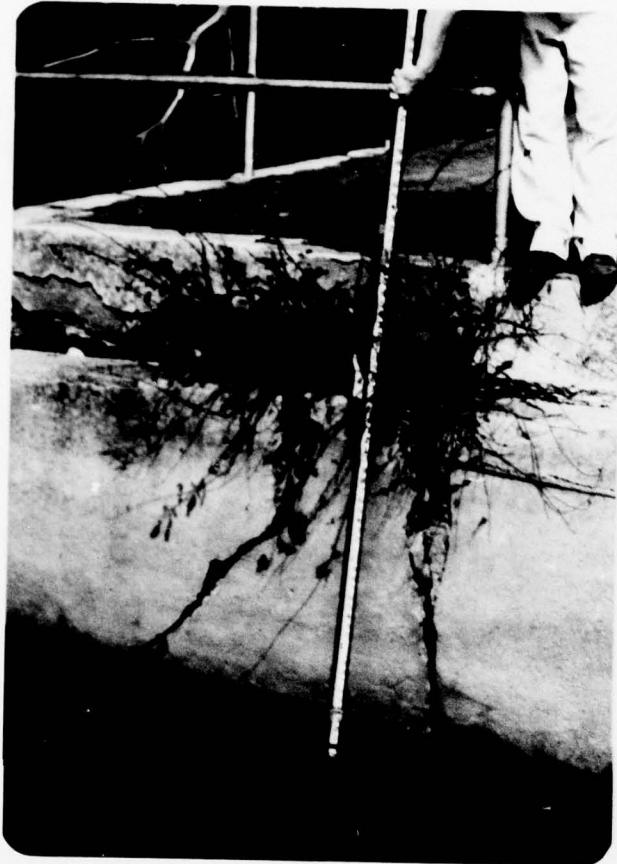
The dike portion, approximately 85-foot long, extends from the low level outlet section to the right bank and has vertical concrete facing 6-inch thick over a timber structure. The top of the dike, which varies from 20 to 24 feet in width is paved with 3 to 4 inches of asphalt. The concrete facing on the dike section has cracked and deteriorated extensively on the upstream face and channel side by the low level outlets. On the channel side of the dike, the damage to the concrete facing is such that the space between the cracks, in some cases is 2 inches or greater, and the entire corner of the downstream face has washed away.

According to local residents, last year when divers inspected the dike, they reported extensive voids in the dike embankment. The asphalt on the top is in good condition, but the railing for the downstream and channel side is either missing or so loose that it is a hazard.

Photo 11 - Cracked concrete facing
of right abutment dike on
discharge channel side.
(Photo taken September 7,
1978)

- a. Within one year sheeting should be driven around the perimeter of the right and left abutment dike and all voids within the embankments should be filled.
- b. Within eighteen months repair the cracked buttress and stilling basin at the low level outlet sections.
- c. Within eighteen months fill in the area downstream of the concrete weir with heavy riprap stone to prevent scouring.
- d. Within two years the right low level outlet gate should be repaired.
- e. Within six months replace and repair the railing on the dike and walkway so that it serves its intended purpose.

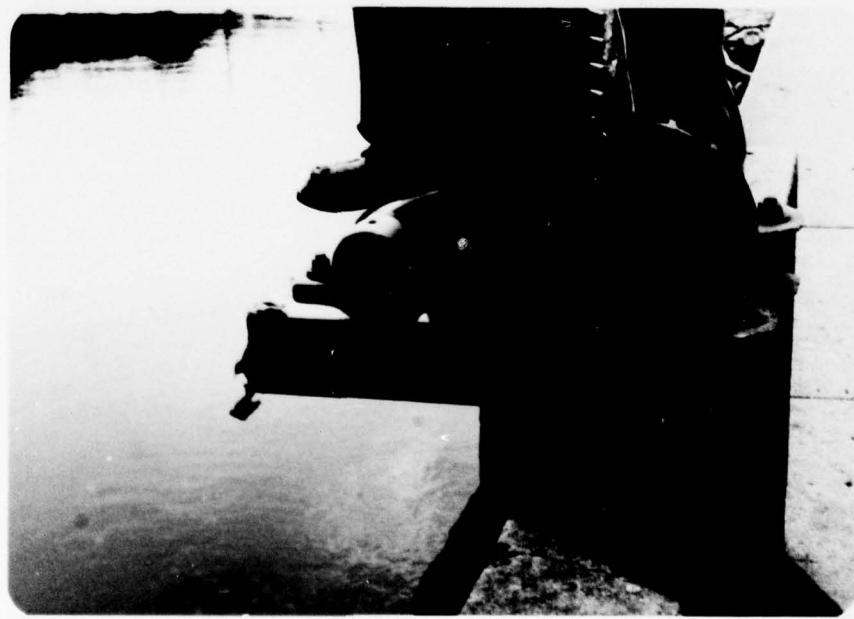
Oakford Lake Dam contains three low level outlet gates mounted on the upstream face of the concrete section controlling openings that are 3.5-foot wide and 5.5-foot high. The gates are steel plates with steel operating mechanisms. The lifting mechanism for each slide gate is a rack and pinion gear with a safety ratchet and pawl and is lever operated. During the initial inspection, the left and center slide gates were fully opened and right slide gate was partially opened. Since then, the gates have been closed, but the right slide gate which was damaged during the August 1978 flood cannot be closed completely and remains open approximately 3 inches. There is a structural crack in the gear base plate of the left gate.

Photo 12 - Operating mechanism of left outlet gate showing
cracked plate. (Photo taken September 7, 1978)
