UPPER HUDSON RIVER WATERSHED
SACANDAGA RIVER BASIN

**LAKE ALGONQUIN DAM
HAMILTON COUNTY, NEW YORK**

**PHASE I INSPECTION REPORT
NATIONAL DAM SAFETY PROGRAM**

CONVERSE WARD DAVIS DIXON
CONSULTING ENGINEERS
91 ROSELAND AVENUE, P.O. BOX 91
CALDWELL, NEW JERSEY 07006

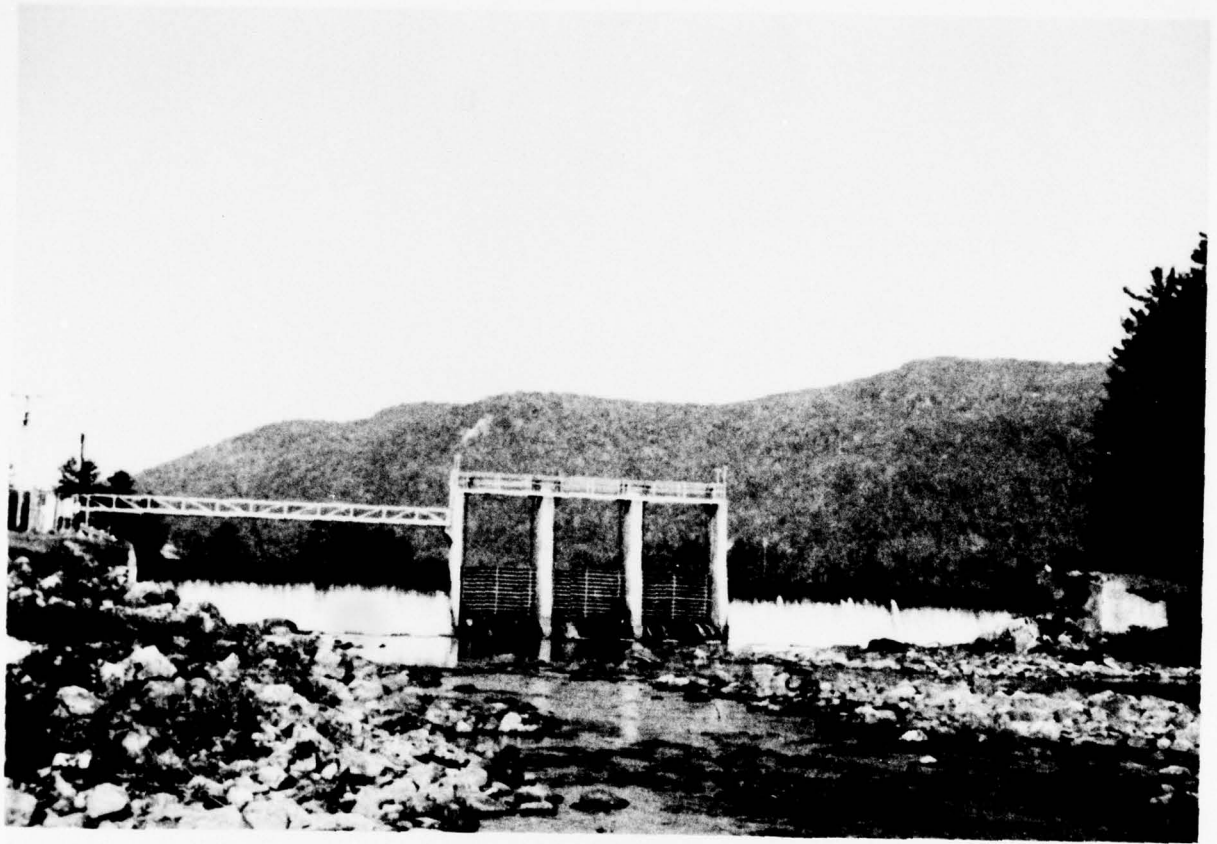
OVERVIEW-LAKE ALGONQUIN DAM

At the start of the inspection, all three gates were shut. A slight amount of leakage was noted coming from beneath each gate. (See Overview Photo.) On the day of the inspection, the right gate was inoperable because the lift motor was down for repairs. The middle gate was raised about $1\frac{1}{4}$ inches in 15 minutes from a switch in the control panel at the right abutment area (Refer to Section 1.2h and Fig. 1, Appendix D). The left gate was raised a total of about 4 feet in approximately 45 minutes by an operator with a portable electric motor (Fig. 2, Appendix D). This was done in order to lower the lake level below spillway crest elevation so that the downstream face of the spillway could be inspected. The left and middle gates and gate controls functioned satisfactorily and, except for some rust on the lift arms, they appeared to be in good condition and generally well maintained.

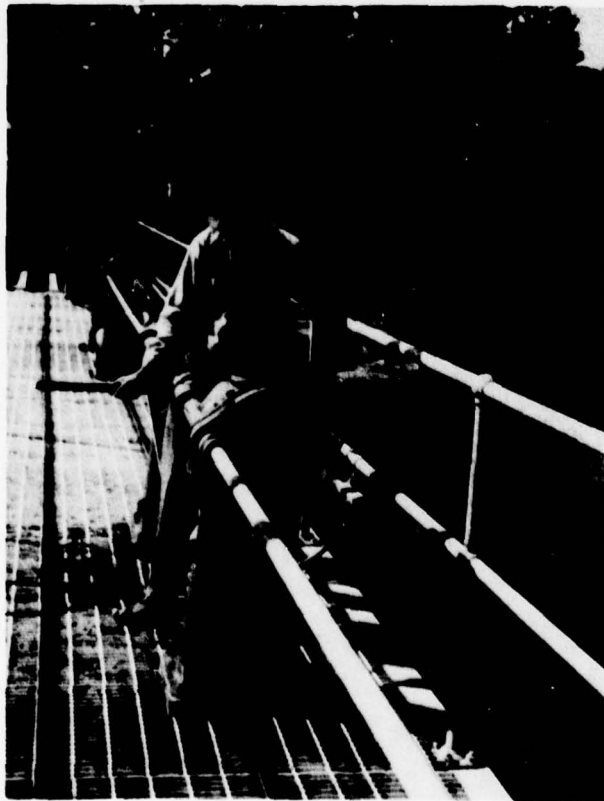
The steel frame and grates of the gate control platform atop the gate structure piers, and the steel truss access walkway over the right spillway section, appeared to be in generally good condition (Figs. 2 and 20, Appendix D). The walkway from the left abutment to pier 4, as shown on the design drawings (Plate III), was never built, although the foundations are in place.

FIGURE 2 RAISING OF LEFT GATE

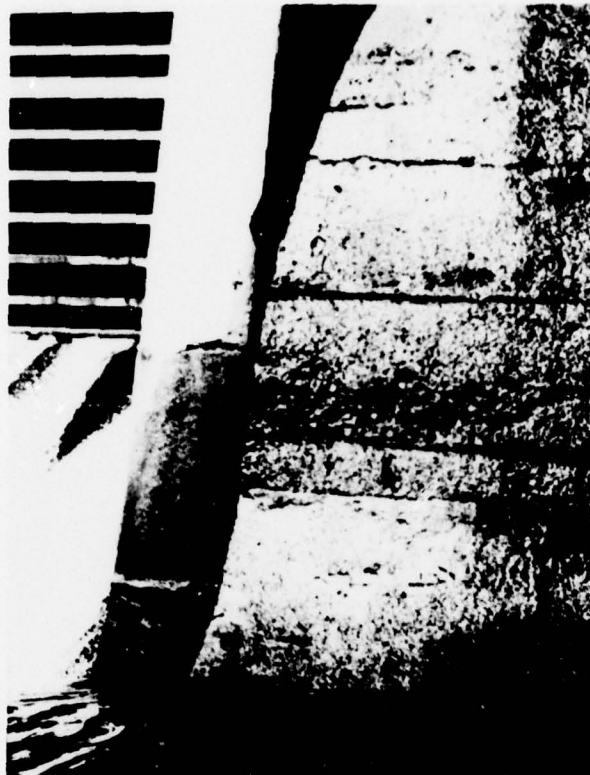
The gravity/spillway sections of the dam appeared to be in generally good condition, with only minor erosion on the crest and downstream faces (Figs. 3, 4 and 5, Appendix D). Some moderate structural cracking was noticed on the downstream face of the right monolith of the left gravity/spillway section near its junction with pier 4 (Figs. 4 and 5, Appendix D). No leakage was observed coming through the cracks. A large spall was observed on the crest of the right gravity/spillway section at its junction with the pier 1 key (Fig. 6, Appendix D).

FIGURE 5 CRACKS IN LEFT GRAVITY/SPILLWAY SECTION
NEAR PIER 4

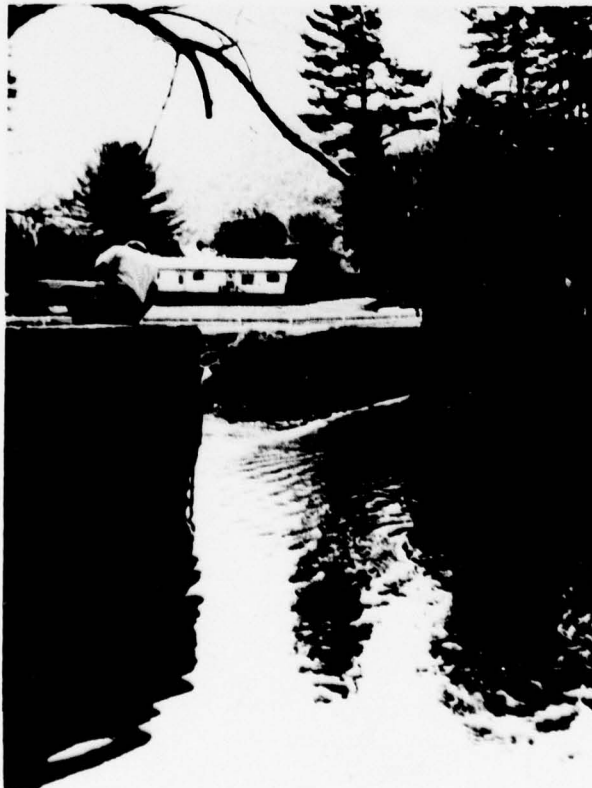
The left abutment appeared to be in generally poor condition. The upstream wingwall (perpendicular to direction of flow) had a vertical crack that extended transversely over the top of the wall. There was a slight displacement of the wall upstream. The edge of the wingwall was badly cracked and spalled, and a reinforcing bar was clearly exposed (Fig. 10, Appendix D). The left abutment sidewall (parallel to direction of flow) was moderately eroded at and below the spillway water line. There were large areas that had apparently been patched recently. Seepage was occurring from a large spall about 5 feet downstream of the gravity/spillway joint and approximately 2/3 of the way from the top (Figs. 11 and 12, Appendix D). There was also a large spall at the junction of the sidewall and downstream wingwall near the base (Figs. 11 and 13, Appendix D). Water was seeping through the spall, and reinforcing steel was clearly visible. The concrete at the base of the sidewall was moderately eroded below the water line.

FIGURE 10 FEATURES OF LEFT UPSTREAM WINGWALL

2. Appropriate steps should be taken to stop or control seepage through the earthen fill at the left abutment.
3. All cracked, spalled and deteriorated concrete on the left abutment retaining walls, and elsewhere on the gravity/spillway and gate/sluiceway structure and right abutment should be repaired.

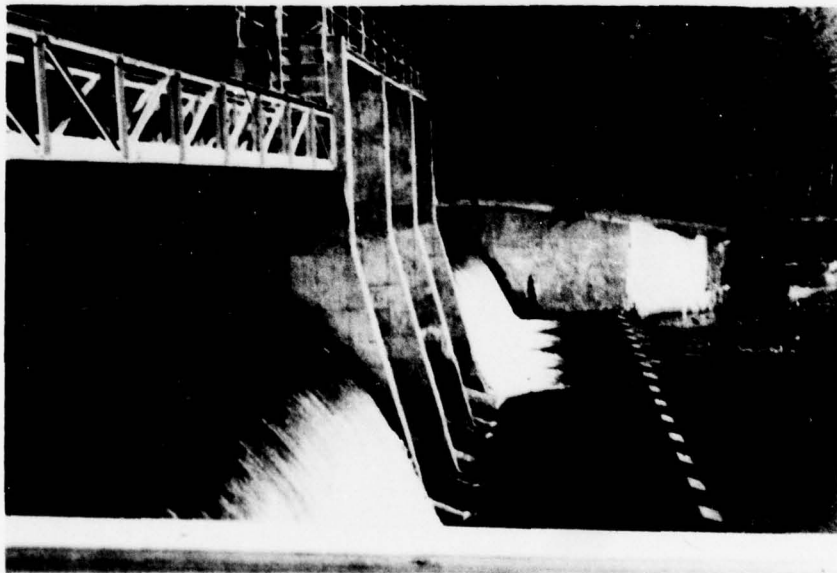
At the start of the inspection, water was flowing over the spillway at a depth of $3\frac{1}{2}$ to 4 inches. With the opening of the two operable gates, the water level dropped below spillway crest elevation, so the downstream face of the spillway could be inspected and joints checked for leaks. Before the end of the inspection, the gates were closed and water began to flow over the spillway section again.

FIGURE 20 FLOW OVER SPILLWAY AT START OF INSPECTION

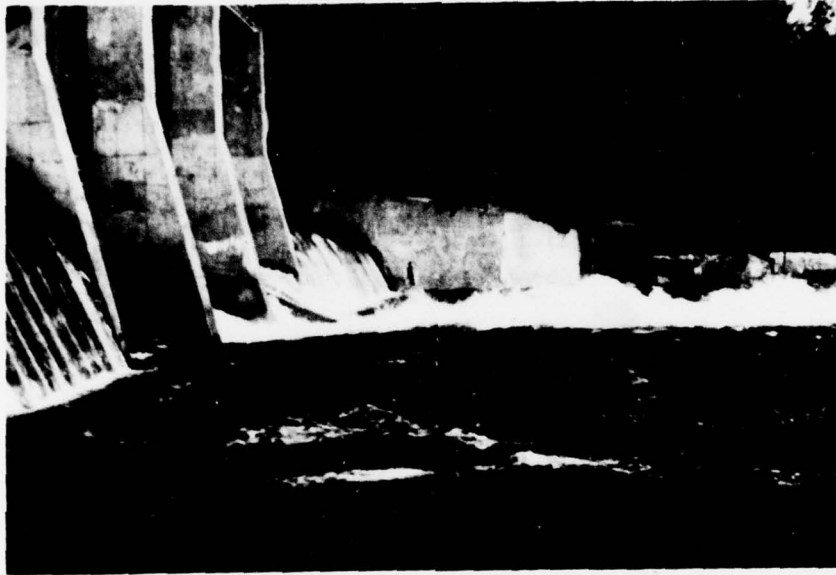
generally good condition, with some minor erosion of surface concrete. Drain weeps were clearly visible and no water was noticed flowing from them. In fact, a small vortex was noticed going into one of the drains of the concrete apron after the gates had been shut and the tail-water had dropped, and before flow had resumed over the spillway. The concrete baffles were very effective in dissipating energy when the gates were opened (Figs. 7 and 21, Appendix D).

FIGURE 21 TAILWATER 30 MINUTES AFTER OPENING OF GATES
