PLEASURE LAKE DAM

SULLIVAN COUNTY, NEW YORK

INVENTORY NO. 345

PHASE I INSPECTION REPORT
NATIONAL DAM SAFETY PROGRAM

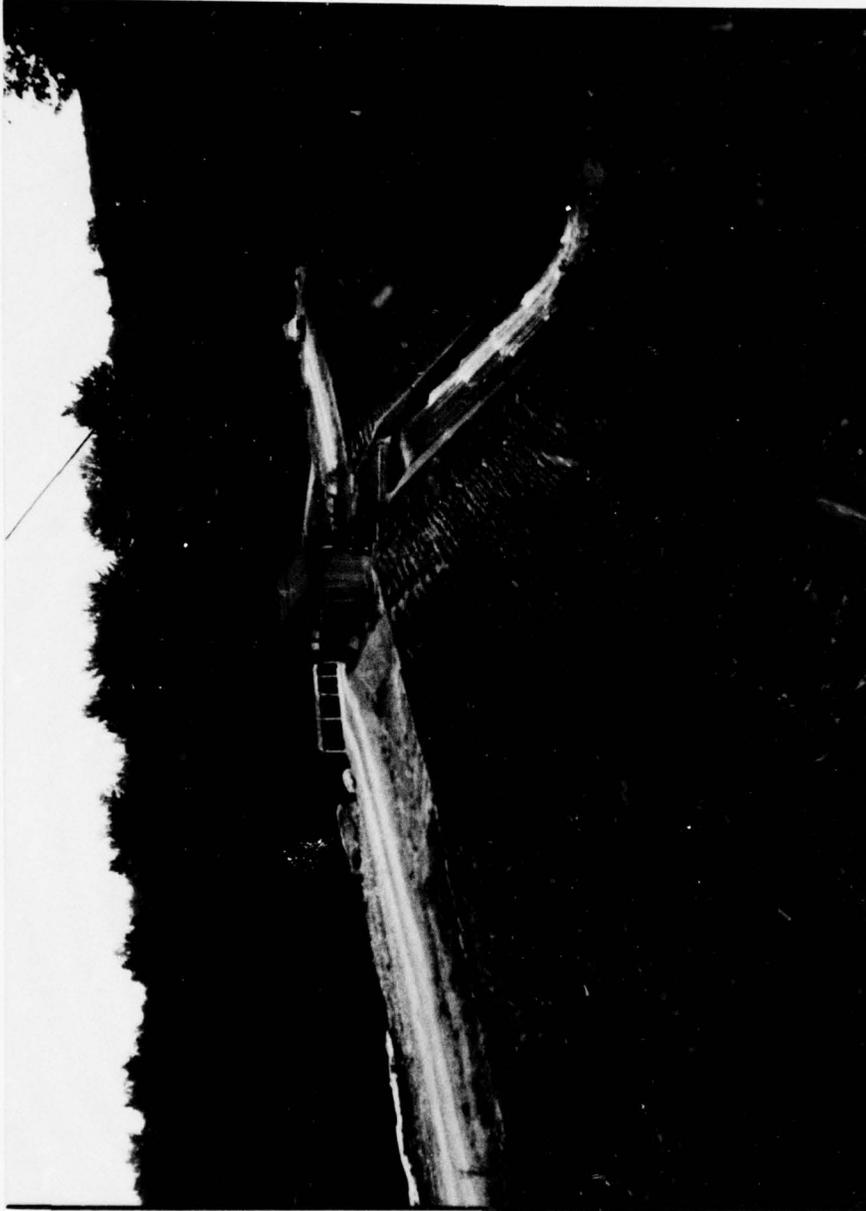
1) GENERAL OVERVIEW OF MASONRY - EARTHFILL DAM AND SPILLWAY

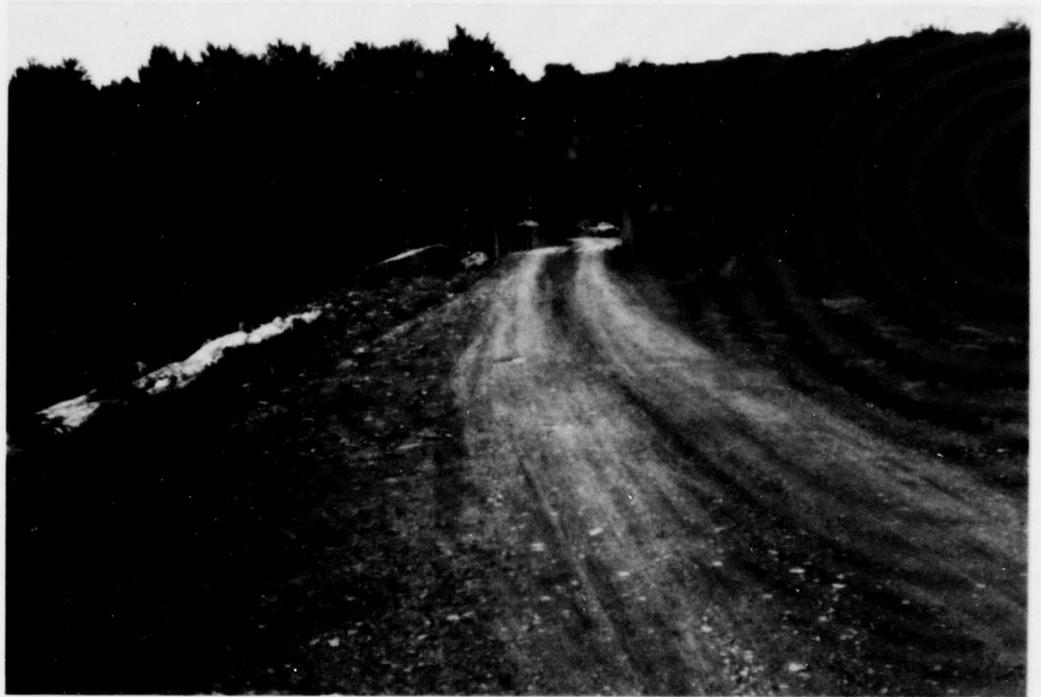
A longitudinal crack about 20 feet long is located on the crest, about two feet upstream of the roadway edge and approximately 40 feet west of the bridge. The crack appears to be caused by settlement of the fill placed in 1978.

2) CREST OF DAM LOOKING EAST

- a. The upstream earth slope should be flattened and riprapped. A bedding layer of suitable material should be placed between the earthfill and the riprap. The remainder of the slope should be seeded. The longitudinal crack observed along the upstream slope should be repaired prior to flattening and seeding the slope.

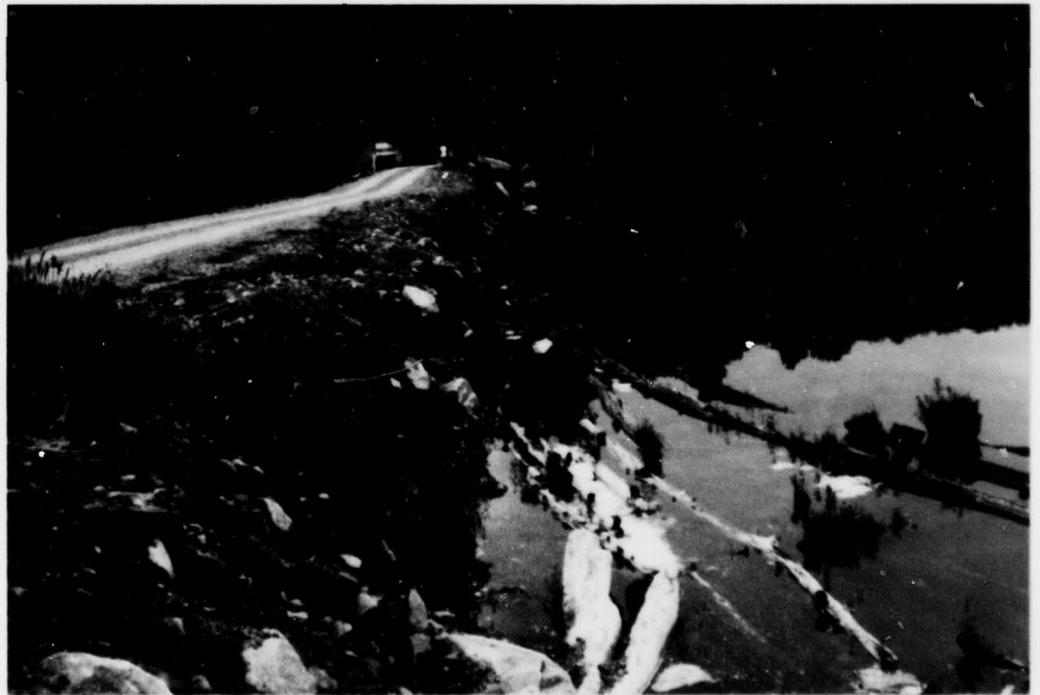
3) UPSTREAM SLOPE LOOKING WEST , NOTE LOGS AT WATERLINE

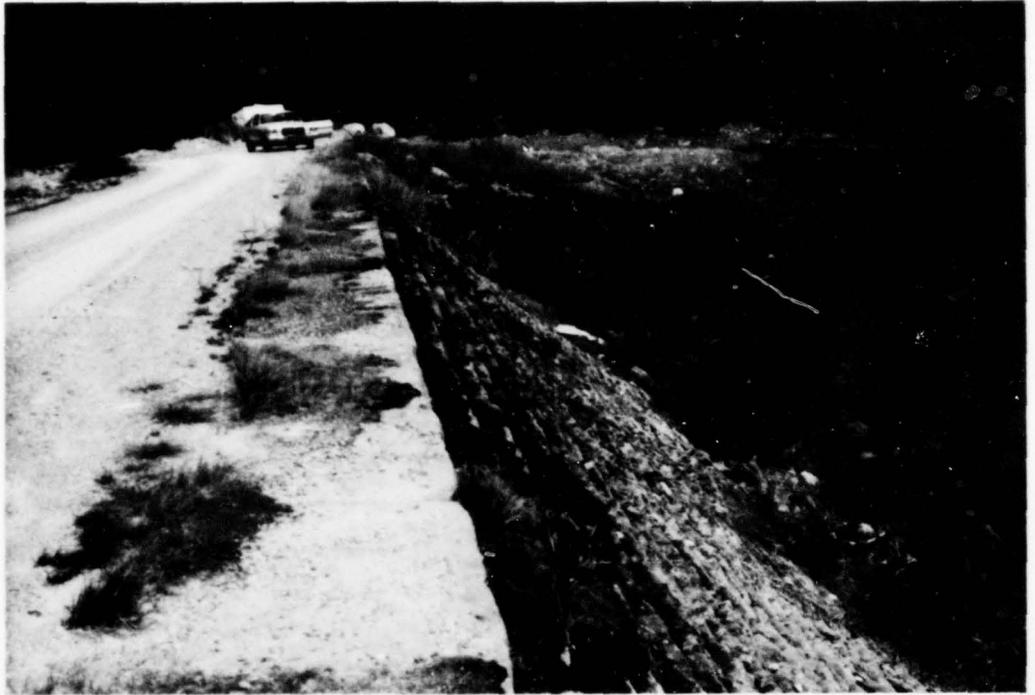
4) DOWNSTREAM SLOPE LOOKING EAST , NOTE AUXILIARY EMERGENCY
SPILLWAY TO RIGHT OF AUTO

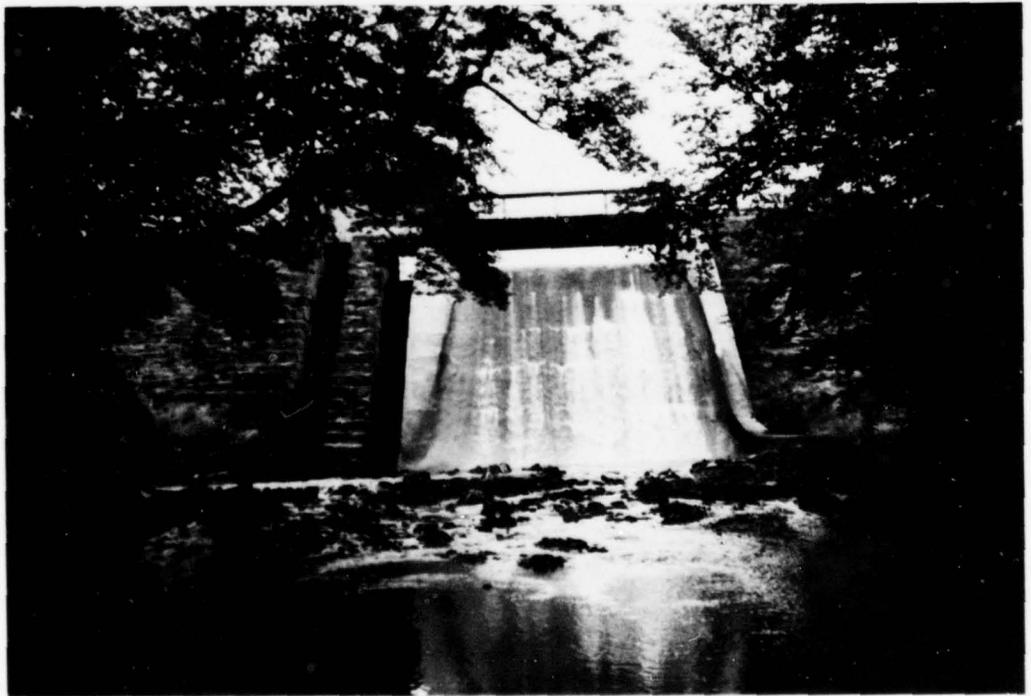
The spillway crest and chute appear to be in good condition. Some minor erosion of the gunite surface is noted. The spillway chute is covered by gunite placed in an overlapped manner.

5) SPILLWAY AND SLUICEWAYS

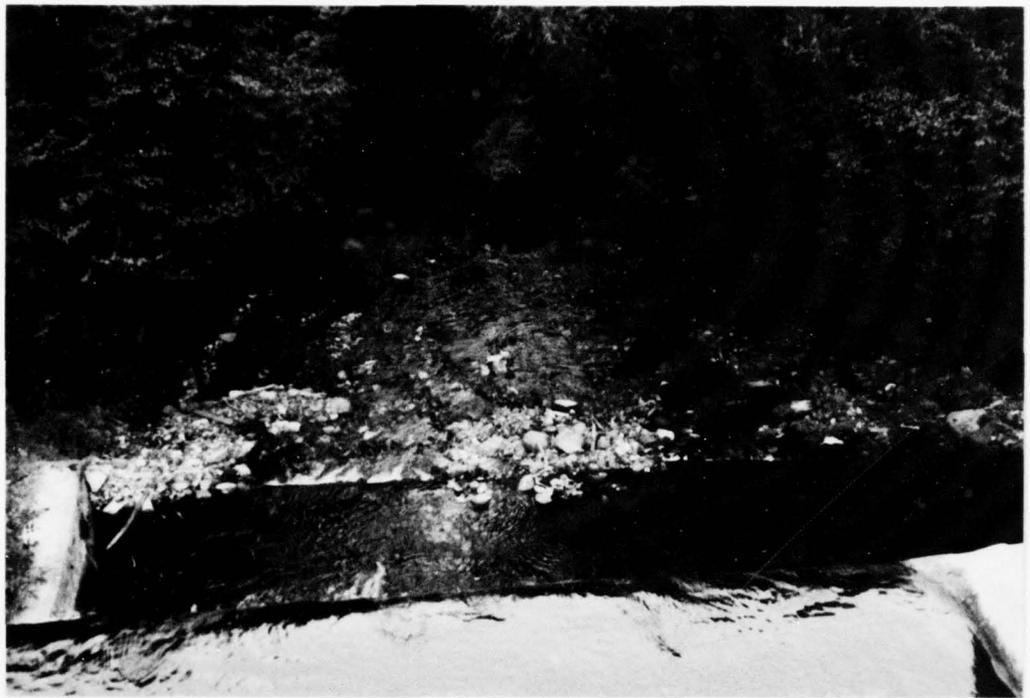
The channel downstream of the emergency spillway tailrace is the Sheldrake Stream. The channel is a natural stream with only minimal vegetation and overhanging trees. Present conditions do not impede the discharge of the flow observed. The auxiliary emergency spillway discharges into the Sheldrake Stream about 300 feet downstream of the dam.

6) SPILLWAY CHUTE AND DOWNSTREAM CHANNEL

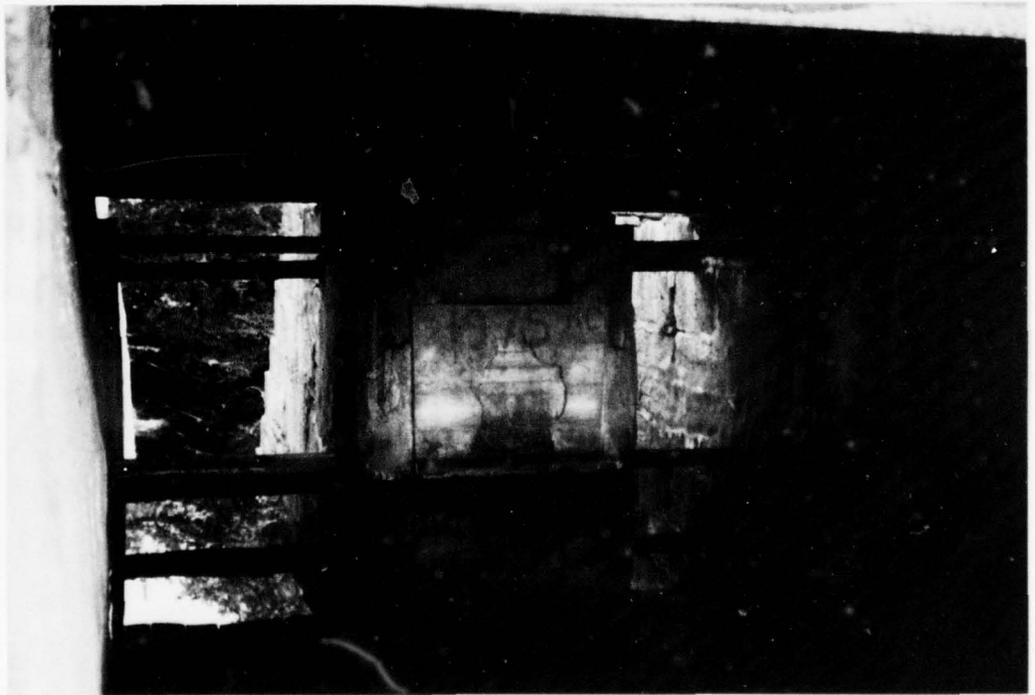
7) APPROACH CHANNEL TO STOPLOG GATES

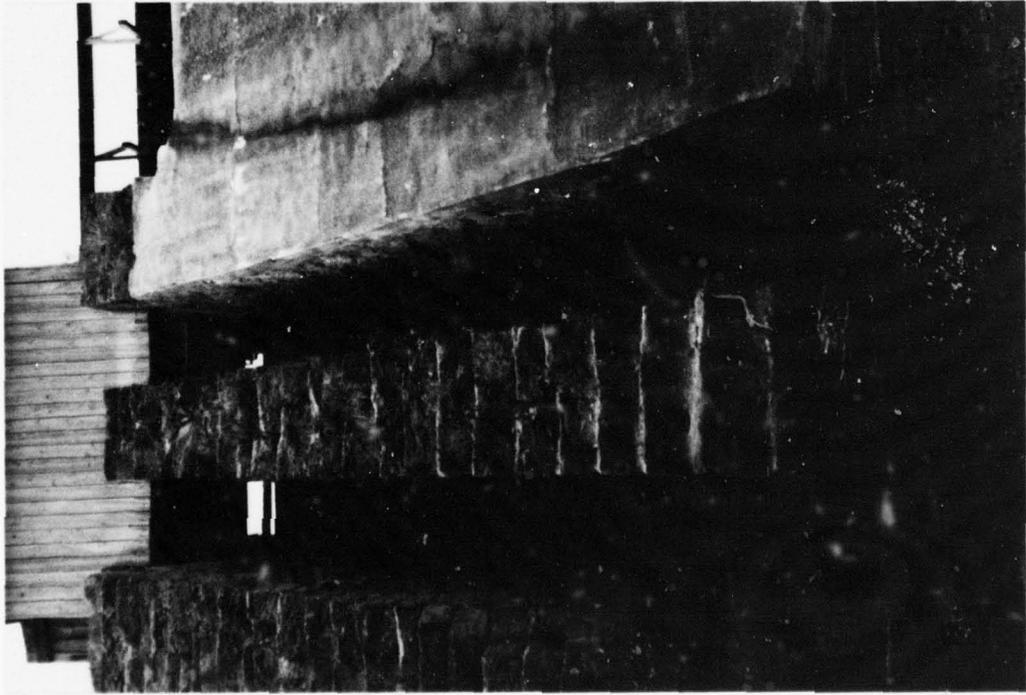
The sluiceways and emergency spillway appear to be in generally fair condition. The approach channels to the sluiceways and emergency spillway are clear of aquatic growth. There was evidence of some minor cracking and some missing pointing along the concrete training wall surfaces. Slight leakage was observed between the masonry and gunite surface on the east wall of the west sluiceway.

8) SLUICEWAYS

- d. The auxiliary emergency spillway should be finish-graded and seeded.
- e. Loose and missing pointing at sluiceways and emergency spillway should be repaired.

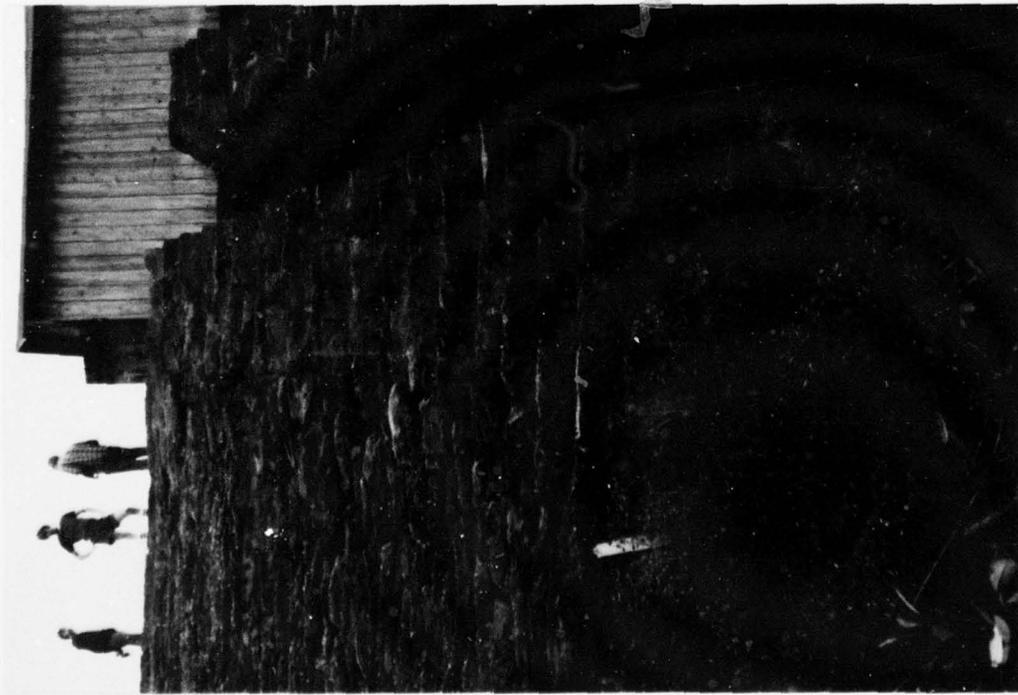
10) ABUTMENT WEST OF SLUICeways, NOTE
VERTICAL SETTLEMENT IN MASONRY

training wall there appears to be a settlement which has caused
a vertical displacement of stones approx 3"

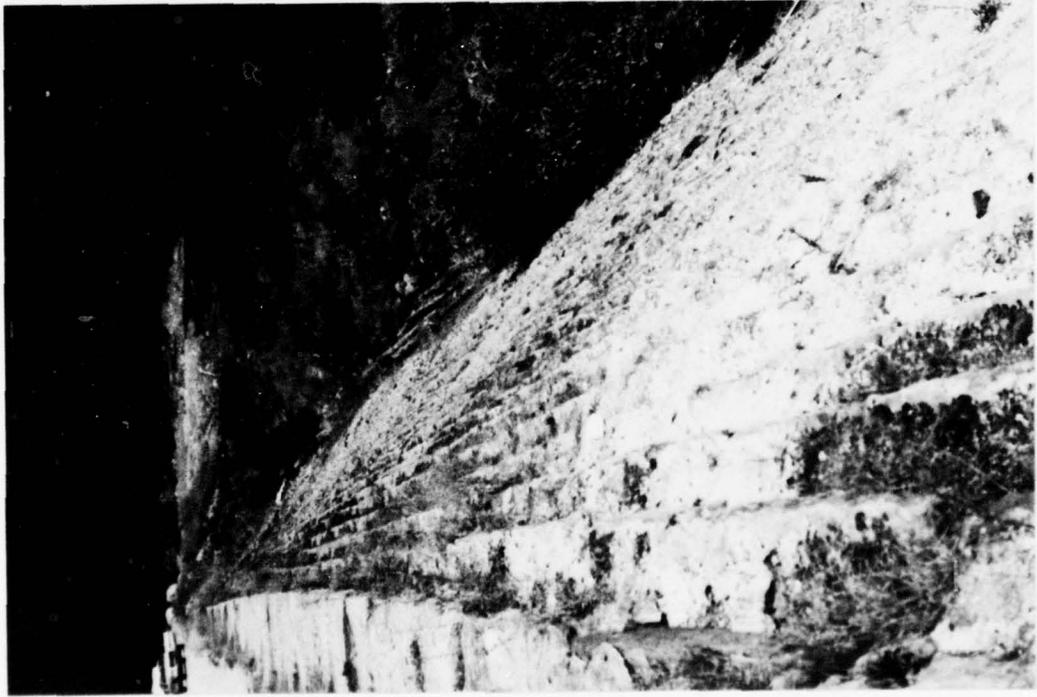
12) DEBRIS AND VEGETATION AT DOWNSTREAM TOE,
NOTE BULGES ON MASONRY FACE ABOVE LOG
PILE AND BUSHES

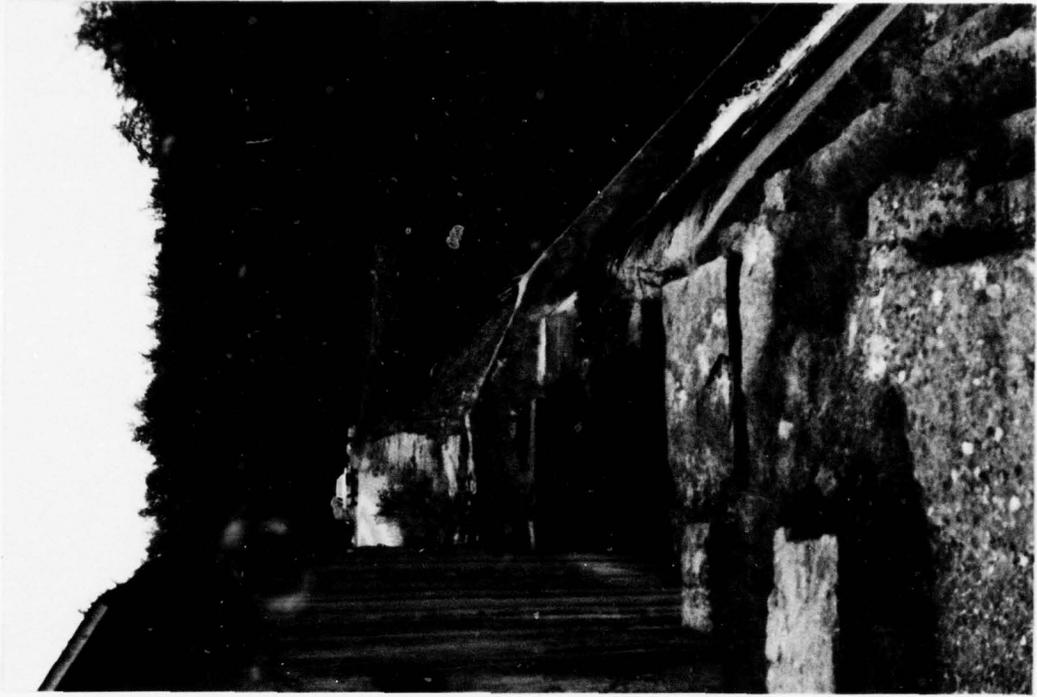
Crest alignment is generally good with only a few depressions created by traffic. An overlay of 65 tons of crushed rock rolled on to the crest road about 10 weeks before the inspection elevates only the road surface about 6 to 12 inches. The horizontal and vertical alignment of the embankment were good. It was observed that the downstream edge of the masonry crest, east of the gatehouse shows some curvature; however, no recent movement is apparent.

13) EAST VIEW ALONG DOWNSTREAM CREST,
NOTE CURVATURE ALONG CREST EDGE

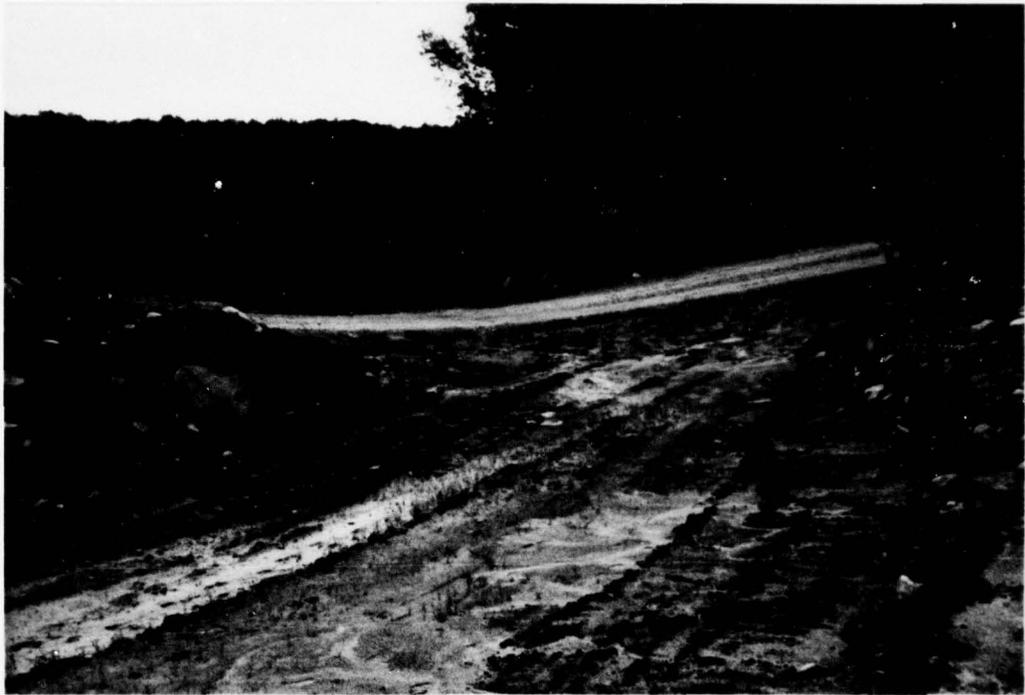
The auxiliary emergency spillway is an unfinished channel cut into natural ground at the east end of the dam. Some minor depressions and erosion gullies from runoff are noted. The gravel crest roadway crosses the channel near its entrance, the road surface being approximately 6 to 8 inches

15) UPSTREAM VIEW OF AUXILIARY EMERGENCY SPILLWAY

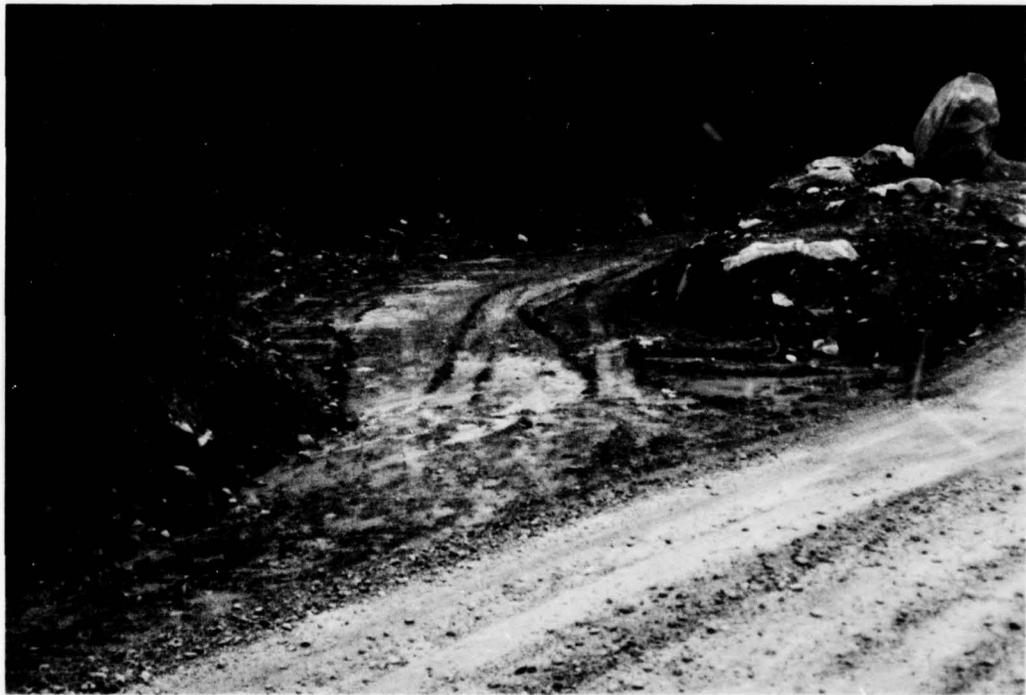
16) DOWNSTREAM VIEW OF AUXILIARY EMERGENCY SPILLWAY AND CHANNEL
