# INFRARED THERMOGRAPHY OF BUILDINGS

## Qualitative Analysis of Five Buildings at Rickenbacker Air Force Base, Columbus, Ohio

Richard H. Munis  
Stephen J. Marshall

September 1977

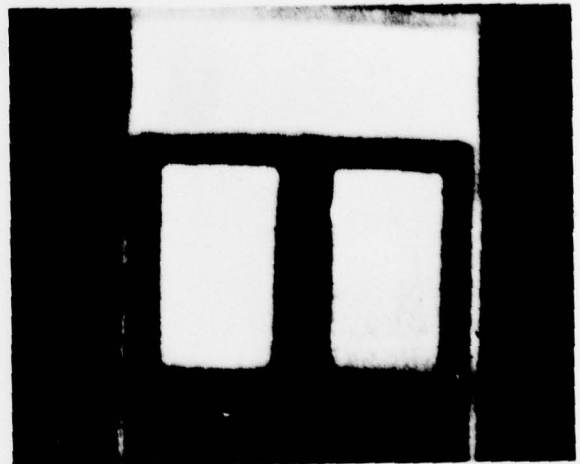
Figure 12 shows more heat loss from the single-pane glass above the two doors on the east face than from the single-pane glass in the two doors. Figures 13 and 14 show the same effect as shown in Figures 6 and 7 at the door on the north side of the building. Figures 15 and 16 show leakage around individual sash units. Figure 17 is a photograph of the south and east sides of this building.
