LAKE SEBAGO DAM  
ROCKLAND COUNTY  
NEW YORK  
INVENTORY NO 772

PHASE I INSPECTION REPORT  
NATIONAL DAM SAFETY PROGRAM

National Dam Safety Program. Lake Sebago  
Dam (772), Lower Hudson River Basin,  
Rockland County, New York. Phase I  
Inspection Report.

11 19 SEPTEMBER 1978

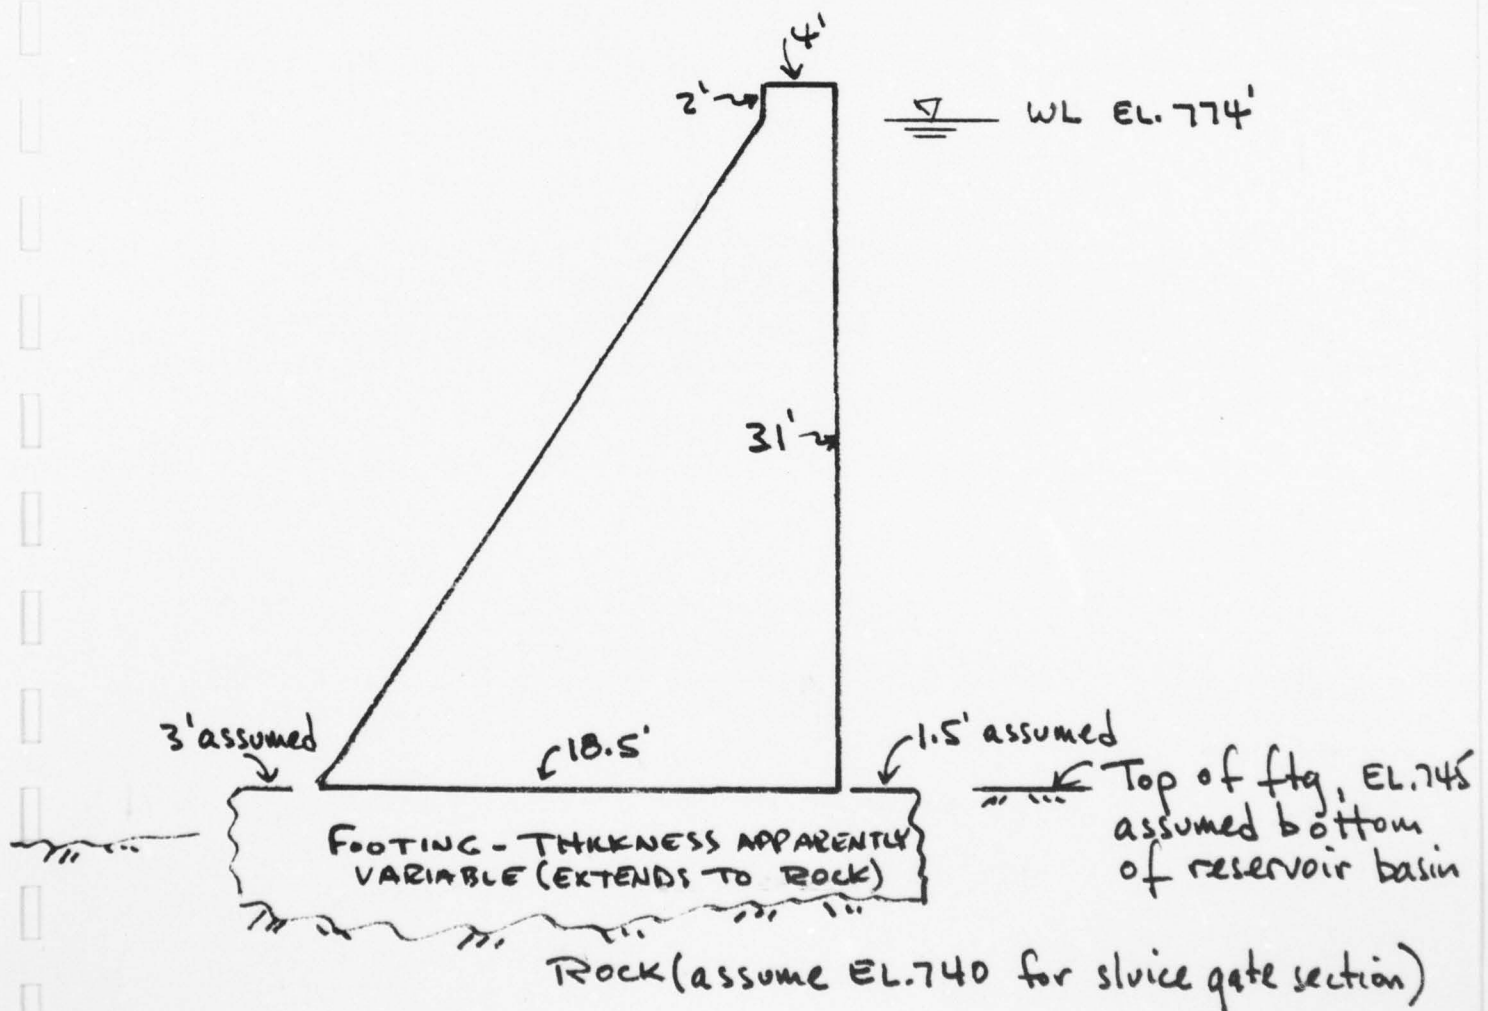
MASONRY/CONCRETE DAM

The analysis performed (See Appendix D) indicate unsatisfactory stability against overturning and sliding for the forces assumed (wherever the computed factors of safety under certain conditions approach unity; below unity is considered to be unstable).

Critical to the analysis and resulting indication of stability are the items of uplift water pressures acting on the foundation of the dam and the permeability of the sites foundation rock. The analysis uplift force was based on full headwater hydrostatic pressure acting on the dam's foundation upstream corner; tailwater hydrostatic pressure acting at the dams downstream corner was assumed to be zero pounds per square foot. The uplift pressures were assumed to vary linearly between upstream and downstream corners of the dam base, and were applied over 100 percent of the section. The resulting uplift is significant in arriving at the condition of low factors of safety against overturning/sliding.

Based on available information, stability of the concrete gravity sections of the dam is unsatisfactory. It is recommended that the owner have a licensed professional engineer perform a field investigation and engineering study, as necessary, to properly determine the conditions and effect of underdam seepage and more fully ascertain the seismicity of the reservoir area. The necessary engineering geology field explorations will include a geophysical investigation of the general area and subsurface exploration methods, such as borings, to obtain undisturbed rock samples to determine the engineering/geologic character and properties of the reservoir's foundation rock, and the installation of instruments for determining seepage pressures and gradients in the vicinity of the dam.
