**GRENLOCH LAKE DAM**

**NJ 00402**

**PHASE 1 INSPECTION REPORT  
NATIONAL DAM SAFETY PROGRAM**

**79 04 16 087**  
March, 1979

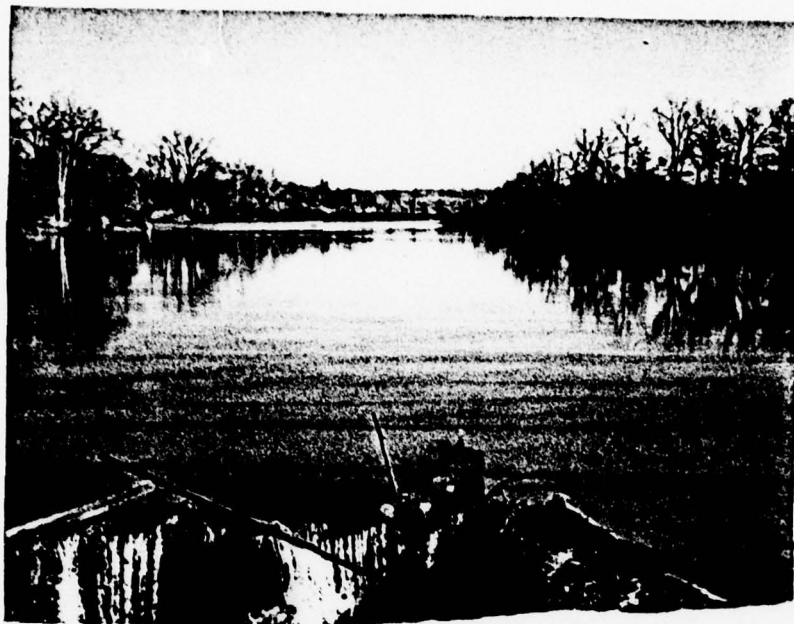
Grenloch Lake

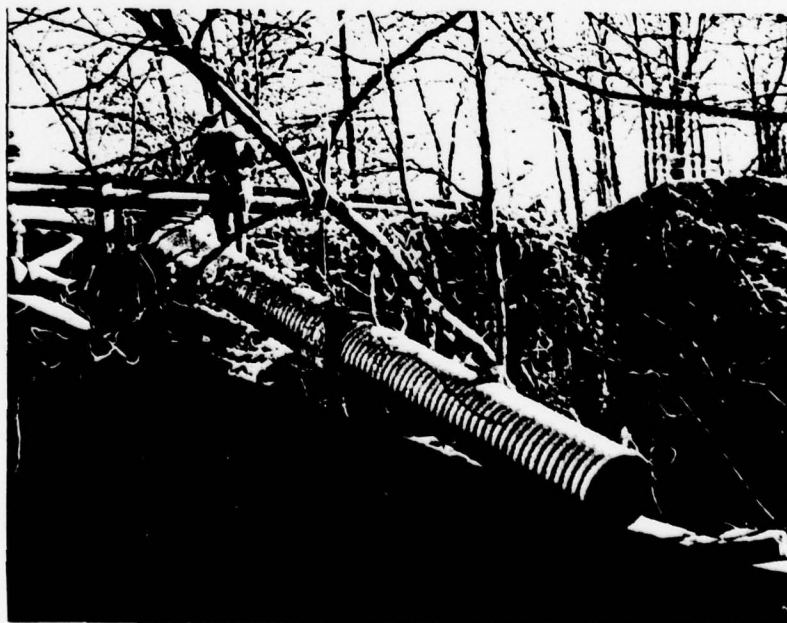
Surface drain pipe
