# LAKE MUSCONETCONG DAM

NJ 00328

PHASE 1 INSPECTION REPORT  
NATIONAL DAM SAFETY PROGRAM

Philadelphia District  
Corps of Engineers  
Philadelphia, Pennsylvania

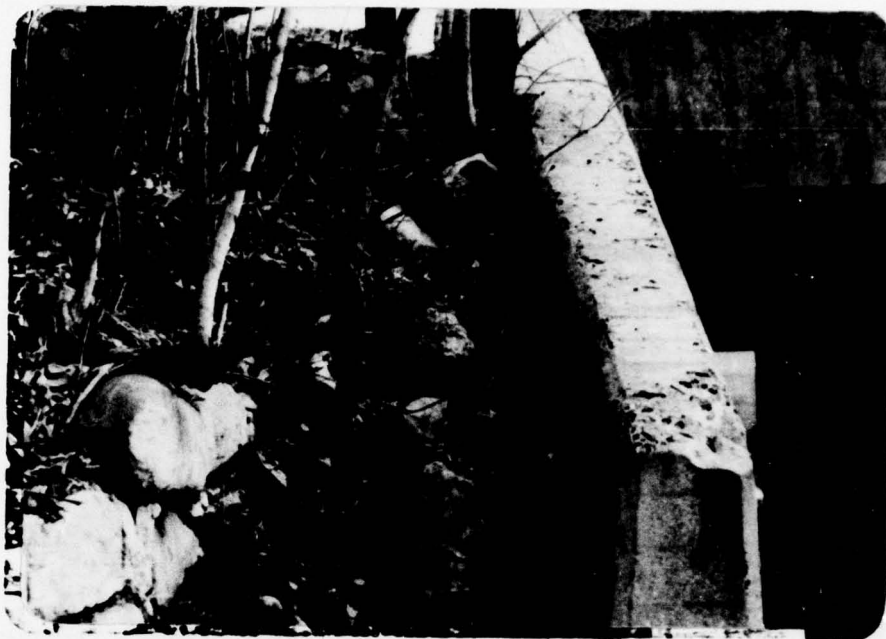
Erosion and spalled concrete      7 December 1978  
at right sidewall below culvert  
under Route 206.

5. Spalled and eroded areas on the downstream face of the spillway, the sidewalls, the discharge outlet structure, and the upstream end of the culvert under Route 206 should be repaired. This should be done in the near future.

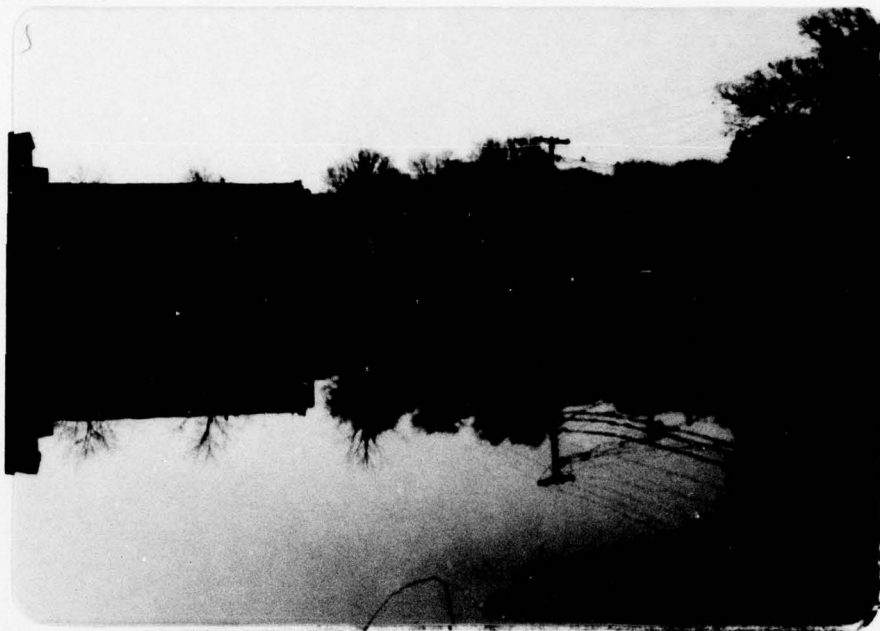
| VISUAL EXAMINATION OF | OBSERVATIONS | REMARKS OR RECOMMENDATIONS |
|---|---|---|
| STRUCTURE TO<br>ABUTMENT/EMBANKMENT<br>JUNCTIONS<br>(Direction: looking d/s) | At left end of spillway, erosion of<br>over 2 ft in depth and width of<br>15 ft and length of 25 ft. | Eroded area should be suitably<br>repaired. |

Left abutment area.  
Looking south.
