TIMBER LAKE DAM

NJ 00416

PHASE 1 INSPECTION REPORT
NATIONAL DAM SAFETY PROGRAM

May, 1979

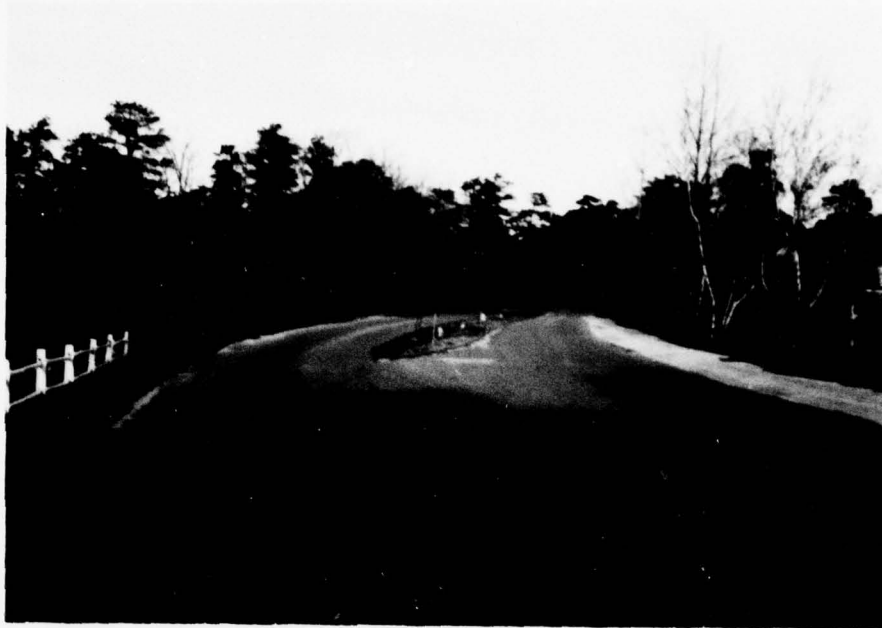
PHOTO 9
ROADWAY ON CREST OF DAM
