BIRCHWOOD LAKE DAM

NJ 00417

PHASE 1 INSPECTION REPORT NATIONAL DAM SAFETY PROGRAM

May, 1979

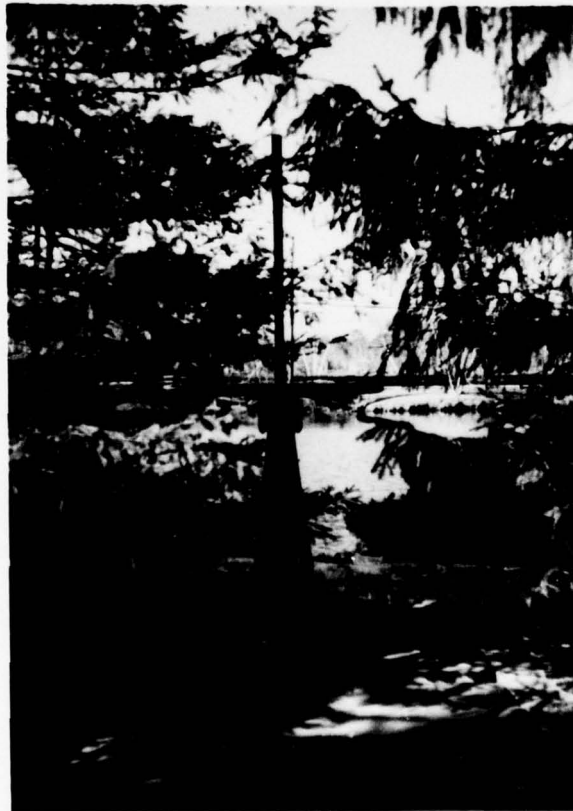
The outlet works, although fitted with a wheel mechanism for opening a slide gate, was observed to contain stoplogs in the same box manhole formerly containing the slide gate.

Maintenance of operating facilities such as the outlet works and the embankment sprinkler system is performed on an "as needed" basis. Approximately six years ago, the slide gate was replaced with stoplogs when the operating mechanism became inoperable.

PHOTO 2
OUTLET WORKS
OPERATING
MECHANISM.
