NANTICOKE RIVER BASIN
CLEAR BROOK, SUSSEX COUNTY
DELAWARE

WILLIAMS POND DAM DE 00064

PHASE 1 INSPECTION REPORT NATIONAL DAM SAFETY PROGRAM

April, 1979

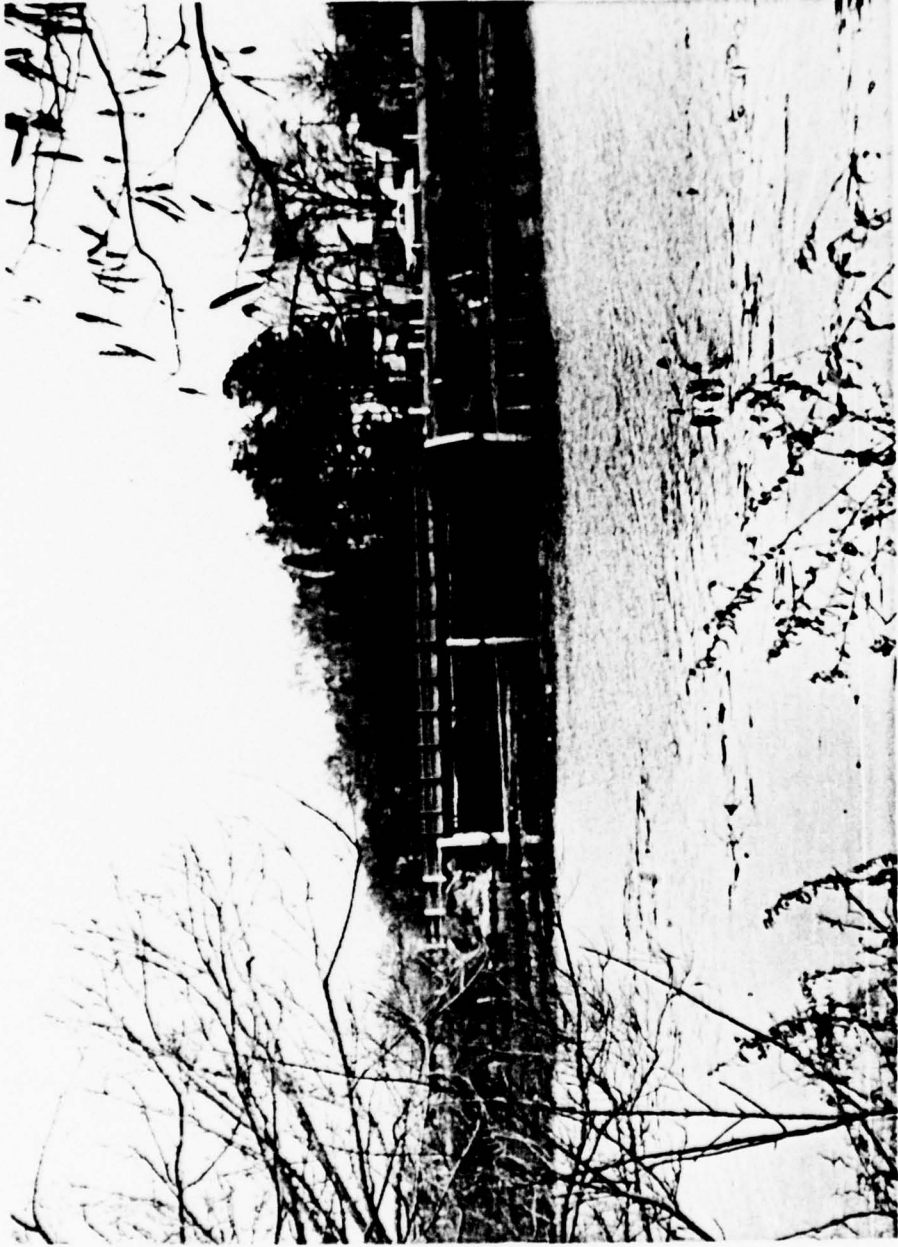
OVERALL VIEW
OF
DAM

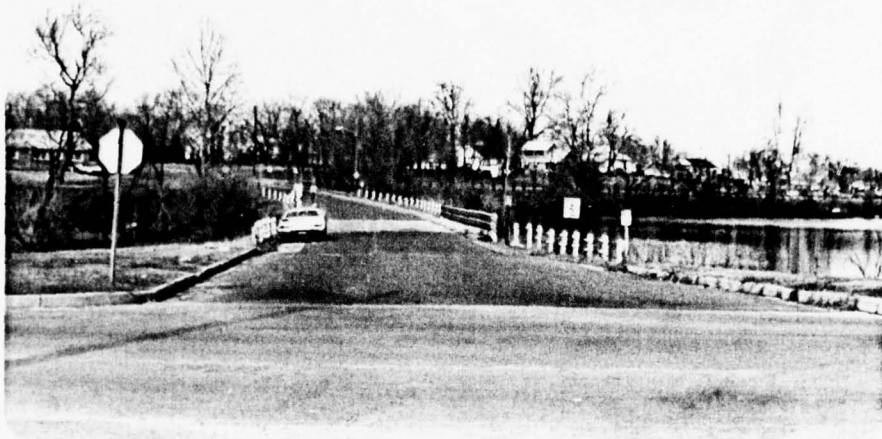
PHOTO 1
Poplar Street Over Williams
Pond Dam

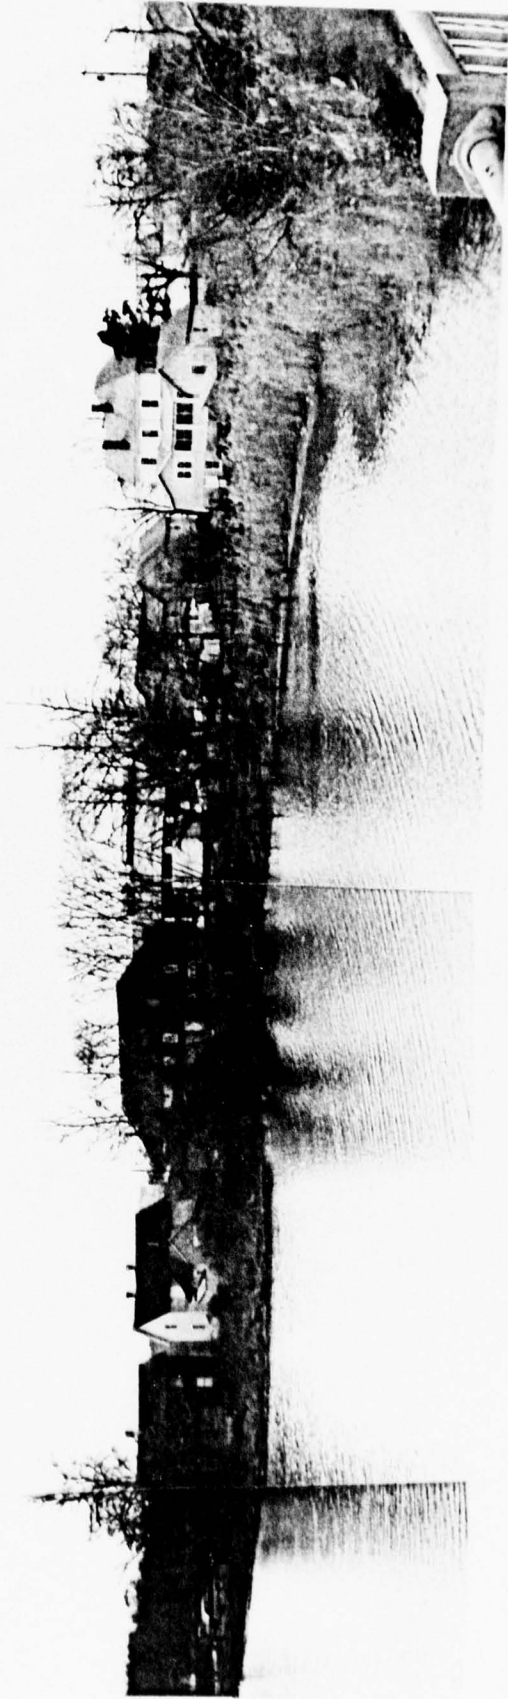
PHOTO 3
Williams Pond - Upstream Homes

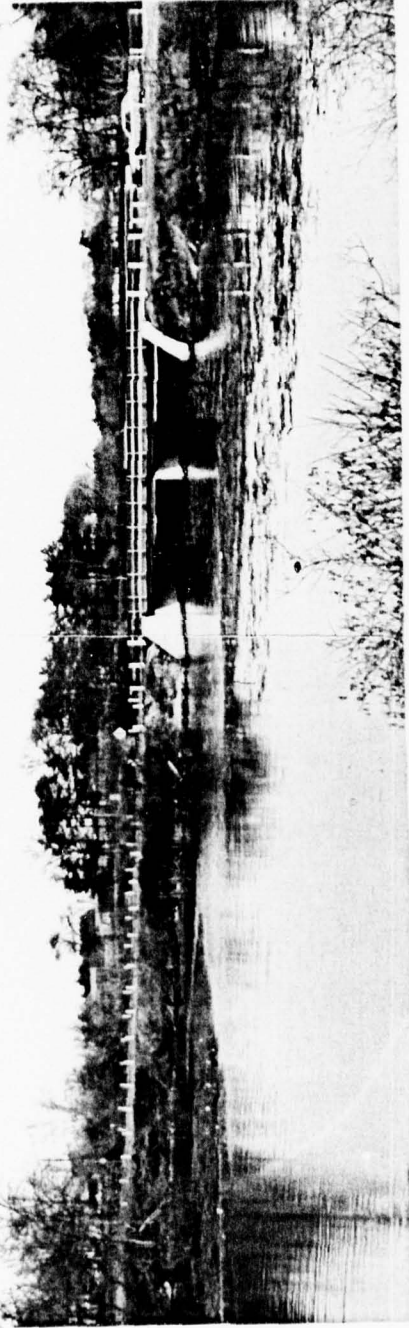
PHOTO 4
Downstream View - Williams Pond
and Embankment

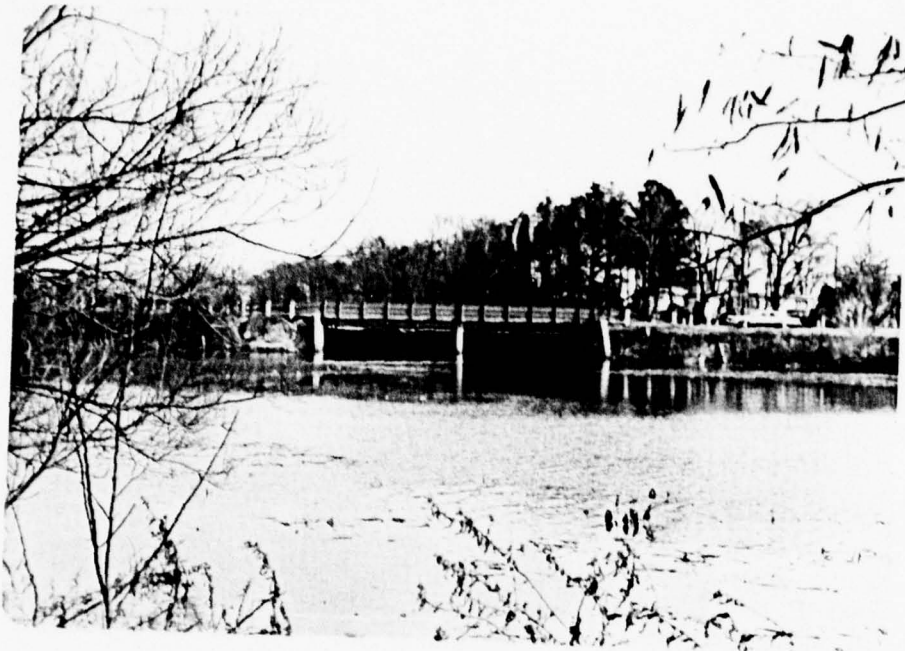
PHOTO 5
Downstream View-Williams Pond Dam

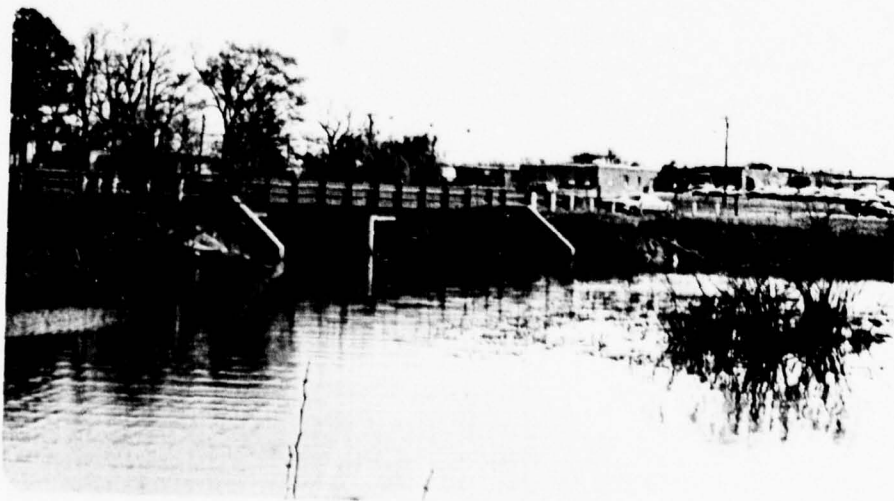
PHOTO 6
Downstream View-Williams Pond Dam

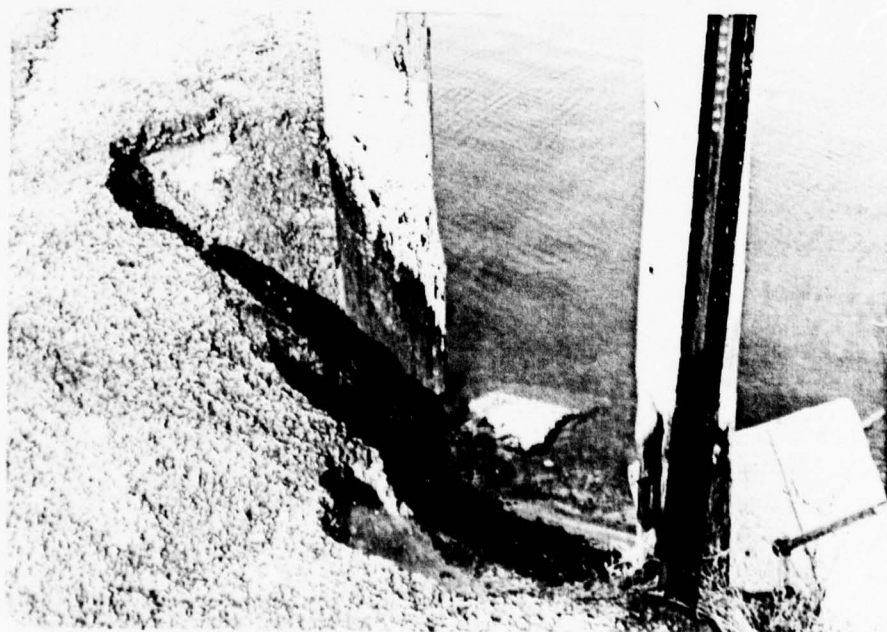
No visible signs of movement either vertically or horizontally were evident. Erosion to the embankment has occurred adjacent to the downstream wingwalls, apparently occurring from poor control of road surface run-off. The total depth of the eroded channels approaches 3 feet. Further, slight erosion is occurring on the upstream side of the embankment at its junction with the dam structure. No seepage was observed in the embankment.

PHOTO 8
Eroded Upstream Embankment
Williams Pond

The erosion occurring at the earthfill embankments should be repaired in the future.

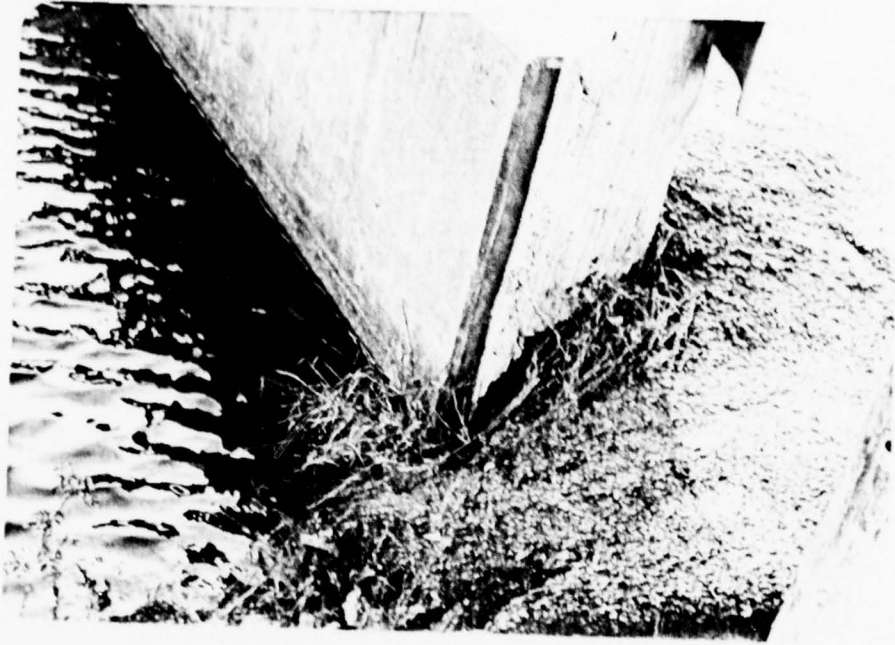
Normal maintenance procedures are accomplished on a bi-annual inspection and repair basis, scheduled by the Delaware Department of Transportation, the only changes, visually observed, are erosion control techniques used to stabilize the earth embankment.

PHOTO 9
Bituminous Paving Installed To
Correct/Prevent Erosion-Williams
Pond

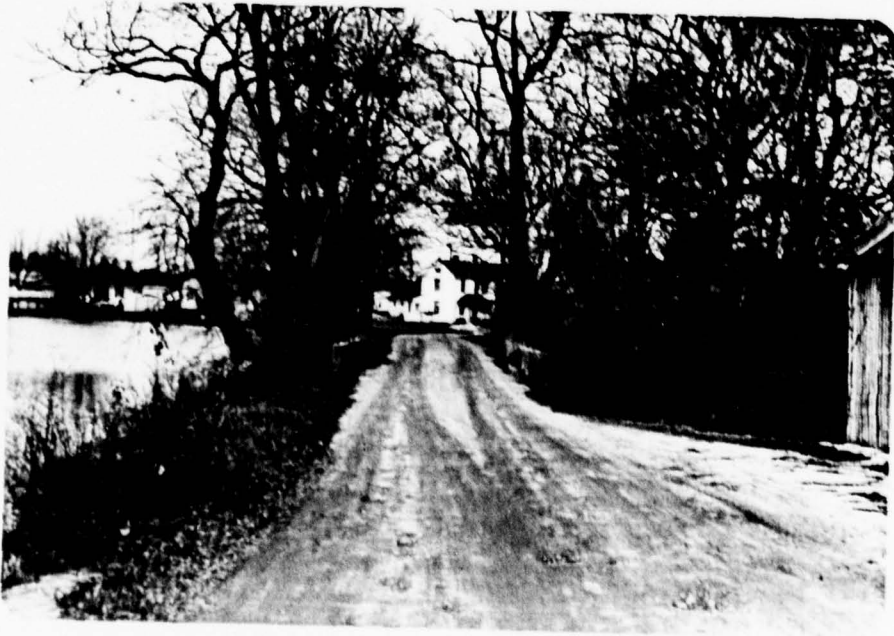
PHOTO 10
Hearns Pond Mill Road Over
Embankment and Dams - 7140 Feet
Upstream of Williams Pond

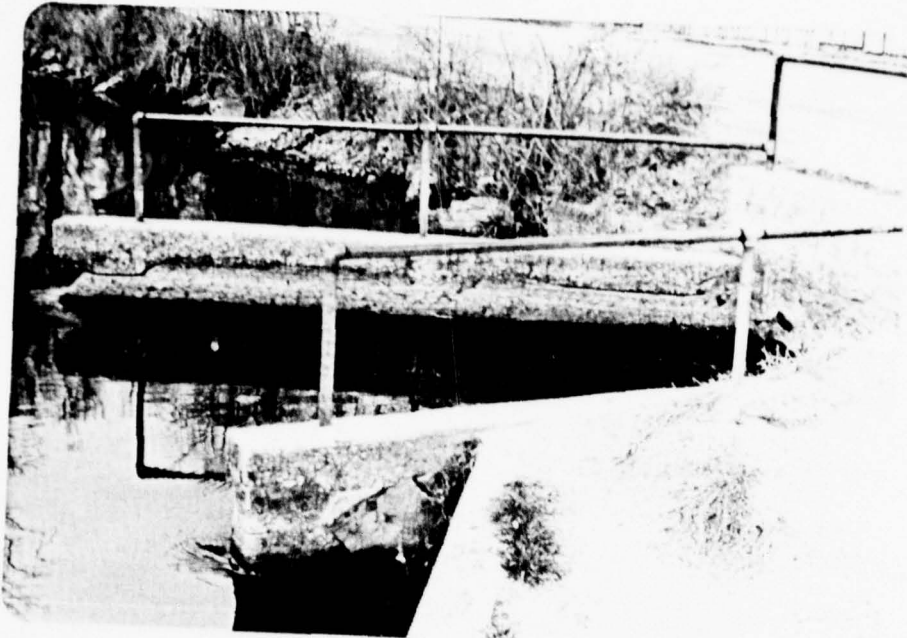
PHOTO 11
Hearns Pond Mill Inlet

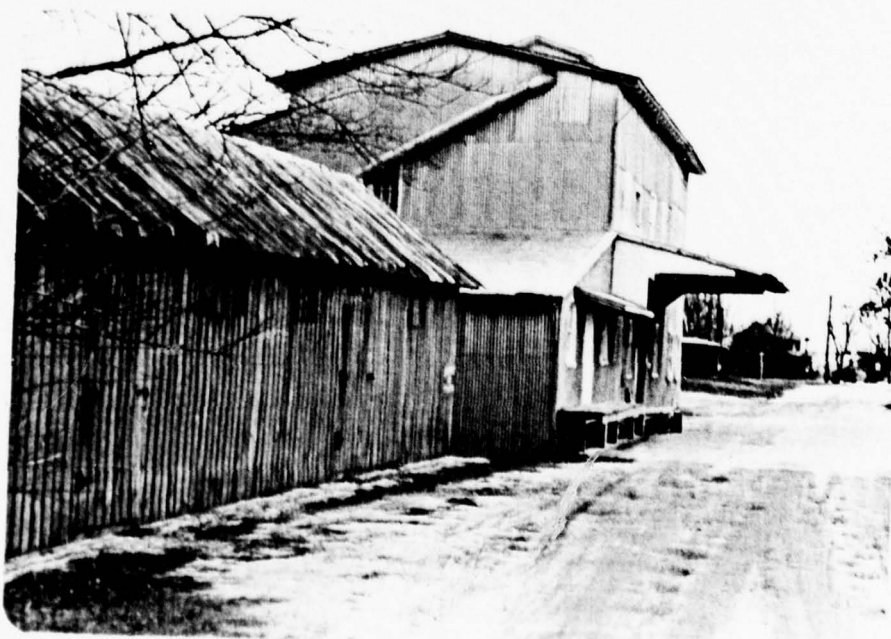
PHOTO 12
Hearns Pond Mill Building

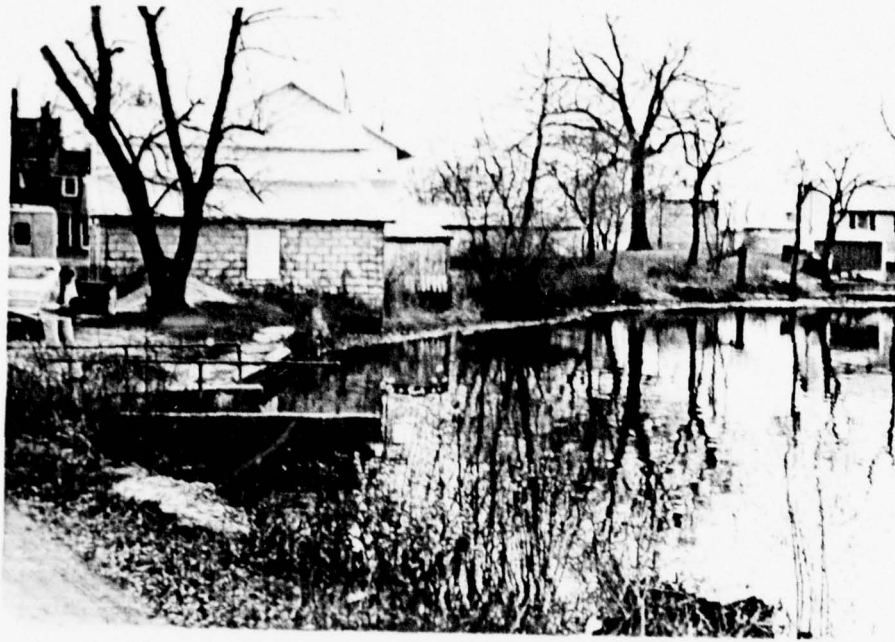
PHOTO 13
Upstream View-Hearn's Pond & Dam

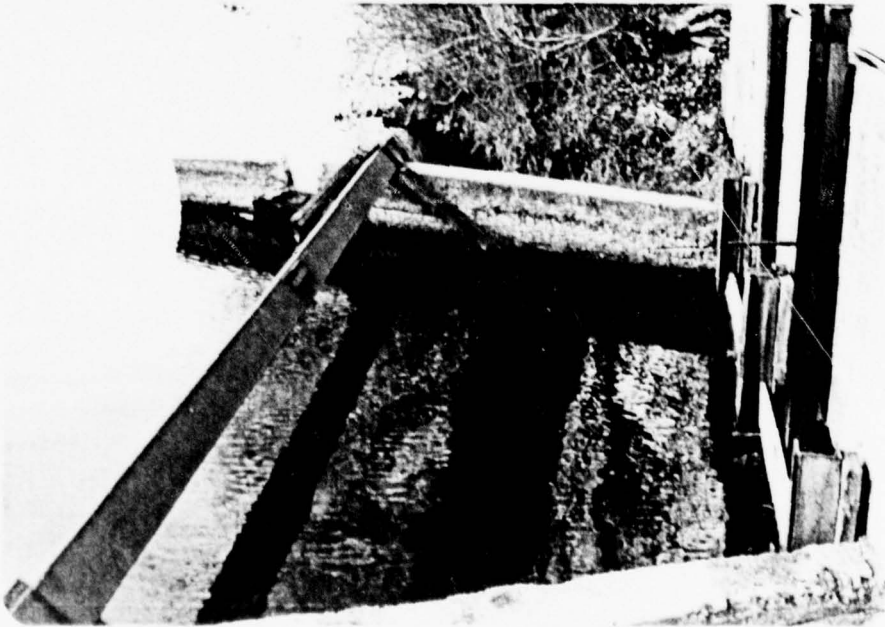
- Photo 14 - Closeup of upstream inlet control at Hearns Pond main road dam structure.

PHOTO 14
Upstream View - Hearn's Pond Dam
