ATLANTIC COAST BASIN
QUIGLEY CREEK
MONMOUTH COUNTY
NEW JERSEY

SHADOW LAKE DAM

NJ 00090

PHASE 1 INSPECTION REPORT NATIONAL DAM SAFETY PROGRAM

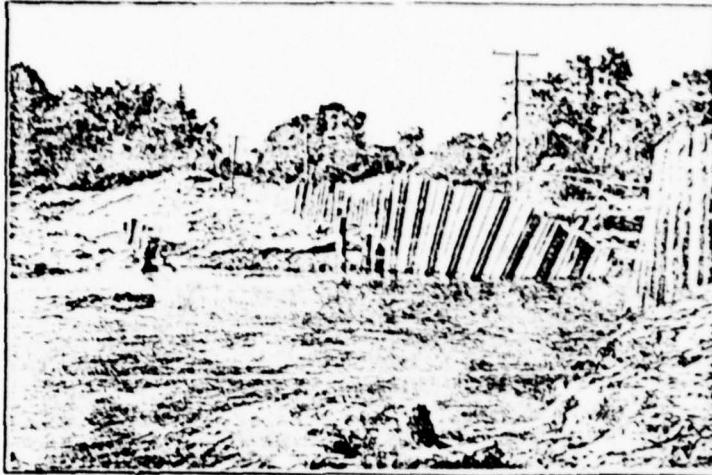
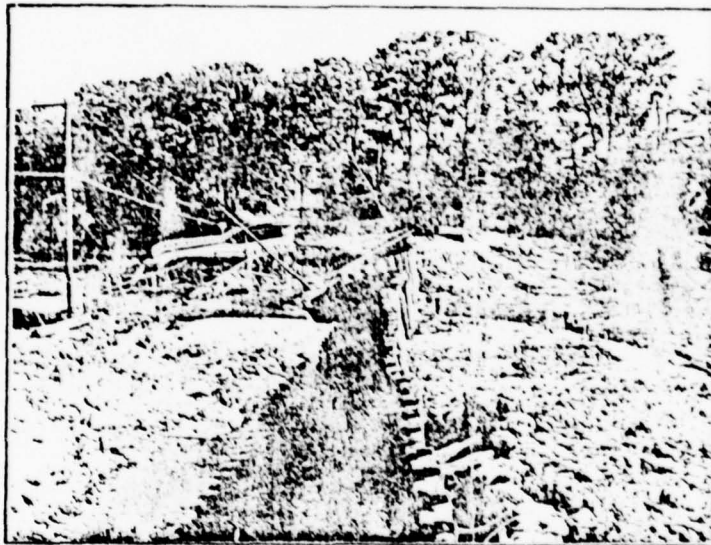
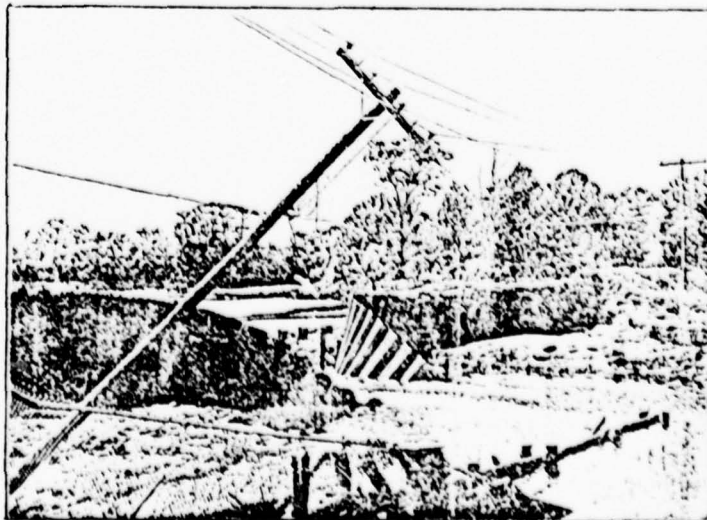
1938
FAILURE
Figure 4

Looking North Sept. 1938

Looking South Sept. 1938

Breached Area Sept. 1938

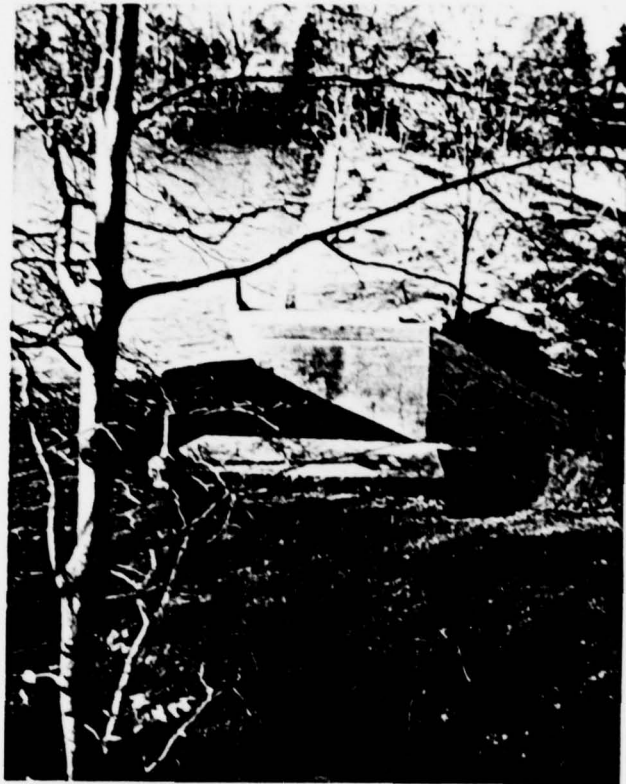
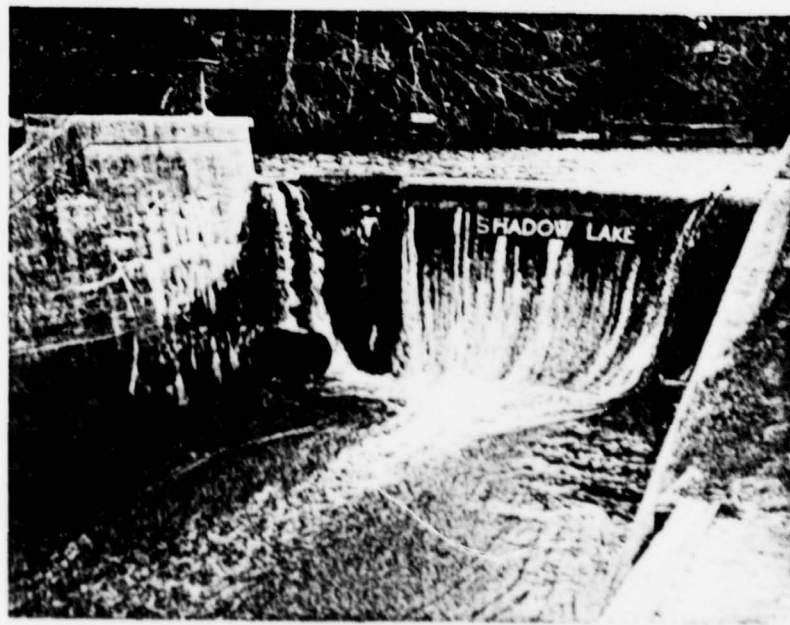
The two spillways exhibit some weathering reflecting their age but are in basically sound structural condition. The main circular crest has a 23-foot depressed notch in the center portion of the overflow lip and the sides, which are about 6 inches higher, are badly spalled and cracked. However, the overall structure appears in an integral condition with no differential settlement or tilting observed.

VISUAL EXAMINATION OF	OBSERVATIONS	REMARKS OR RECOMMENDATIONS
SURFACE CRACKS CONCRETE SURFACES	<p>Main spillway: Deterioration of crest lip. Extensive spalling of upstream face of weir at waterline. Auxiliary spillway: Superficial cracks on spillway as well as some spalling on broad crested weir.</p>	<p>Approximately 2½' section of lip has broken off on main spillway.</p>
STRUCTURAL CRACKING	<p>See previous page</p>	
VERTICAL AND HORIZONTAL ALIGNMENT	<p>Satisfactory</p>	
MONOLITH JOINTS	<p>None</p>	
CONSTRUCTION JOINTS	<p>Satisfactory</p>	<p>Spillway structures old but in fairly good condition.</p>

Main Spillway

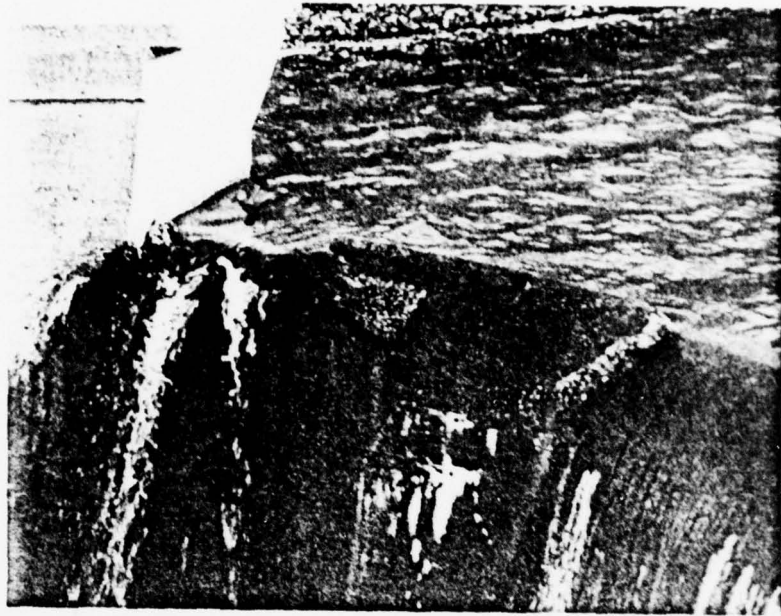
No records are available but the spillways operate satisfactorily and exhibit little structural deterioration except for the top of the ogee lip on the main circular spillway. The downstream toe of embankment which, in effect, forms the westerly shoulder of the Nut Swamp Road travelled way appears to be a continual maintenance problem, with clogged drains and roadway run-off ponding in the low spots. Heavy storm flows over the spillways appear to be continuously damaging both downstream road structures. As previously stated, the 5' x 9' culvert at the north spillway has shifted laterally and

Deterioration of main spillway crest

On the basis of the present conditions and structural geometry, improvements to the existing spillways are not warranted. The deteriorated areas of the concrete work should be patched, especially on the top of the curved ogee crest of the main spillway.

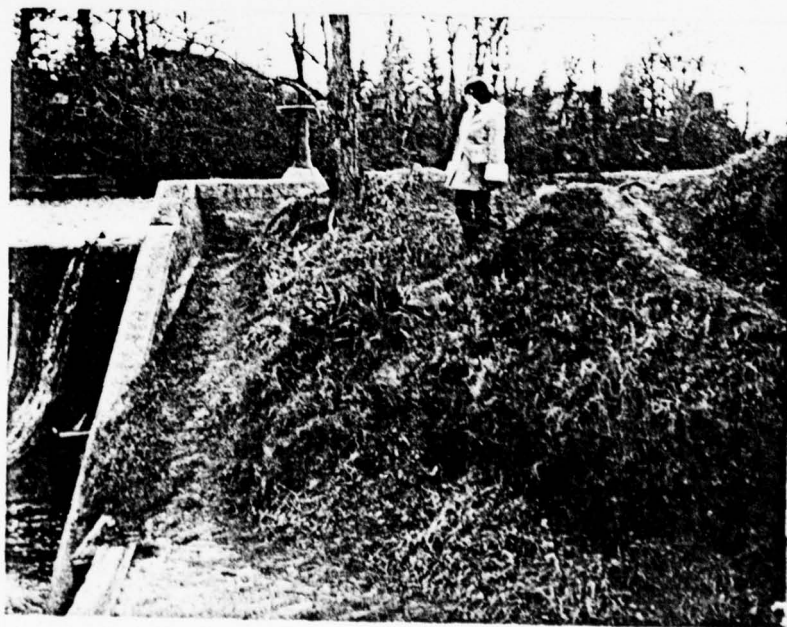
The embankment portion and timber bulkhead were found to be in a satisfactory condition and stable except for deep erosion which has developed behind both wingwalls of the main spillway. The backslopes are covered with grass and occasional bushes. The alignment of the bulkhead is slightly distorted but is in overall good condition. Minor sections of the timber whalers are rotted but this could be easily repaired. There was little evidence of any seepage, although much of the backslope area was frozen. Water was flowing into the auxiliary spillway through a CMP in the north wingwall. It could not be determined whether this was a cut-off pipe outlet or a roadway drain. From earlier records, it is doubtful that any cut-off drains were ever installed. The sloughed areas at the toe of the backslopes are of minor concern and could possibly be caused by clogged roadway drains and vehicular splashing rather than a result of seepage. Water appears to have accumulated in several low areas on the west pavement edge.

Erosion behind left wingwall of main spillway

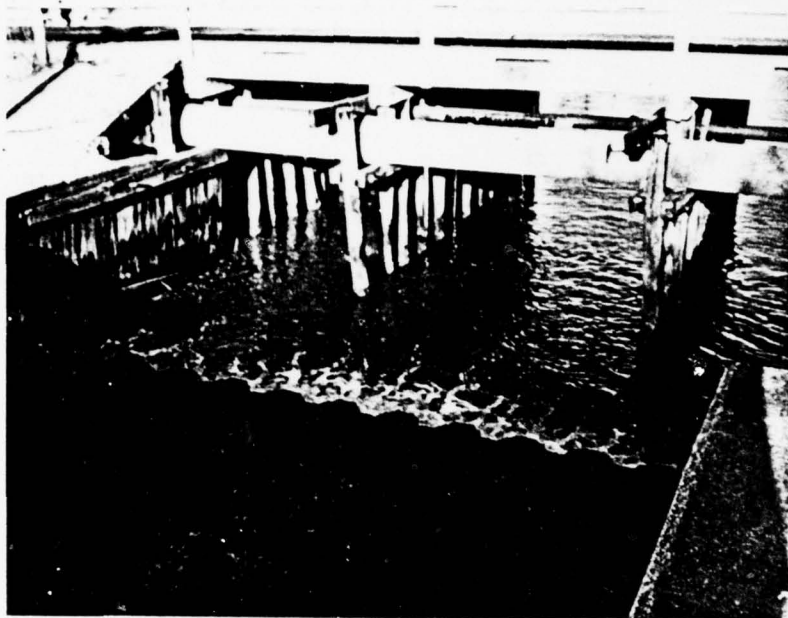
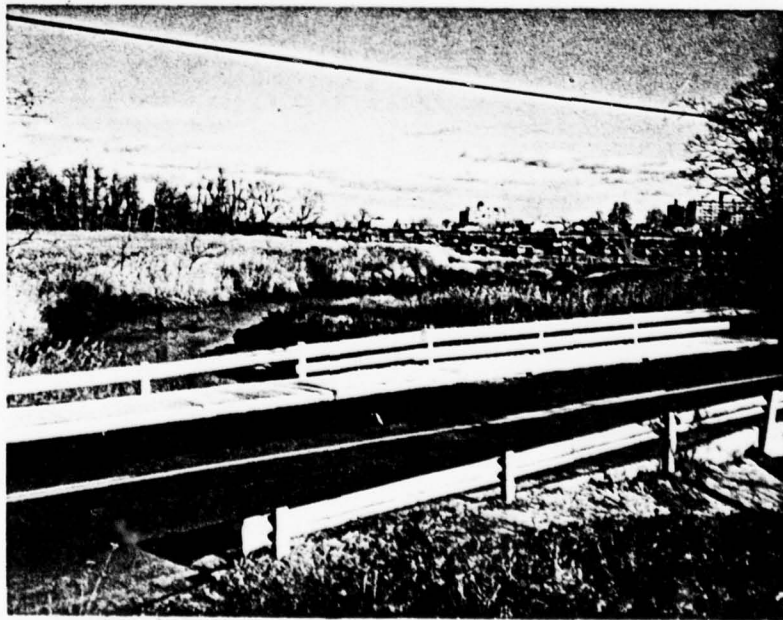
The 24" sluice gates are located on each side of the spillway and discharge directly onto the circular sill below. They appear to be operable. Discharge from the spillway apron flows directly into the Navesink River tidal marshland immediately to the east thru a timber trestle structure under Nut Swamp Road. This bridge is hydraulically inadequate to handle the spillway discharge and is of dubious structural strength. A 20" water main is carried along the west fascia which additionally restricts the hydraulic opening.

VISUAL EXAMINATION OF	OBSERVATIONS	REMARKS OR RECOMMENDATIONS
CONCRETE WEIR	Main spillway: narrow crested arch ogee weir (see plans)	
APPROACH CHANNEL	None	
DISCHARGE CHANNEL	See above	
BRIDGE AND PIERS	Satisfactory but hydraulically restricted.	Bridge below auxiliary spillway has foundation failure at NW corner (settled 4"+). Road bridge below main spillway hydraulically blocked by 24" line.

Bridge below Main Spillway

g. An engineering investigation should be made of the hydraulic capacity of the downstream Nut Swamp Road bridges in cooperation with the owner of these structures. This investigation should determine the necessity of developing remedial measures to increase the hydraulic capacity of the timber trestle and box culvert to adequately pass the spillway discharges from the dam.
